# Corporate Bridge Register (CBR) Structure Inventory Data Form "BRIDGES"

**Routine Condition Bridge Inspection Form**  
(except for log stringer or timber stringer bridges)

| GENERAL INFORMATION | | (enter either long/lat or UTM - not both) | | |
|---|---|---|---|---|
| Site # | CK2102 | Structure # | | |
| FSR Name | FLORENCE ROCKY | User km | 0.9 | Project File ID 8648 |

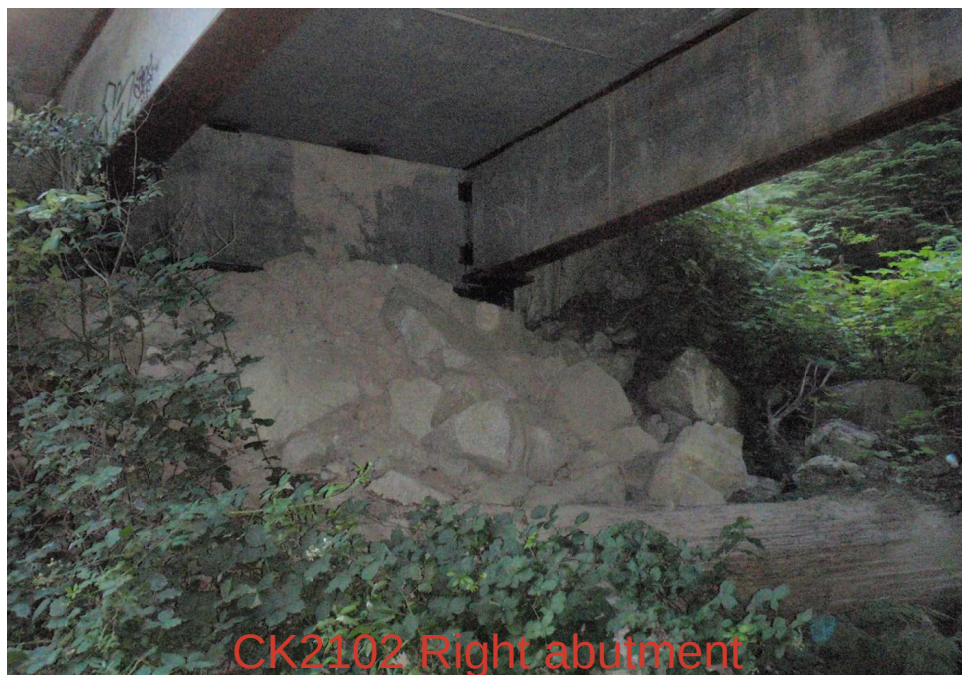
CK2102 Right abutment

| GENERAL INFORMATION | | (enter either long/lat or UTM - not both) | | |
|---|---|---|---|---|
| Caps or Sills | E (G) F P | RUBBER PADS | | |
| Piles or Posts | E (G) F P (N/A) | PILE RIGID & SPREAD FOOT. | | |
| Ballast Wall | E (G) F P | INJECT CONCR. | | |
| Bearings | E G (F) P | SOME OF RUBBER PADS BUILDING UP | | |
