# Corporate Bridge Register (CBR) Structure Inventory Data Form "BRIDGES"

| *Forest Service Road: Harrison East | Kilometres: 64.4 |

CK-2116

**Routine Condition Bridge Inspection Form**  
(for log stringer or timber stringer bridges)

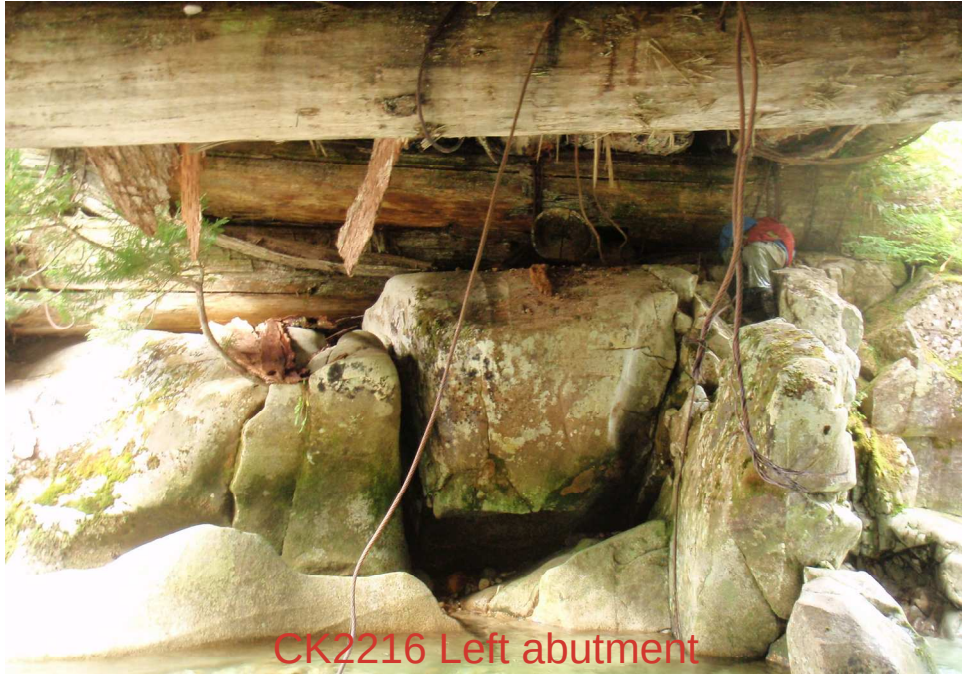
CK2216 Left abutment

| GENERAL INFORMATION | | | | (enter either long/lat or UTM below - not both) | | | |
|---|---|---|---|---|---|--|--|
| Log/Timber Cribs | E G <u>(F)</u> P N/A UR | | <u>2x CRIB CLOSED TIED - LARGE CHECKS</u> | | | | |
| Hardware | E G F P N/A UR | | <u>LAMBS AT SANDS. LASHING LOOSE</u> | | | | |

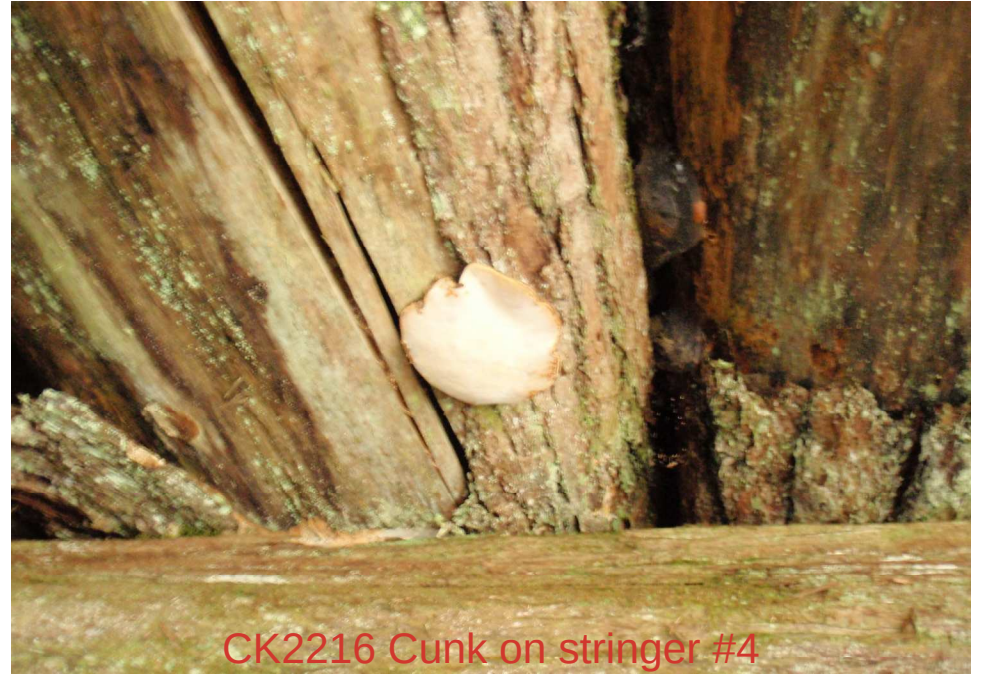
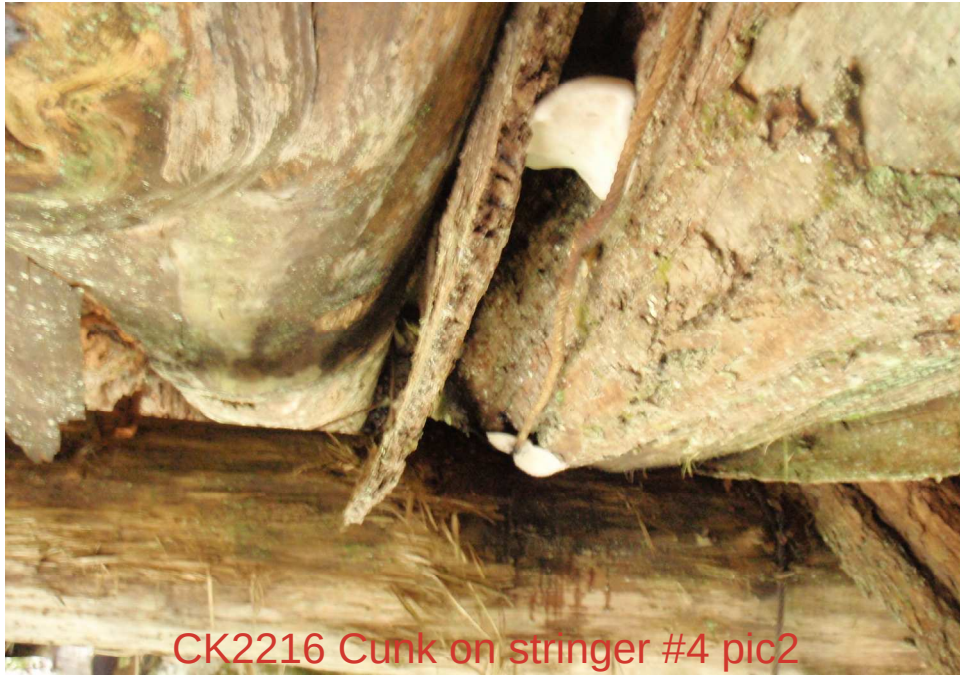
| GENERAL INFORMATION | | | | | | | |
|---|---|---|---|---|---|---|---|
| 4 | " | Y <u>N</u> | 116 | | | | ROTTEN - CUNKS |

CK2216 Cunk on stringer #4

CK2216 Cunk on stringer #4 pic2

| GENERAL INFORMATION | | | | | | | |
|---|---|---|---|---|---|---|---|
| P Eng Reviewer's Comments<br>Close bridge by barricades or remove bridge. | | | | | | | |

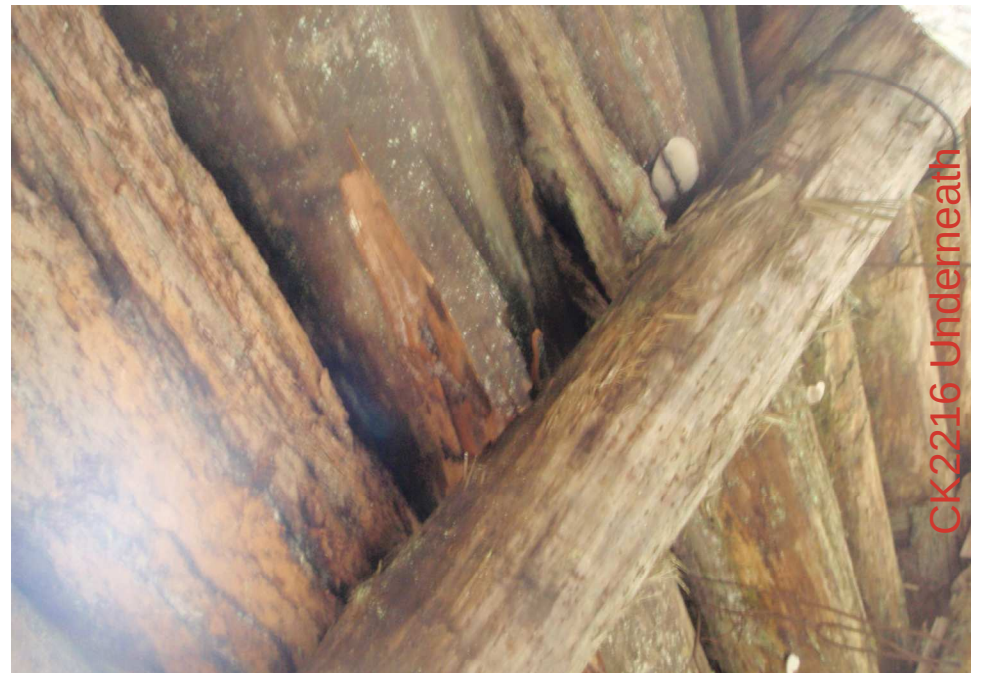
CK2216 Underneath

| GENERAL INFORMATION | | | | | | | |
|---|---|---|---|---|---|---|---|
| Needle Beams and Shims | E G F <u>P</u> N/A UR | | | NOT PROPERLY LASHED. | | | |
| 10 | | Y <u>N</u> | | | | | 2 needle beams not properly lashed. |

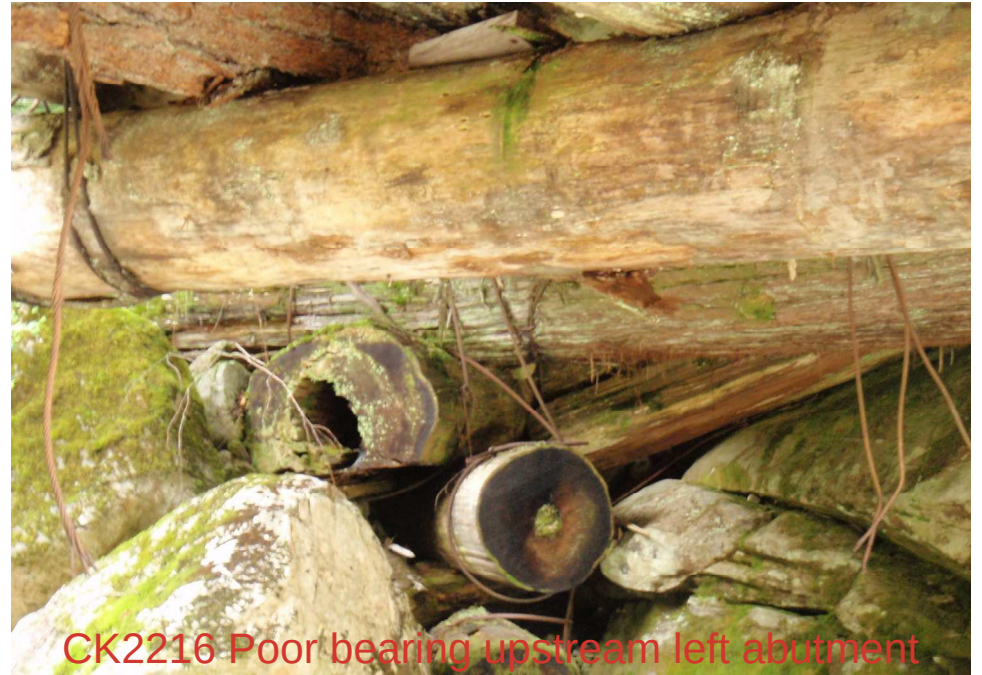
| GENERAL INFORMATION | | | | (enter either long/lat or UTM below - not both) | | | |
|---|---|---|---|---|---|--|--|
| Bearings | E G F <u>(P)</u> N/A UR | | <u>LEFT ABUT. BOTTOM LOG BEARS DIRECTLY ON POTENTIAL TIEBACK. NOT ON GROUND. SEE PHOTOS</u> | | | | |

| GENERAL INFORMATION | | | | | | | |
|---|---|---|---|---|---|---|---|
| Inspector's Comments<br>STRINGERS & ABUT IN POOR CONDITION. THE BEAKING ON THE LEFT ABUTMENT SHOULD BE CHECKED BY A P. Eng. | | | | | | | |

CK2216 Poor bearing upstream left abutment
