## Corporate Bridge Register (CBR) Structure Inventory Data Form "BRIDGES"

CK-2144

**Routine Condition Bridge Inspection Form**  
(except for log stringer or timber stringer bridges)

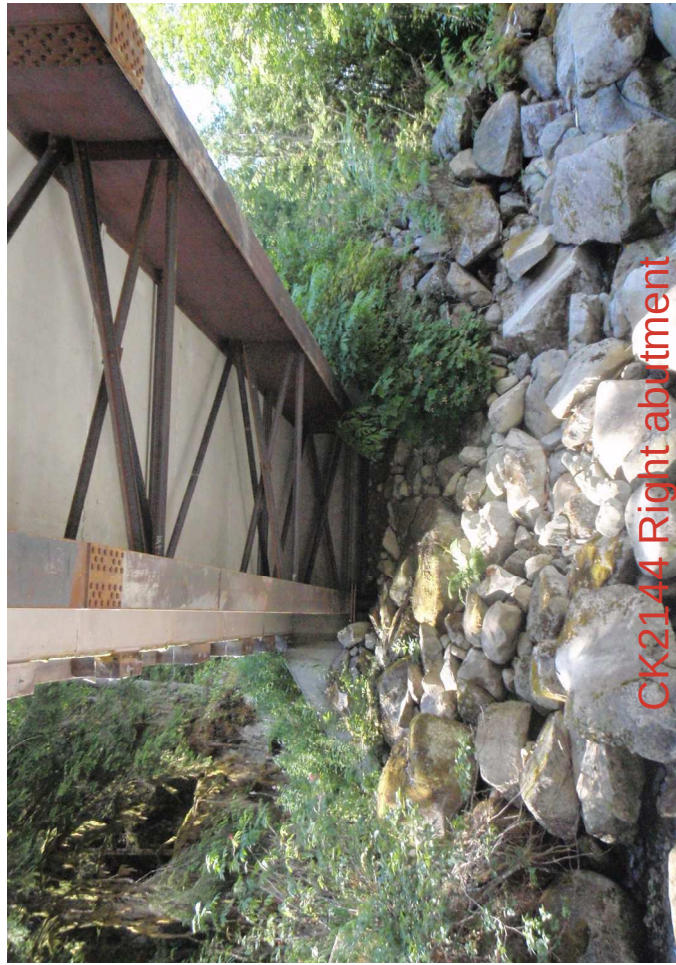
CK2144 Right abutment

| GENERAL INFORMATION | | | | (enter either long/lat or UTM below -- not both) | | | |
|---|---|---|---|---|--|--|--|
| Ballast Wall | E G <u>(F)</u> P N/A UR | TOP OF BALLAST WALL DAMAGED DUE TO LARGE POTHOLES ON APPROACHES. THE RIGHT BALLAST WALL: RE BAR SHOWING | | | | | |
