| | <b>Corporate Bridge Register (CBR)</b><br><b>Structure Inventory Data Form "BRIDGES"</b> |

| *Forest Service Road: HUNTER EAST | Kilometres: 5.8 |

**Routine Condition Bridge Inspection Form**  
(except for log stringer or timber stringer bridges)

| GENERAL INFORMATION | | | | (enter either long/lat or UTM below - not both) | | | |
|---|---|---|---|---|--|--|--|
| *Site #: CK-2161 | *Crossing Name: | *Type/Class: <input type="checkbox"/> Temporary bridge<br><input checked="" type="checkbox"/> Permanent bridge | *Project File ID# 6086 | | | | |

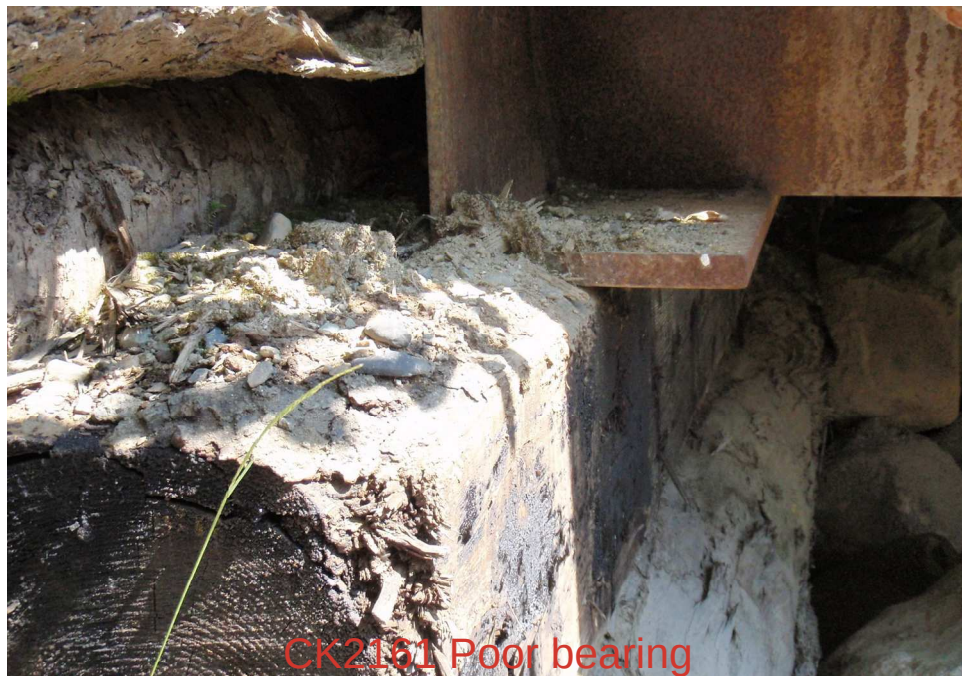
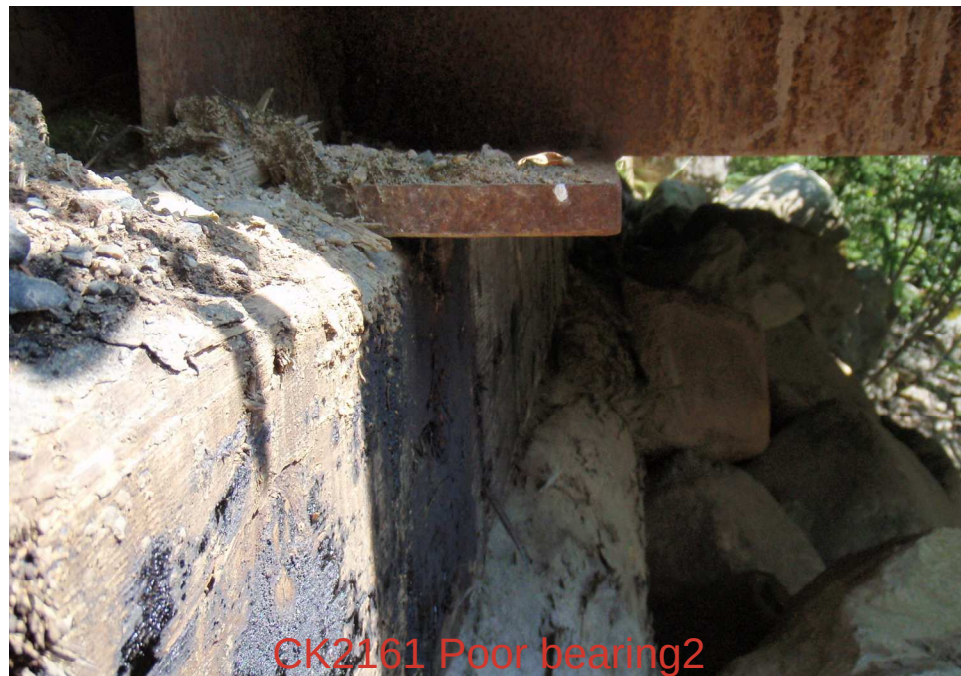
| GENERAL INFORMATION | | | | (enter either long/lat or UTM below - not both) | | | |
|---|---|---|---|---|--|--|--|
| Caps or Sills | E G F (P) (N/A) UR | | TREATED SILL THE BEARING PLATE ON RIGHT ABUT | | | | |
| Piles or Posts | E G F P N/A UR | | DOESN'T BEAR ENTIRELY ON SILL. | | | | |
| Bearings | E G F (P) N/A UR | | BEARING PLATE DOESN'T BEAR ENTIRELY ON SILL. | | | | |

CK2161 Poor bearing

CK2161 Poor bearing2

Bearing support is only partial at one end and is poor. Sill plate is rotting at other end. Riprap needs work. Bridge needs to be reinstalled asap. Continued current rating is provided for short term only to enable continued industrial traffic until re-installation is completed.

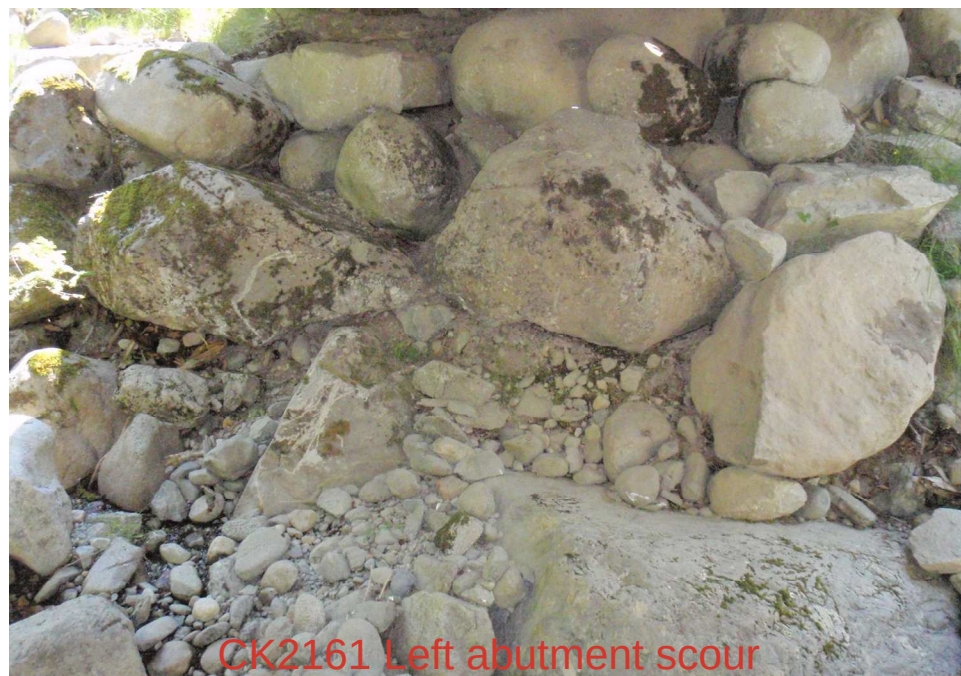
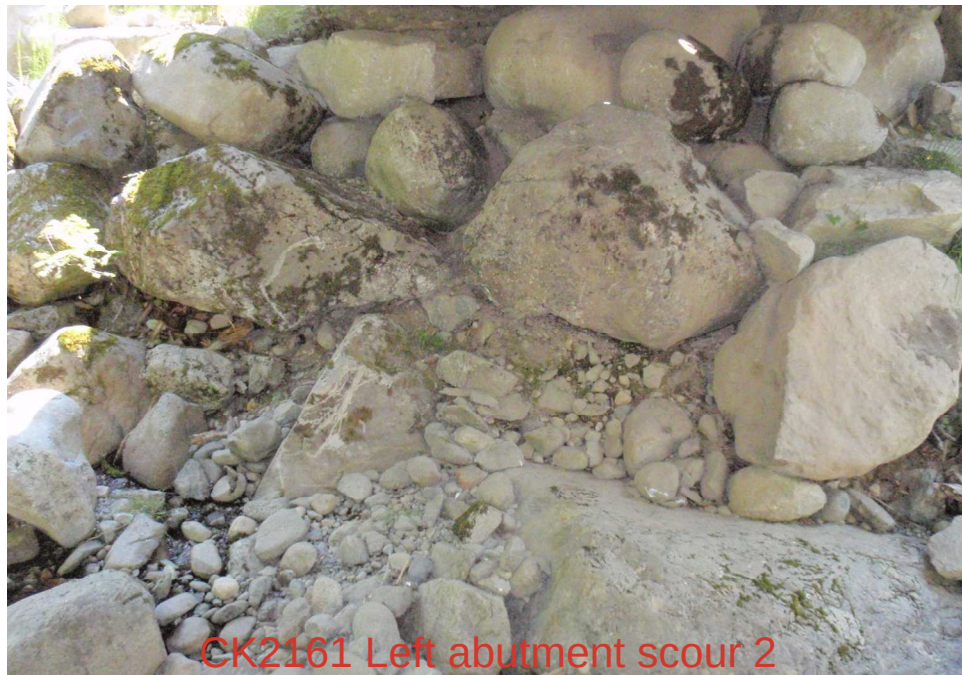
| GENERAL INFORMATION | | | | (enter either long/lat or UTM below - not both) | | | |
|---|---|---|---|---|--|--|--|
| Riprap | E G F (P) N/A UR | | RIP RAP STACKED ALMOST VERTICALLY. THE TOE ON LEFT ABUT | | | | |
| Corrosion Protection | E G F P N/A UR | | STARTING TO SCORING. | | | | |

| GENERAL INFORMATION | | | | |
|---|---|---|---|---|
| Comments <u>TBE IF RIP RAP ON LEFT ABUT.</u> | | | | |
| 1 | RIP RAP AT VERY STEEP ANGLE. FOOTINGS CAN EASILY BE EXPOSED WITHOUT | | | |
| 2 | ADEQUATE RIP RAP | | | |

CK2161 Left abutment scour

CK2161 Left abutment scour 2

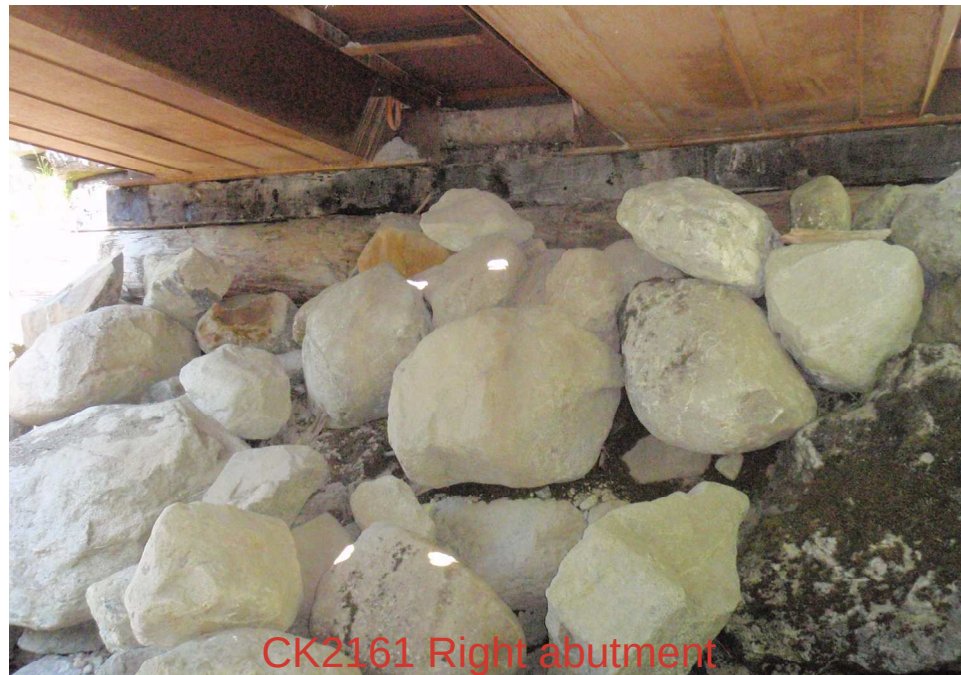
CK2161 Right abutment

| GENERAL INFORMATION | | | | (enter either long/lat or UTM below - not both) | | | |
|---|---|---|---|---|--|--|--|
| Concrete (cast in place; lock blocks, precast) | E G F P (N/A) UR | | TIMBER ON RIGHT ABUT. | | | | |

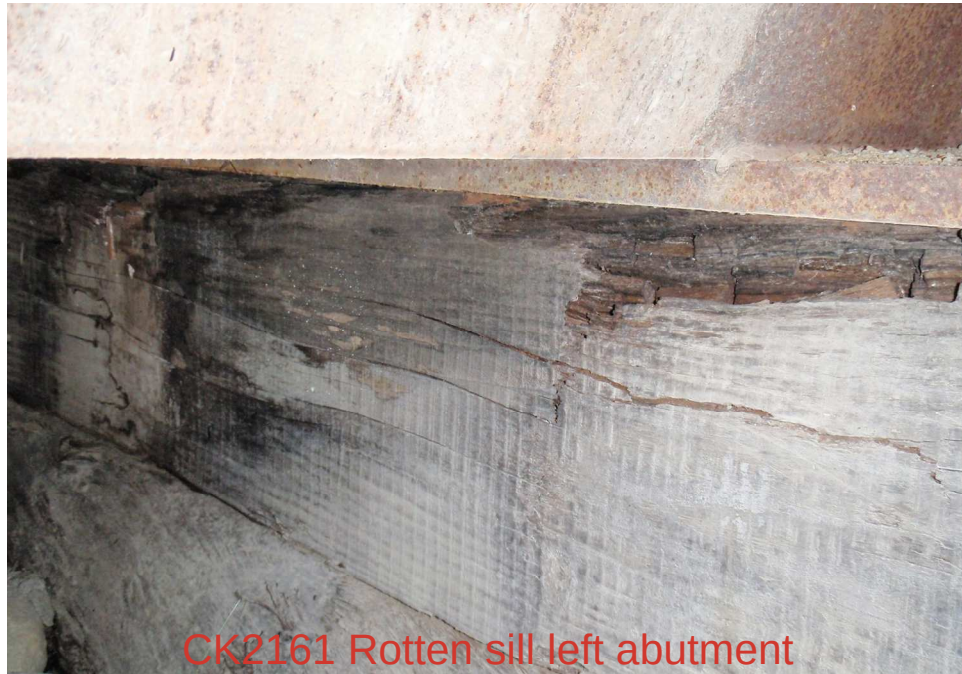
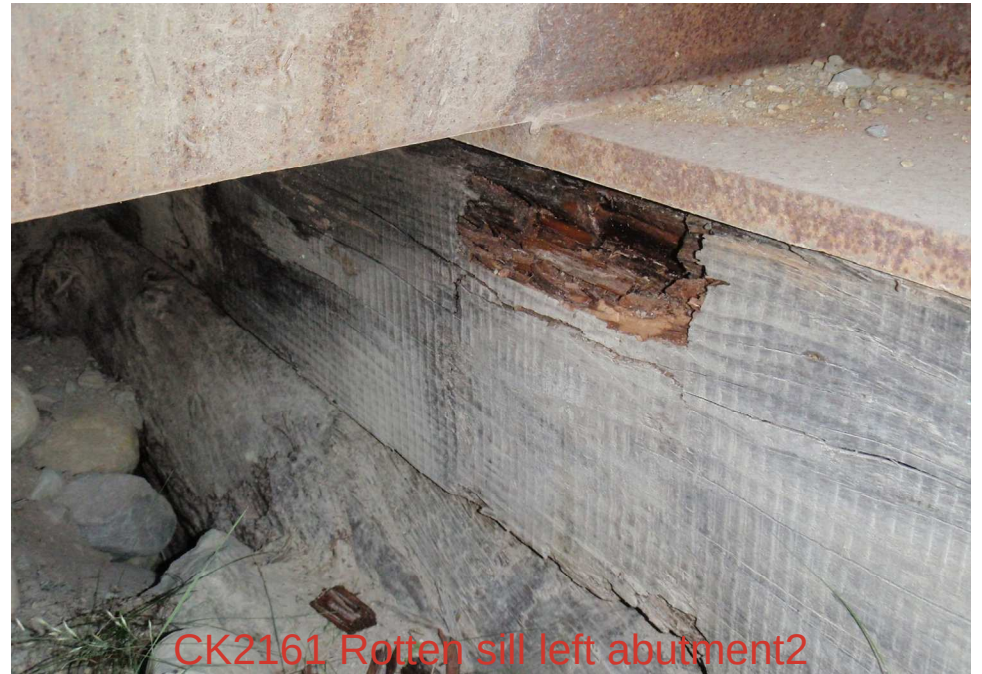
| GENERAL INFORMATION | | | | (enter either long/lat or UTM below - not both) | | | |
|---|---|---|---|---|--|--|--|
| Wing Wall | E G F P (N/A) UR | | LEFT SILL IS | | | | |
| Bracing | E G F P (N/A) UR | | ROTATED & SHOWS | | | | |
| Hardware | E G F P (N/A) UR | | SIGNS OF COMPRESSION | | | | |
| Fill | E G (F) P N/A UR | | FAILURE. | | | | |

CK2161 Rotten sill left abutment

CK2161 Rotten sill left abutment2

| GENERAL INFORMATION | | | | |
|---|---|---|---|---|
| 1 | H M (L) | | REPLACE LEFT ABUT TIMBER SILL. | |
