# Bridge Register Structure Inventory Data Form BRIDGES

**Routine Condition Bridge Inspection Form**  
(except for log stringer or timber stringer bridges)

| GENERAL INFORMATION | | (enter either long/lat or UTM - not both) | | |
|---|---|---|---|---|
| Site # | CK-2167 | Structure # | | |
| FSR Name | LOST CREEK FSR | User km | 8.4 | Project File ID |

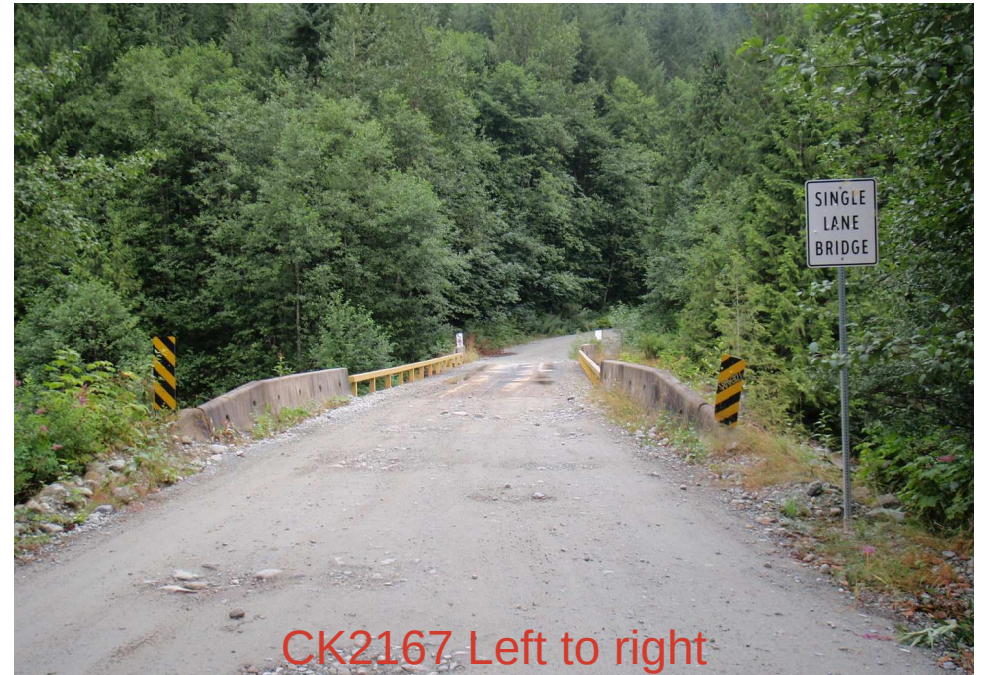
CK2167 Left to right

| DECK | | |
|---|---|---|
| Anti-skid Surface | E G F <b>(P)</b> <b>(N/A)</b> | VERY LITTLE LEFT DUE TO HEAVY USE. |

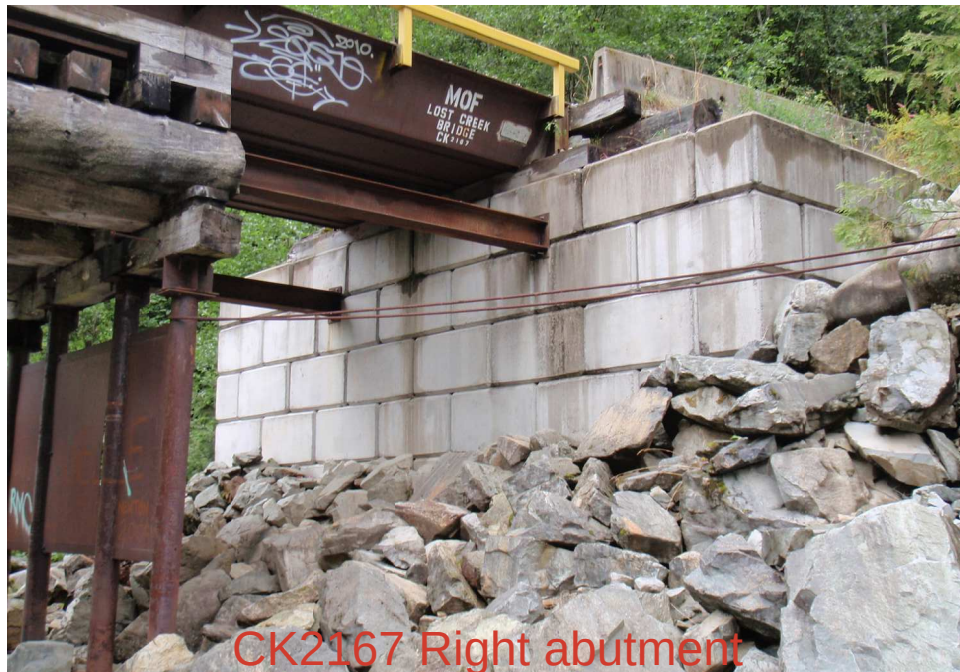
CK2167 Right abutment

| Item | Present Condition (circle) | Comments (a comment is mandatory if condition "Poor" is selected) |
|---|---|---|
| Bin Wall | E <b>(G)</b> F P N/A | CONCRETE LOG BLOCKS |

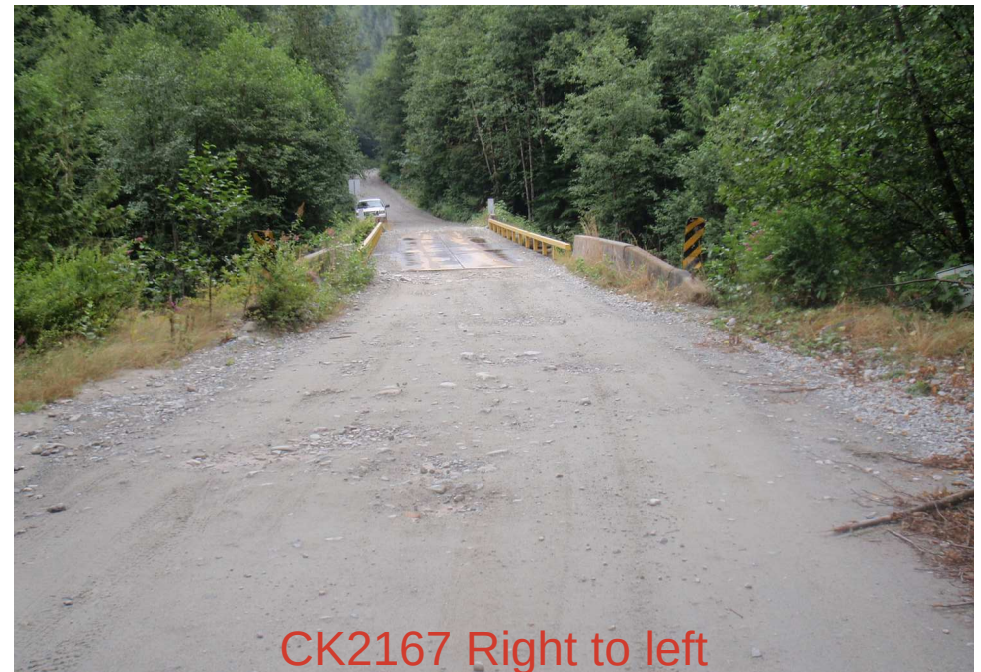
CK2167 Right to left

| Item | Present Condition (circle or fill-in) | Comments (a comment is mandatory if condition "Poor" is selected) |
|---|---|---|
| Alignment | E G <b>(F)</b> P | TIGHT HORIZONTAL CURVE ON RIGHT APPROACH. |
| Road Surface | E G <b>(F)</b> P | LARGE POTHoles ON APPROACHES |

| GENERAL INFORMATION | | | |
|---|---|---|---|
| 1 | H <u>(M)</u> L | | GRADE ROAD ON BOTH APPROACHES - LARGE POTHOLES |

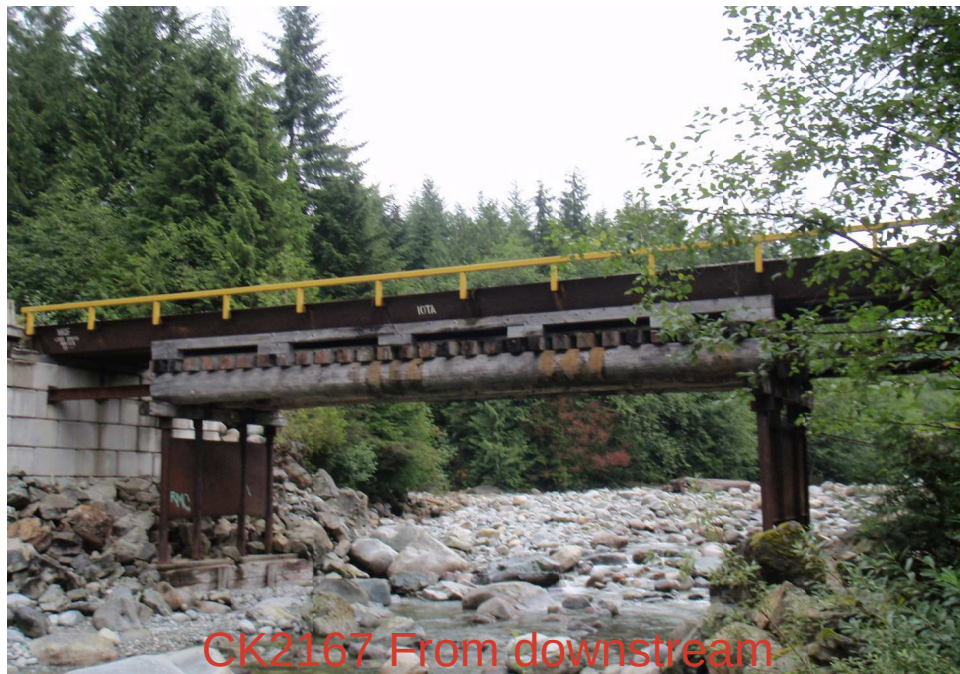
CK2167 From downstream

| Item | Present Condition (circle) | Comments (a comment is mandatory if condition "Poor" is selected) |
|---|---|---|
| Bracing | E G <b>(F)</b> P N/A | STRUCTURE OVER SPANS AN OLD LOG STRUCTURE |

TWO OF THE REMAINING PIERS ARE TIED BACK TO LOG BLOCKS.
