BC Ministry of  
Forests and Range

**Routine Condition Bridge Inspection Form**  
(except for log stringer or timber stringer bridges)

| GENERAL INFORMATION | | | | (enter either longlat or UTM - not both) | | | |
|---|---|---|---|---|---|---|---|
| Site # | CK2168 | | Structure # | | | | |
| FSR Name | LOST CREEK BR | User km | 8.6 | Project File ID | 8466 | Branch | 01 |

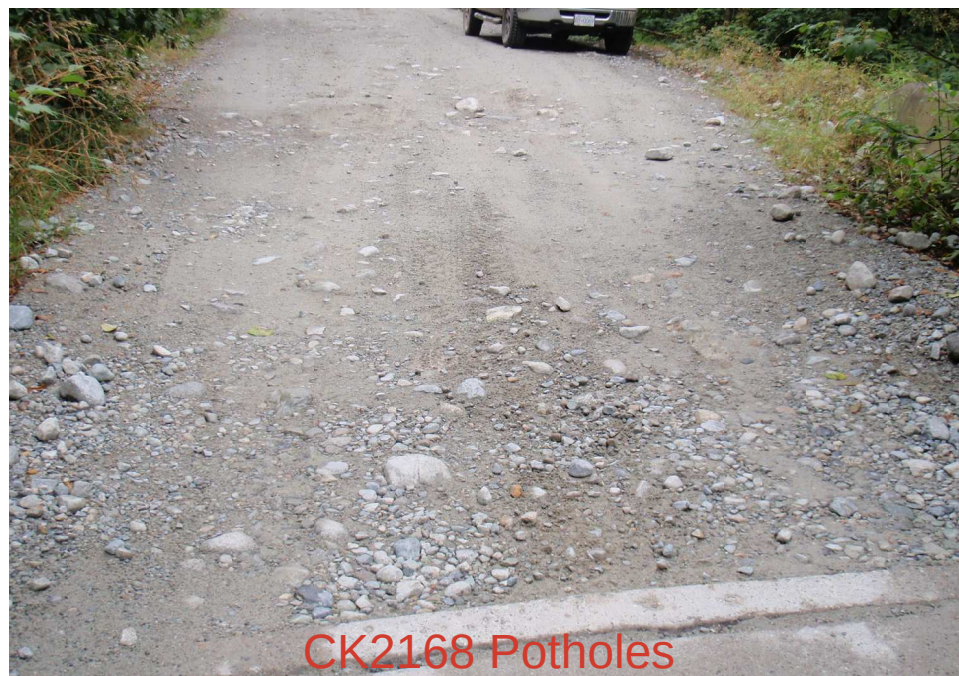
| GENERAL INFORMATION | | | | (enter either longlat or UTM - not both) | | | |
|---|---|---|---|---|---|---|---|
| Road Surface | E G F <u>P</u> | LARGE POTHOLES | | | | | |
| Fill | E G F <u>P</u> | LARGE POTHOLES ON APPROACHES | | | | | |

CK2168 Potholes
