## Corporate Bridge Register (CBR) Structure Inventory Data Form "BRIDGES"

**Routine Condition Bridge Inspection Form**  
(for log stringer or timber stringer bridges)

| GENERAL INFORMATION | | | | (enter either long/lat or UTM - not both) | | |
|---|---|---|---|---|---|--|
| Site # <u>CK-2173</u> | | Structure # | | | | |
| FSR Name <u>LOST CRK FSR</u> | | User km <u>18.9</u> | Project File ID <u>8466</u> | Branch <u>01</u> | | |

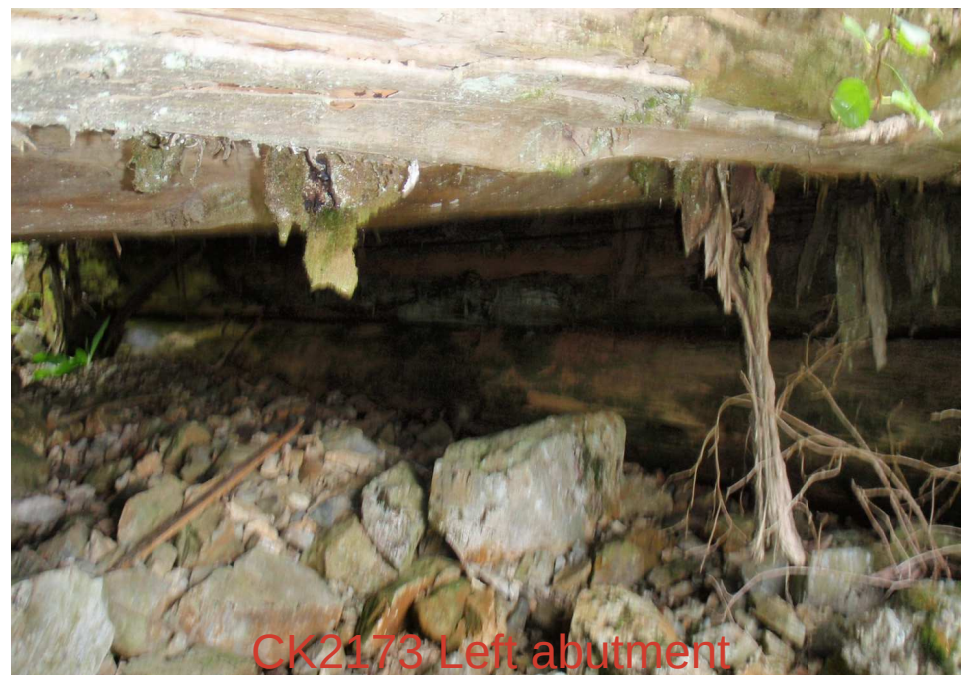
CK2173 Left abutment

| GENERAL INFORMATION | | | | (enter either long/lat or UTM - not both) | | |
|---|---|---|---|---|---|--|
| Log/Timber Crib | E G F <u>(P)</u> N/A | <u>2X CLOSED FACED POOR CONDITION.</u> | | | | |
| Caps or Sills | E G F <u>(P)</u> | <u>RUTTEN CRUB.</u> | | | | |
