# Bridge Register Structure Inventory Data Form BRIDGES

**Routine Condition Bridge Inspection Form**  
(except for log stringer or timber stringer bridges)

| GENERAL INFORMATION | | | | (enter either longlat or UTM - not both) | | |
|---|---|---|---|---|--|--|
| Site # <u>CK2174</u> | | Structure # | | | | |
| FSR Name <u>LOST-MURDO</u> | | User km <u>0.7</u> | Project File ID <u>8466</u> | Branch <u>02</u> | | |

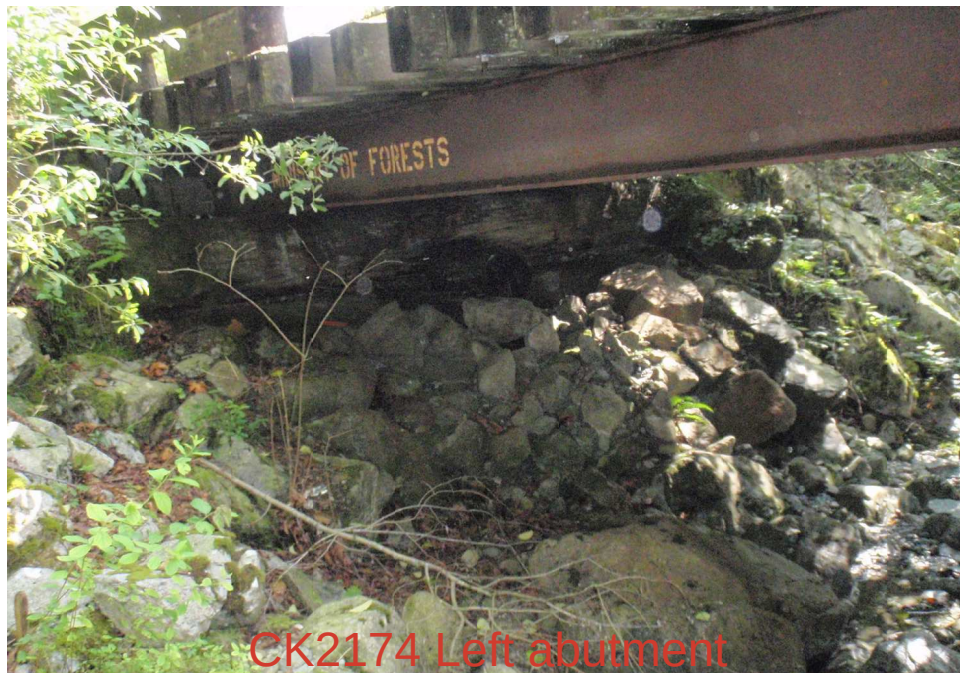
CK2174 Left abutment

| GENERAL INFORMATION | | | | (enter either longlat or UTM - not both) | | |
|---|---|---|---|---|--|--|
| Riprap | E G <u>F</u> P N/A | LEFT ABUT. SLIGHTLY SCURED. | | | | |

| GENERAL INFORMATION | | | |
|---|---|---|---|
| Comments <u>LEFT ABUT. SCOURING.</u> | | | |
