BC Ministry of  
Forests and Range

# **Routine Condition Bridge Inspection Form** (for log stringer or timber stringer bridges)

| GENERAL INFORMATION | | | |
|---|---|---|---|
| *Site # <u>CK-2204</u> | *Crossing Name: | (enter either longlat or UTM below - not both) | |
| *FSR Name:<br><u>N. M. Ainslie Cr</u> | *Forest District:<br><u>Chilliwack</u> | *Kilometres: | User km: |

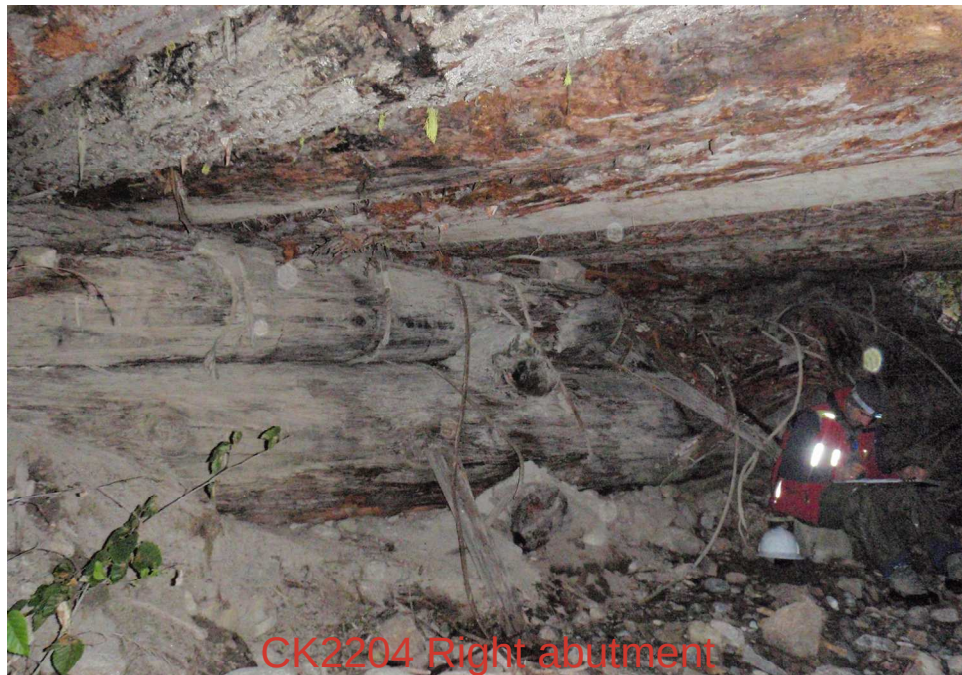
CK2204 Right abutment

| GENERAL INFORMATION | | | |
|---|---|---|---|
| Log/Timber Crib | E G F <u>(P)</u> N/A UR | <u>3X ROTTEN CLOSED FACE CRIB.</u> | |
| Tie-backs | E G F <u>(P)</u> N/A UR | <u>3X ROTTEN.</u> | |

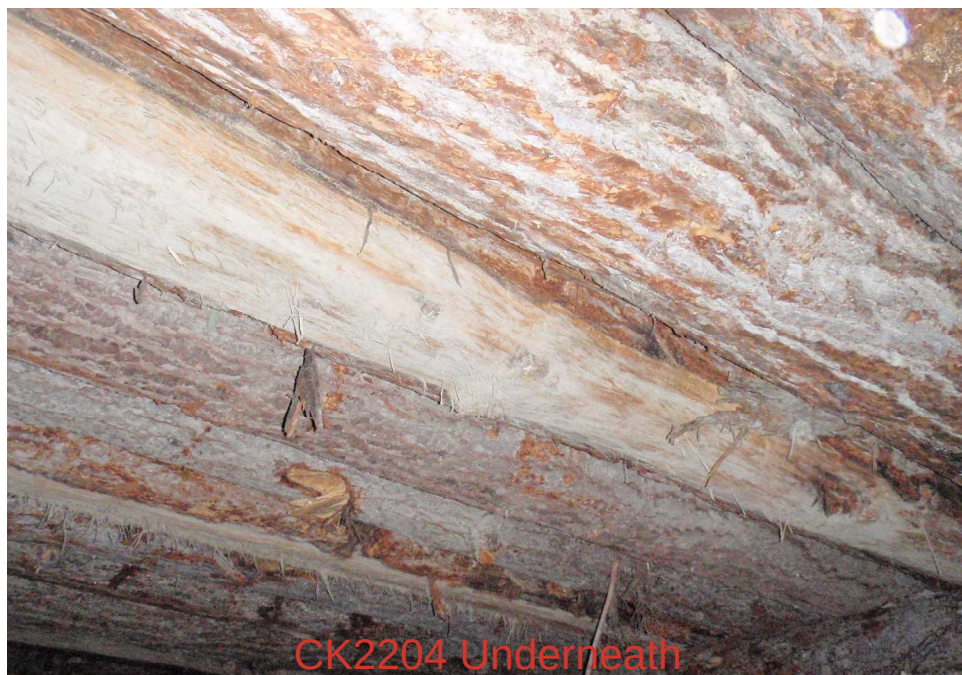
CK2204 Underneath

| 5 | | | | Y N | | 440 | | | | | | | | ALL STRINGERS IN GOOD COND | |

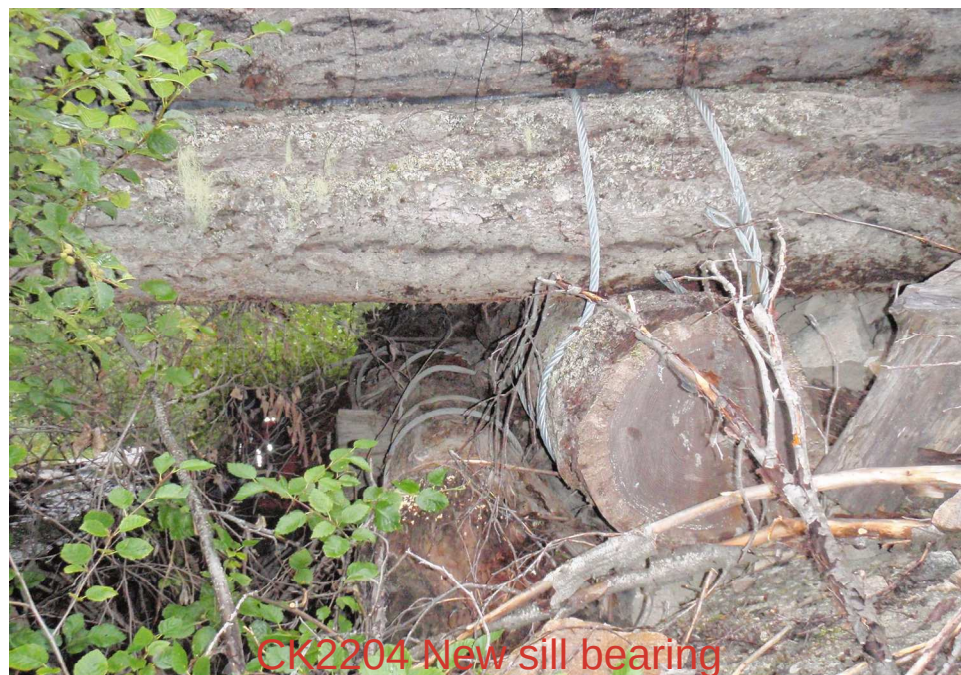
| THE NEW SILLS BEAR TO CLOSELY TO OLD POKEN C.B. | | | | | | | | | | | | | | | |

CK2204 New sill bearing
