**Corporate Bridge Register (CBR)  
Structure Inventory Data Form  
"CULVERTS"**

| *Structure #: <u>42336</u> | *Site #: |
| *Forest Service Road: <u>STONE RIVER</u> | Kilometres: <u>7.3</u> |

Routine Condition Culvert Inspection Form

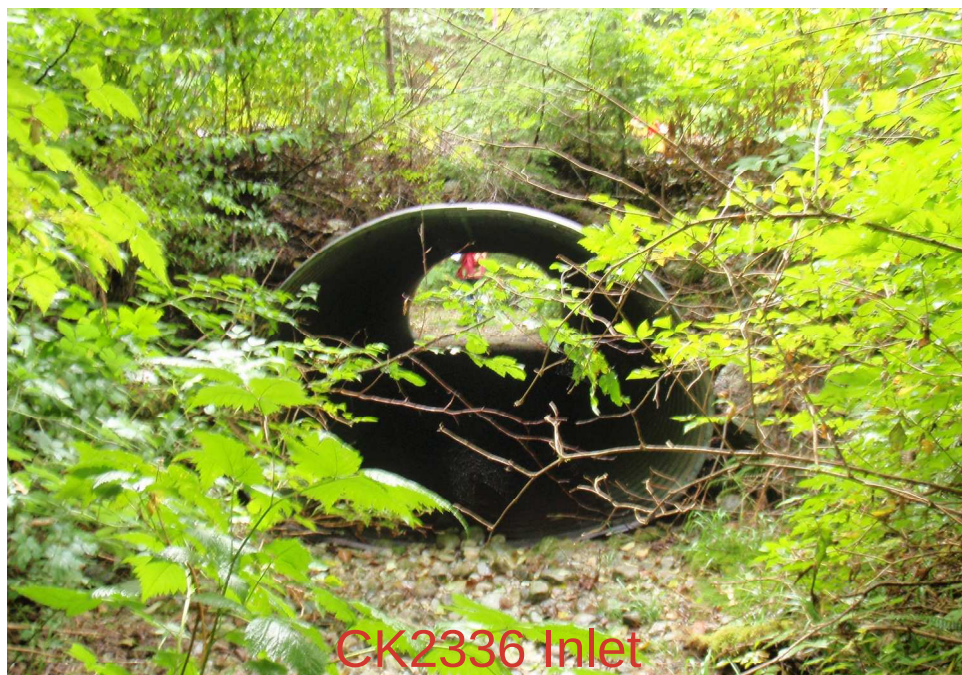
CK2336 Inlet

| GENERAL CULVERT ITEMS | | |
|---|---|---|
| Inlet | E G <u>(F)</u> P UR | |

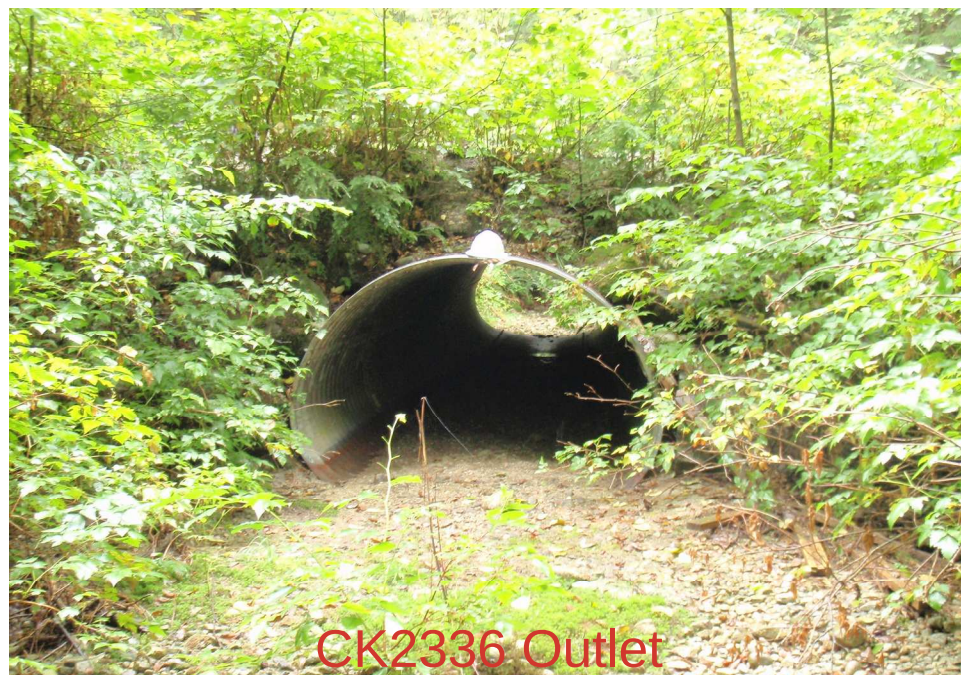
CK2336 Outlet

| GENERAL CULVERT ITEMS | | |
|---|---|---|
| Outlet | E G <u>(F)</u> P UR | |
