**Corporate Bridge Register (CBR)**  
**Structure Inventory Data Form**  
**"CULVERTS"**

BC Ministry of Forests and Range  
Routine Condition Culvert Inspection Form

| GENERAL INFORMATION | | | | | | | | | |
|---|---|---|---|---|--|---|--|---|--|
| *Site #: <u>CK-2338</u> | | *Crossing Name: | | *Type/Class: <input type="checkbox"/> Major Culvert<br><input checked="" type="checkbox"/> Woodbox/Log Culvert | | (enter either long/lat or UTM below- not both) | | | |
| *FSR Name:<br><u>STAG LAKE</u> | | *Forest District:<br><u>CHILLIWACK</u> | | *Kilometres:<br><u>12.2</u> | | User km: | | | |

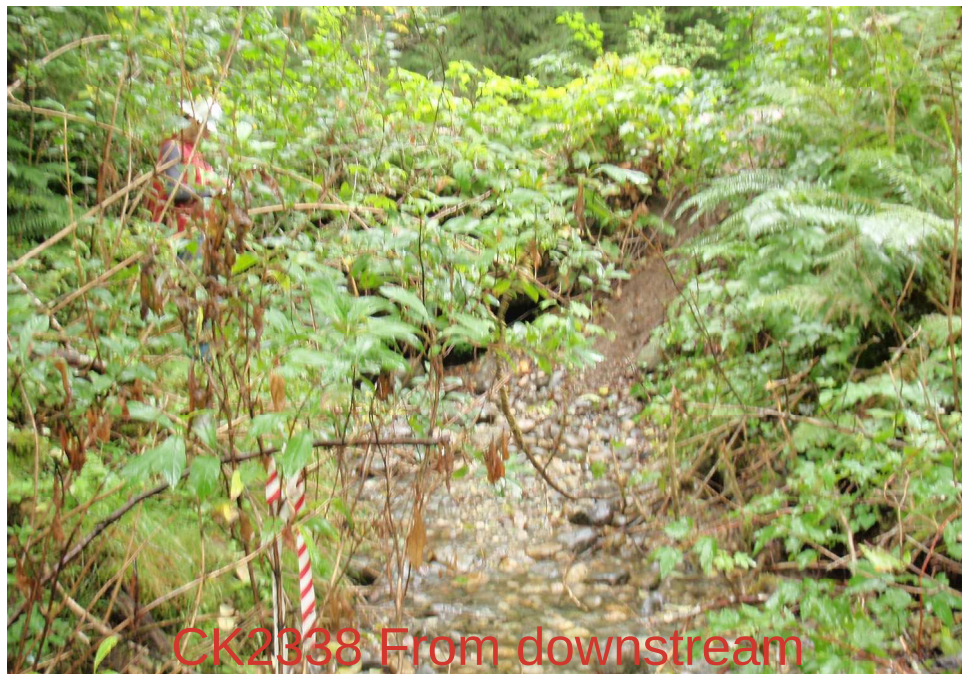
CK2338 From downstream

| GENERAL INFORMATION | | | | | | | | | |
|---|---|---|---|---|--|---|--|---|--|
| Outlet | E | G | F (P) UR | FILL ON LEFT APP. ACTUALLY RAUDELING INTO STREAM | | | | | |

| Inspector's Comments <u>VERY LOW HW CLEARANCE. FILL ON LEFT ABUT. DOWNSTREAM RAVELING CAUSE STRIKE ANY</u> | | | | | | | | | |

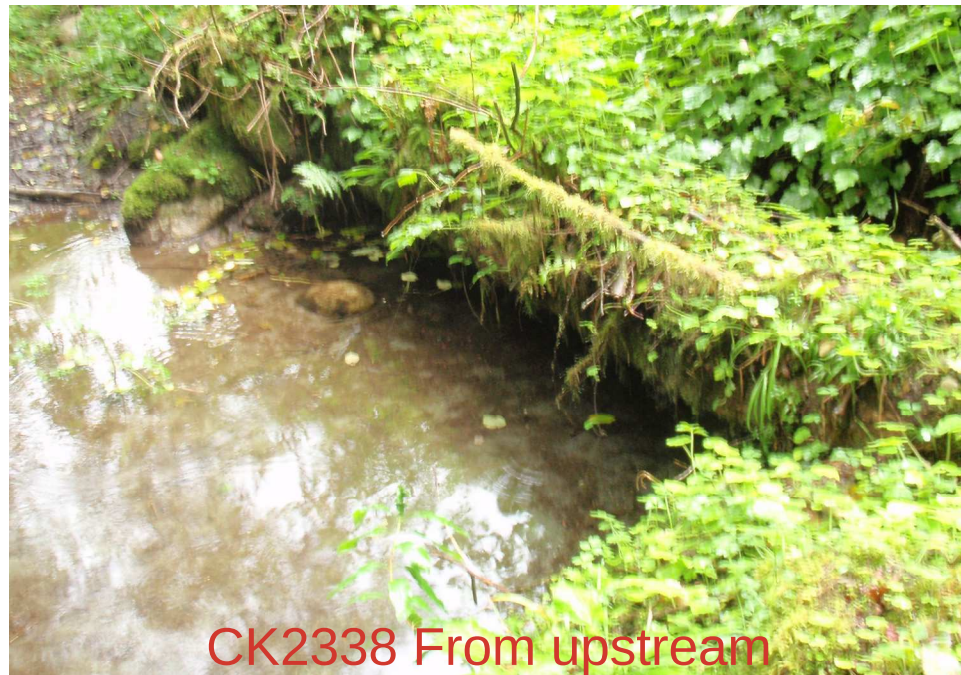
CK2338 From upstream

| GENERAL INFORMATION | | | | | | | | | |
|---|---|---|---|---|--|---|--|---|--|
| Inlet | E | G | F (P) UR | INLET HAS VERY LOW CLEARANCE | | | | | |

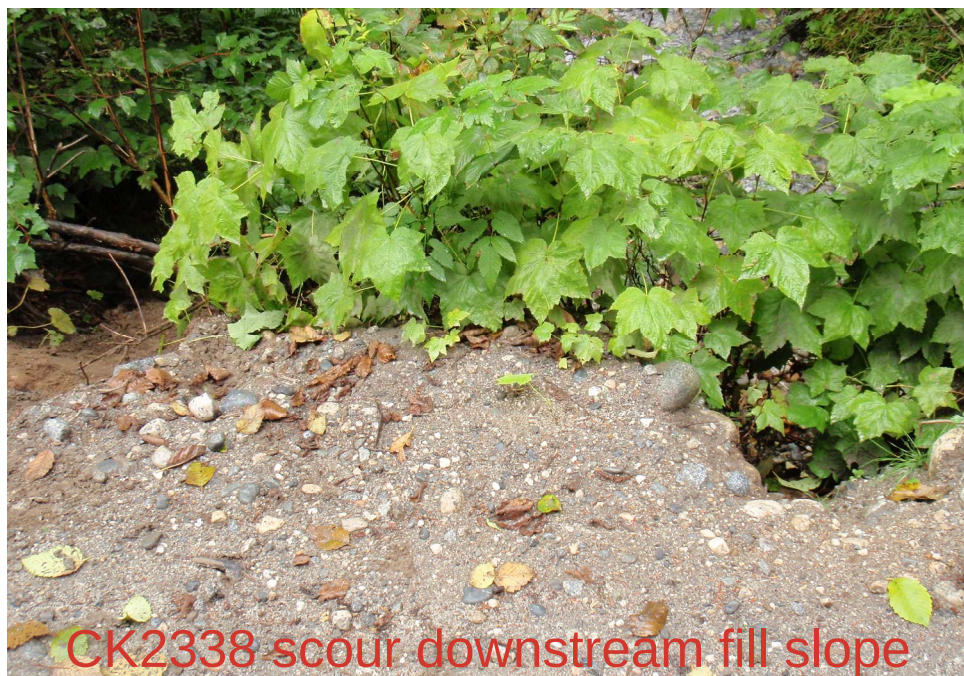
| High Water? | (Yes) No | Scour? | (Yes) No | Ice? | Yes | No | Debris? | Yes | No |
| Comments <u>FILL SCOPE ON DOWNSTREAM.</u> | | | | | | | | | |

CK2338 scour downstream fill slope
