# Corporate Bridge Register (CBR) Structure Inventory Data Form "CULVERTS"

| *Forest Service Road: <i>SIMS CRK</i> | Kilometres: <i>3.8</i> |

## Routine Condition Culvert Inspection Form

2010-08-20

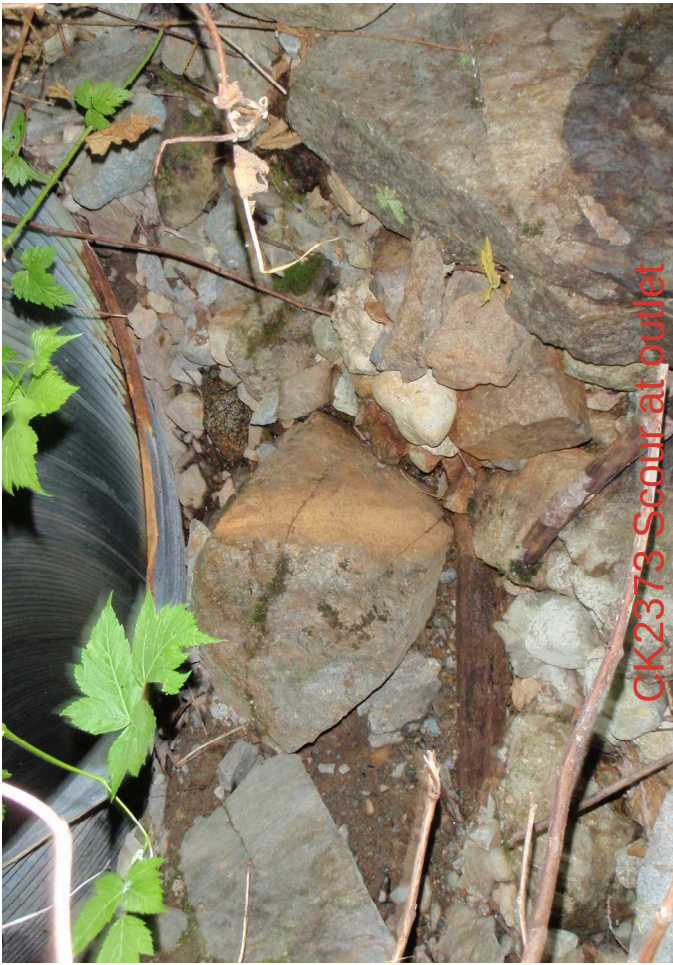
Comments SCOUR AT OUTLET DUE TO LACK OF ARMCHURCH

CK2373 Scour at outlet

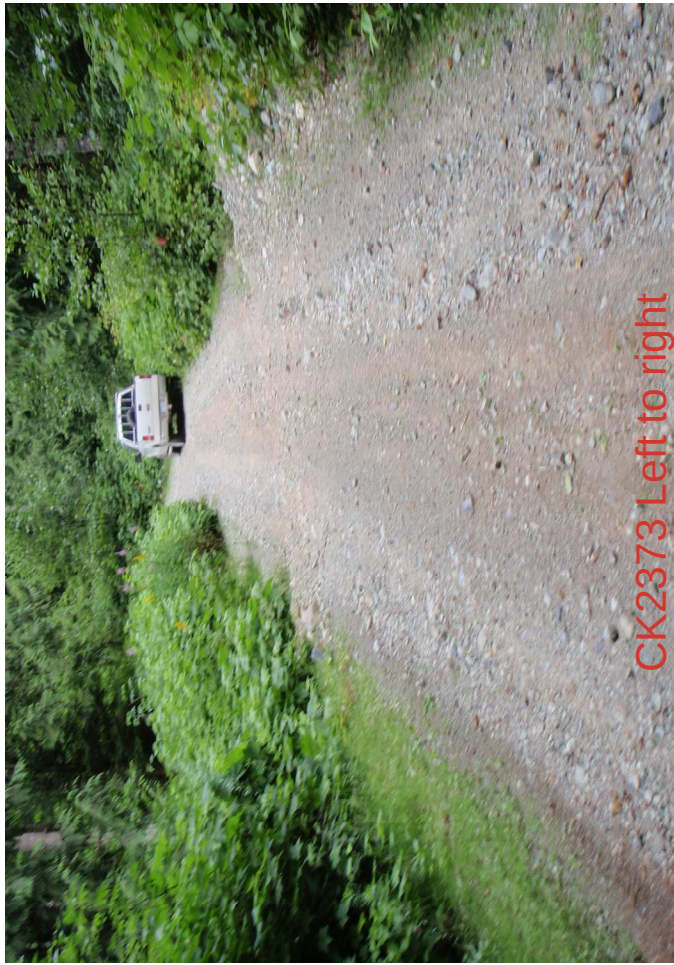
CK2373 Left to right

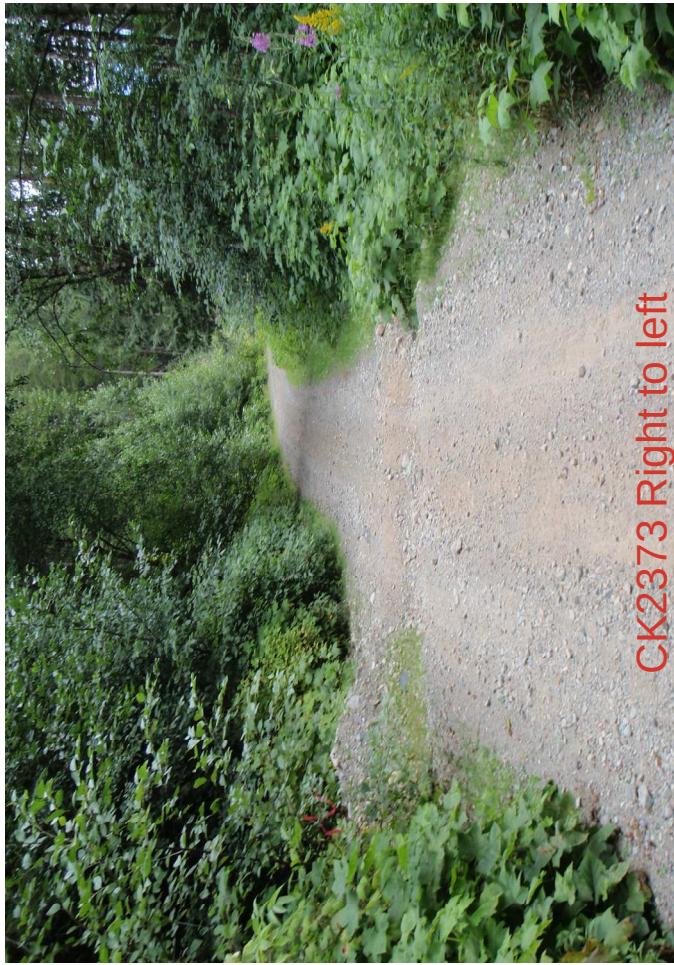
CK2373 Right to left
