## Corporate Bridge Register (CBR) Structure Inventory Data Form "BRIDGES"

| *Forest Service Road: <u>CHILLIWACK RIVER</u> | Kilometres: <u>6.7</u> |

**Routine Condition Bridge Inspection Form**  
(except for log stringer or timber stringer bridges)

| GENERAL INFORMATION | | | | (enter either long/lat or UTM below - not both) | | | |
|---|---|---|---|---|--|--|--|
| *Site #: <u>K-2387</u> | *Crossing Name: | *Type/Class: <input type="checkbox"/> Temporary bridge<br><input checked="" type="checkbox"/> Permanent bridge | *Project File ID# <u>5127</u> | | | | |

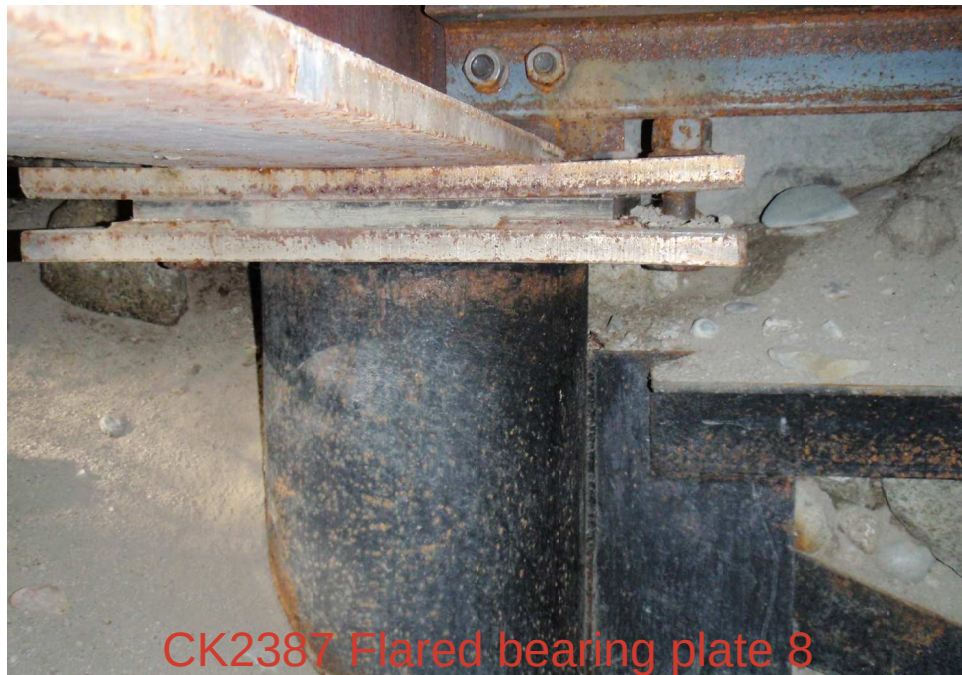
| GENERAL INFORMATION | | | | (enter either long/lat or UTM below - not both) | | | |
|---|---|---|---|---|--|--|--|
| Bearings | E G <u>(F)</u> P N/A UR | THE BEARING PLATES (SPECIALLY DOWN STREAM LEFT ABUT) | | | | | |
| Corrosion Protection | E <u>(G)</u> F P <u>(N/A)</u> UR | HAVE FLARED UP BEARING ACROSS STILL FAIRLY GOOD. SEE PICS. | | | | | |

CK2387 Flared bearing plate 8

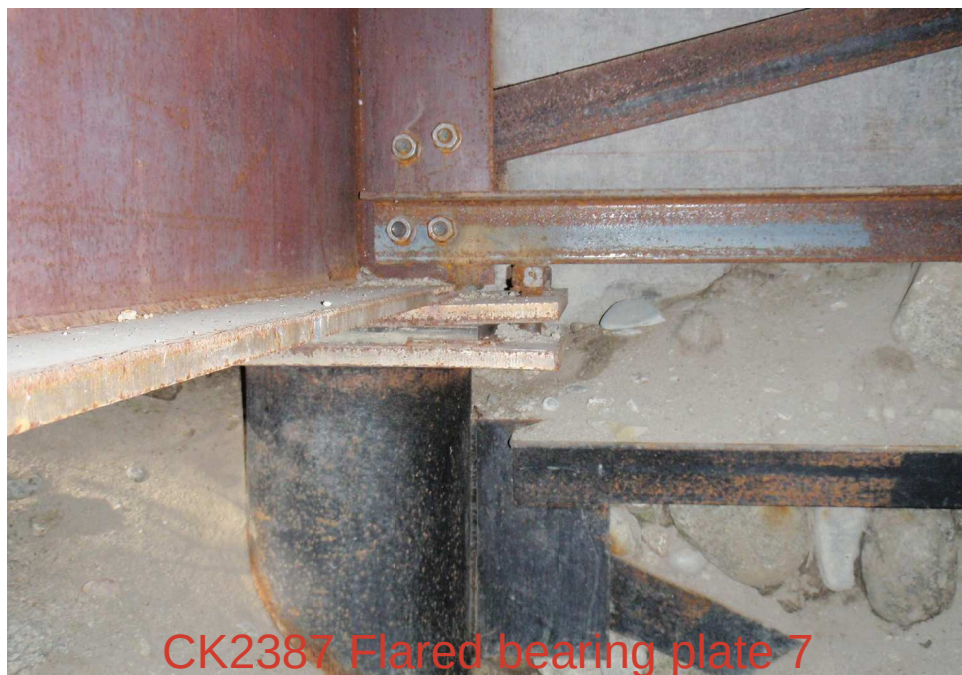
CK2387 Flared bearing plate 7

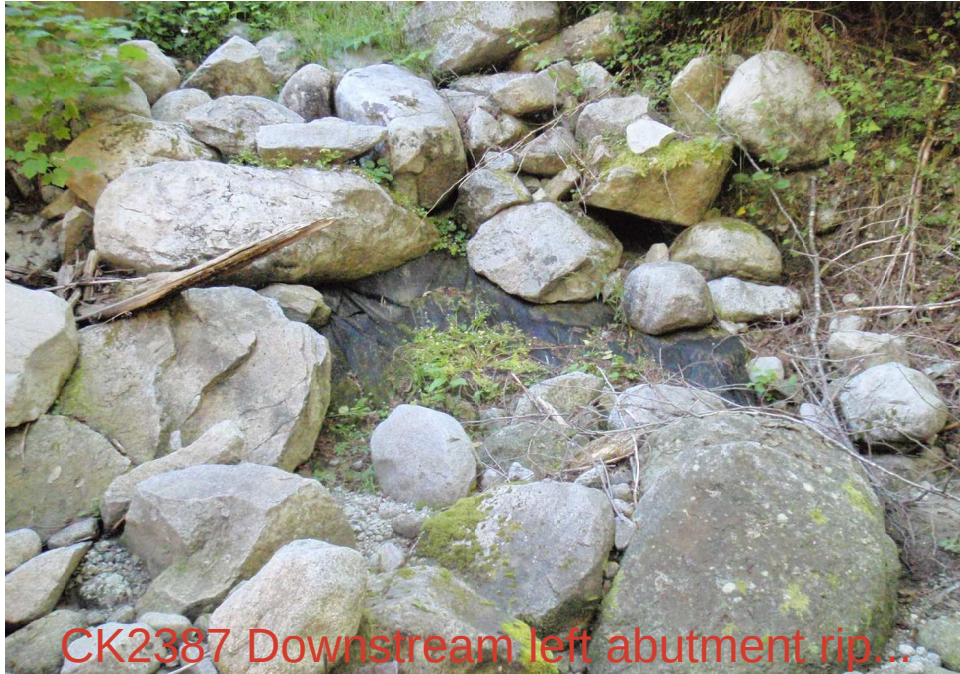
| GENERAL INFORMATION | | | | (enter either long/lat or UTM below - not both) | | | |
|---|---|---|---|---|--|--|--|
| Riprap | E G <u>(F)</u> R N/A UR | DOWNSTREAM LEFT ABUT RIP RAP RAILING AS IT WAS | | | | | |

CK2387 Downstream left abutment rip...

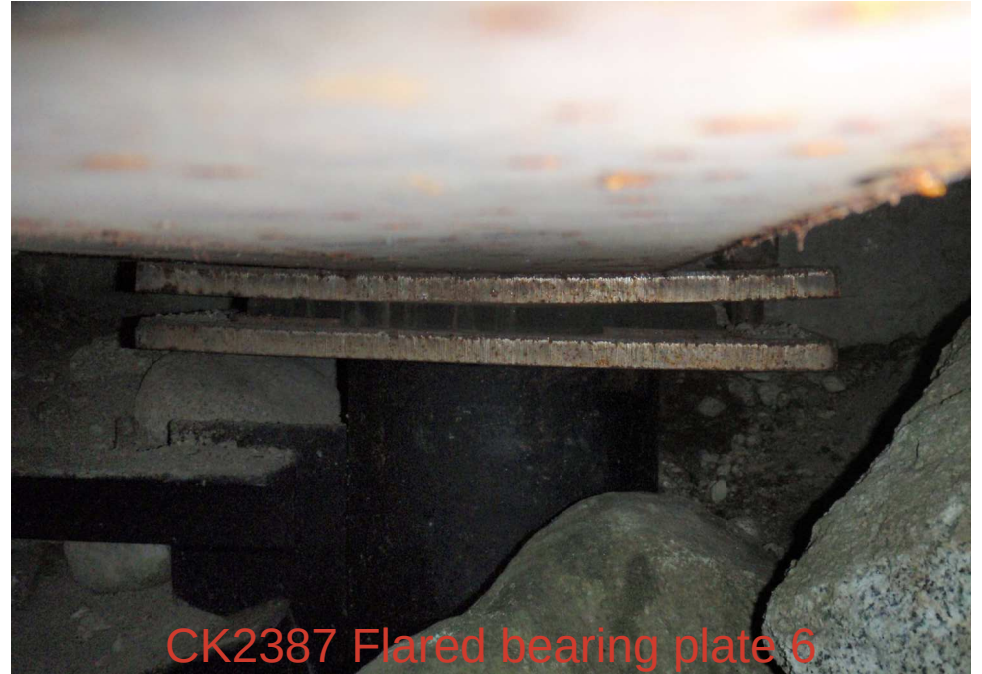
CK2387 Flared bearing plate 6

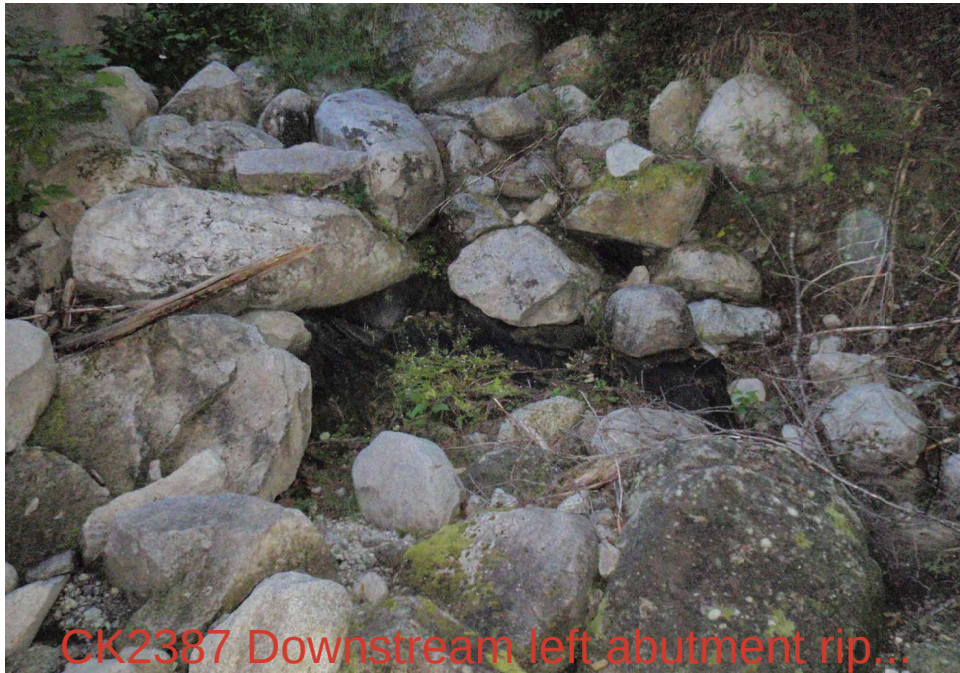
CK2387 Downstream left abutment rip...

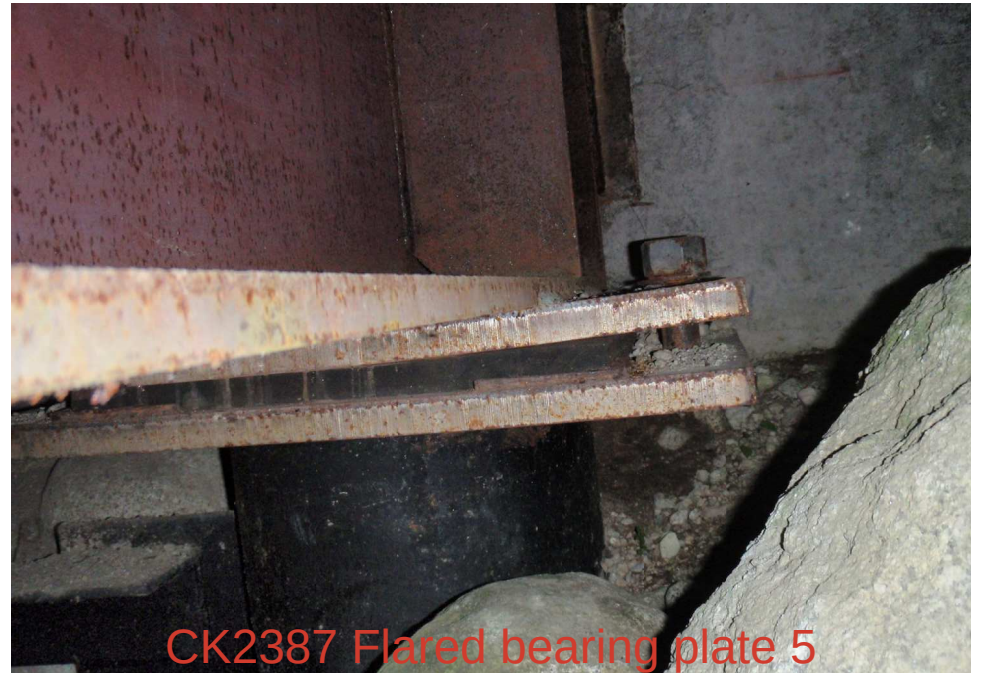
CK2387 Flared bearing plate 5

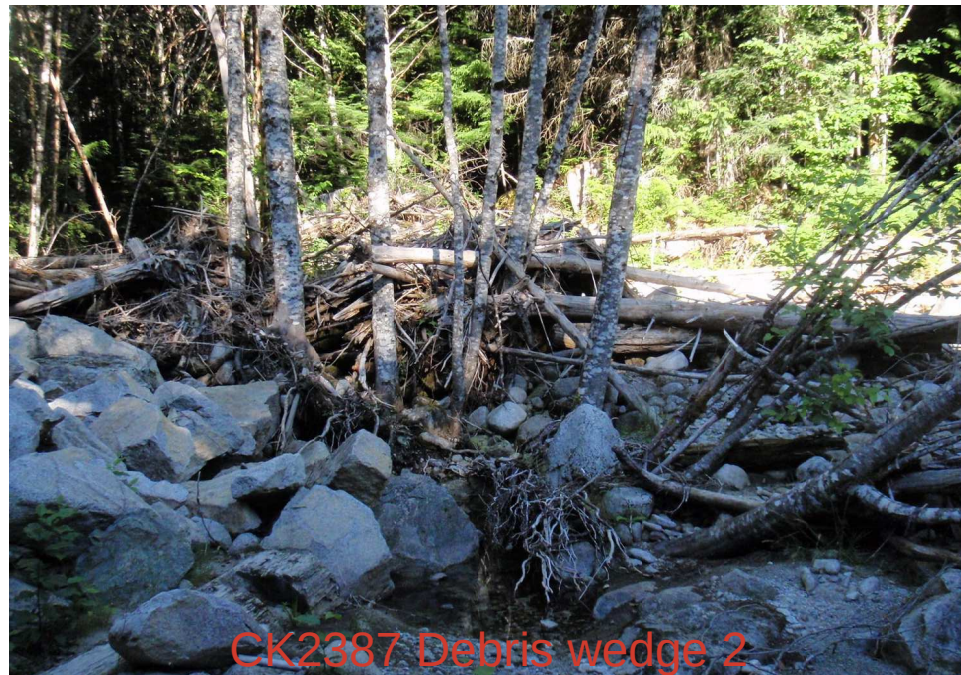
| GENERAL INFORMATION | | | |
|---|---|---|---|
| 1 | SEDIMENT WEDGED UPSTREAM OF STRUCTURE, MONITOR | | |

CK2387 Debris wedge 2

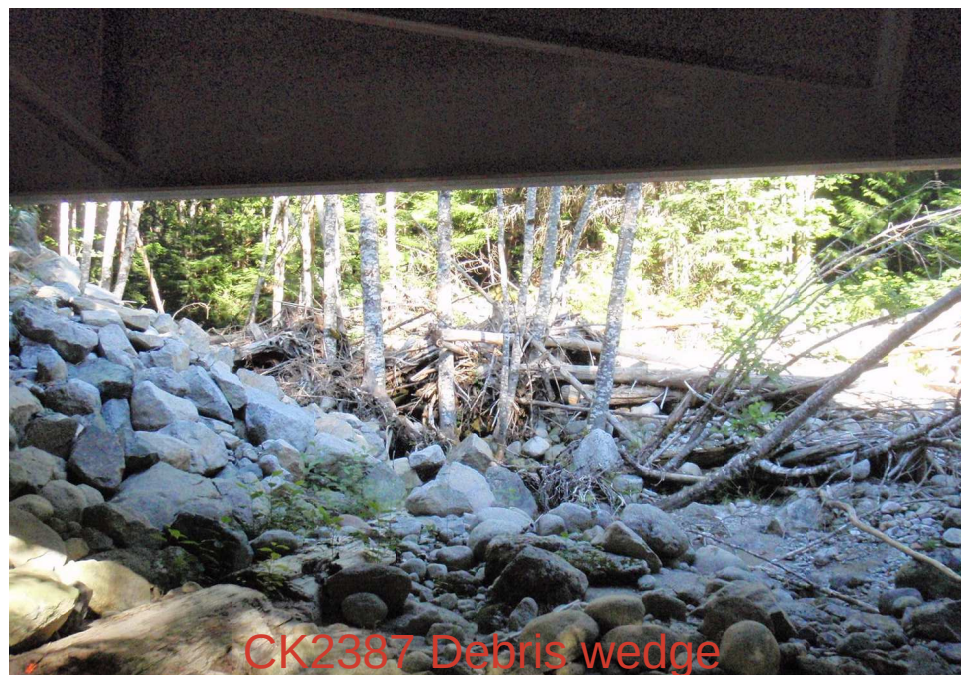
CK2387 Debris wedge

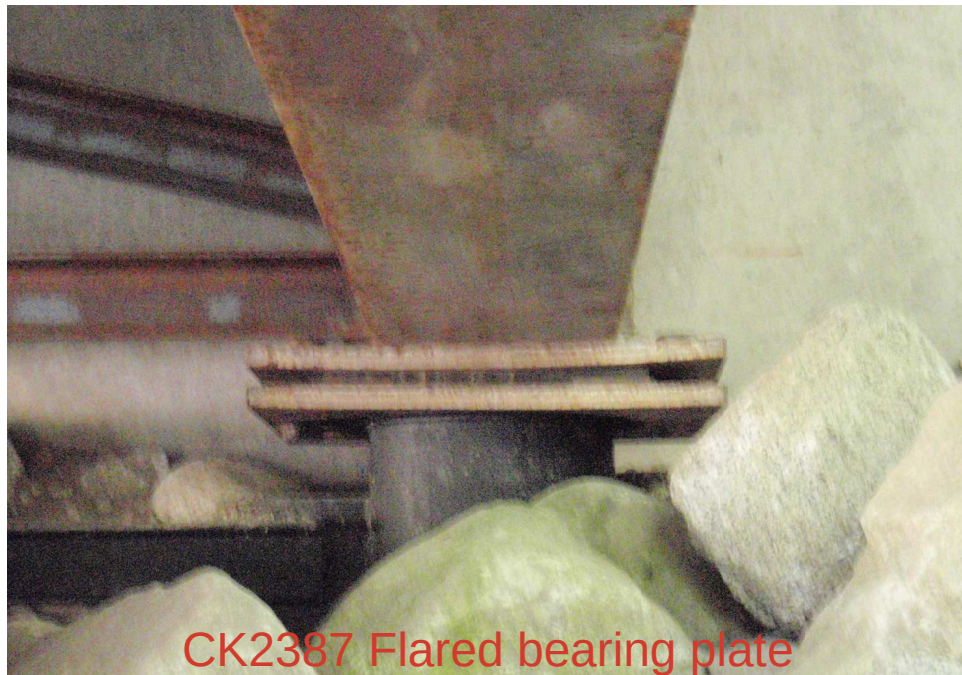
CK2387 Flared bearing plate

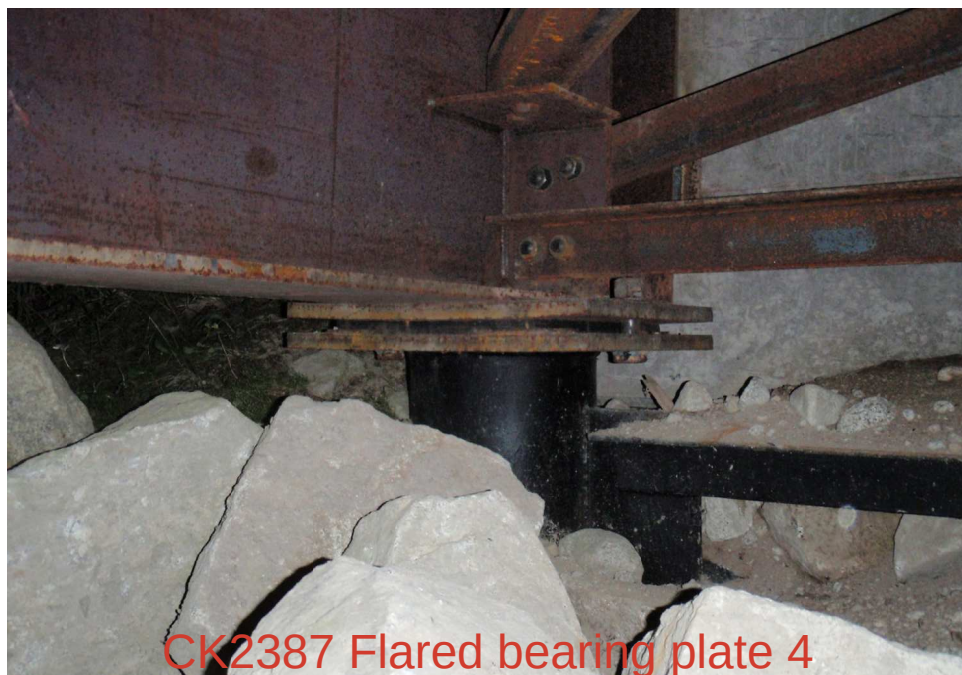
CK2387 Flared bearing plate 4

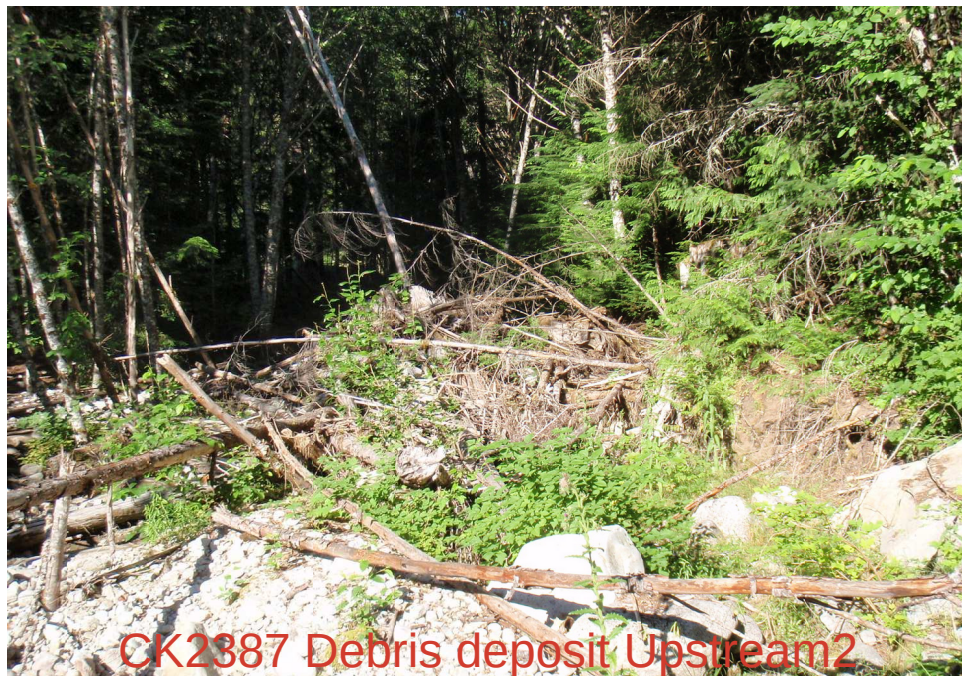
CK2387 Debris deposit Upstream2

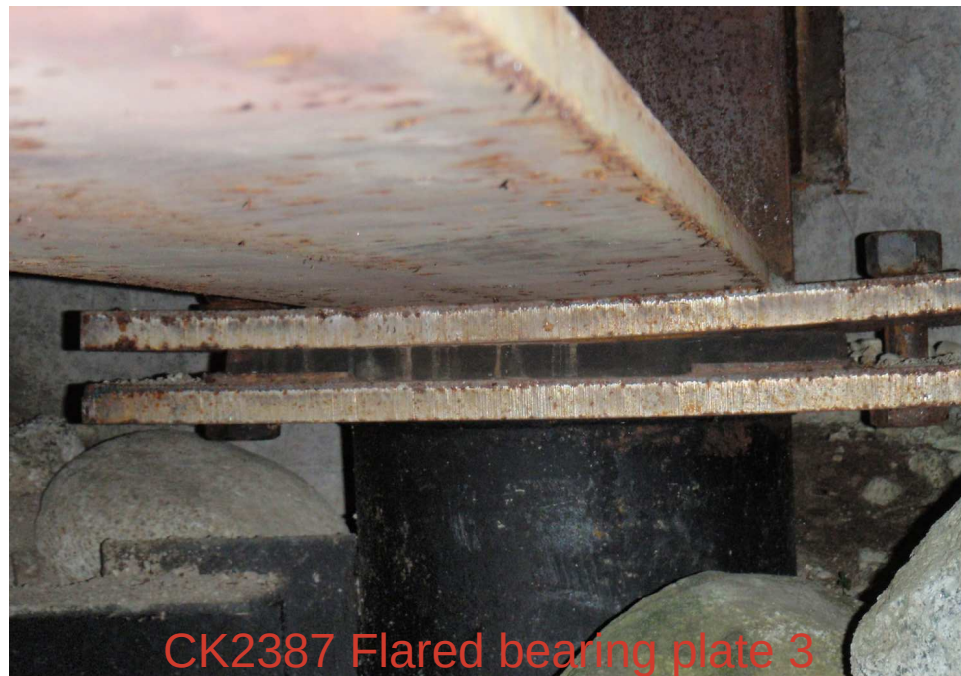
CK2387 Flared bearing plate 3

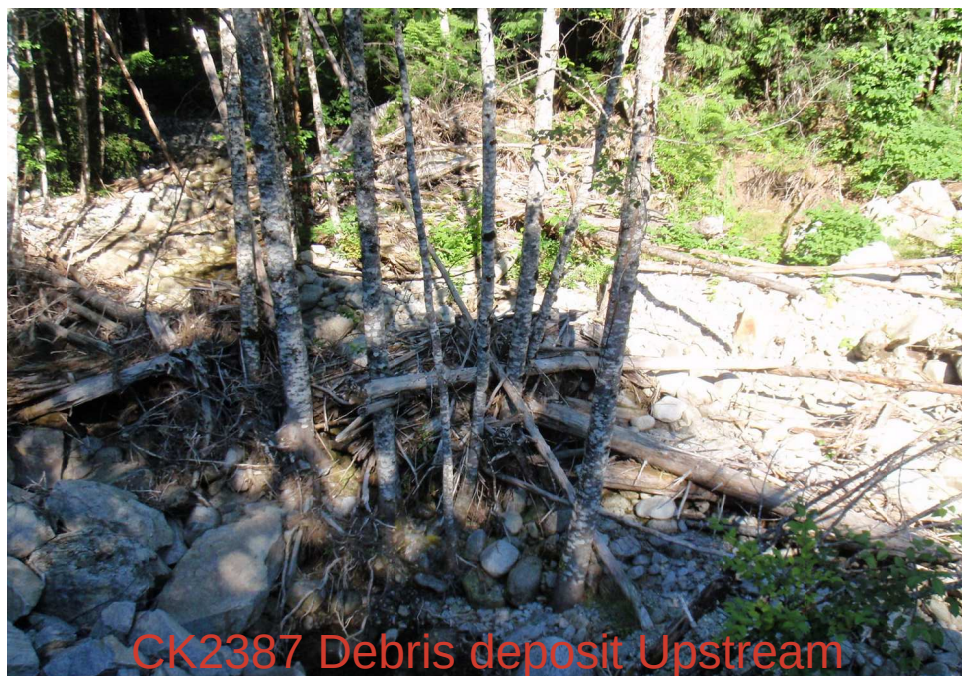
CK2387 Debris deposit Upstream

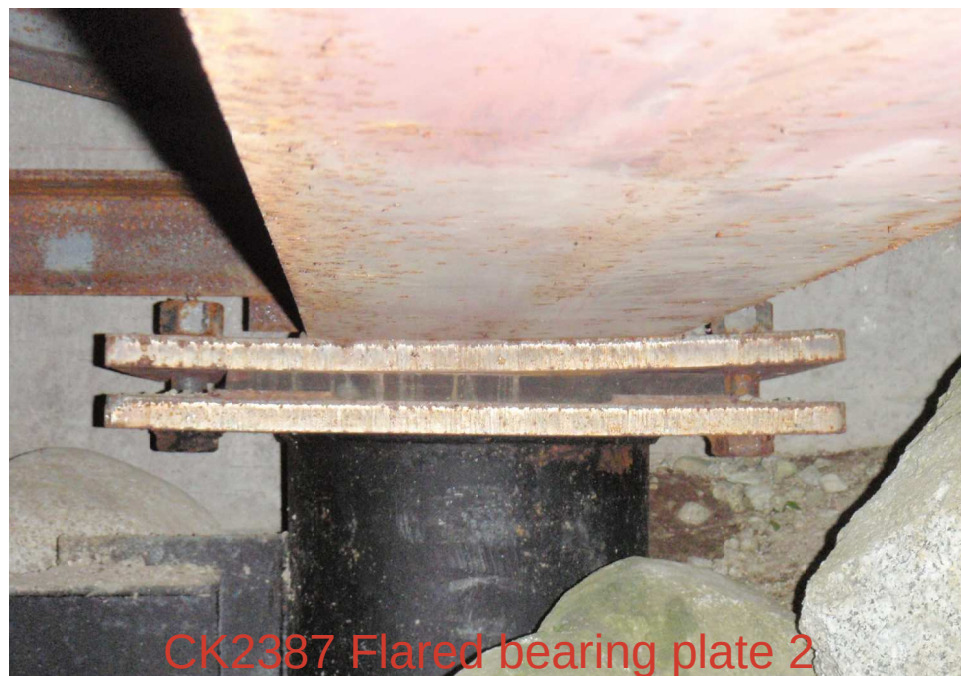
CK2387 Flared bearing plate 2

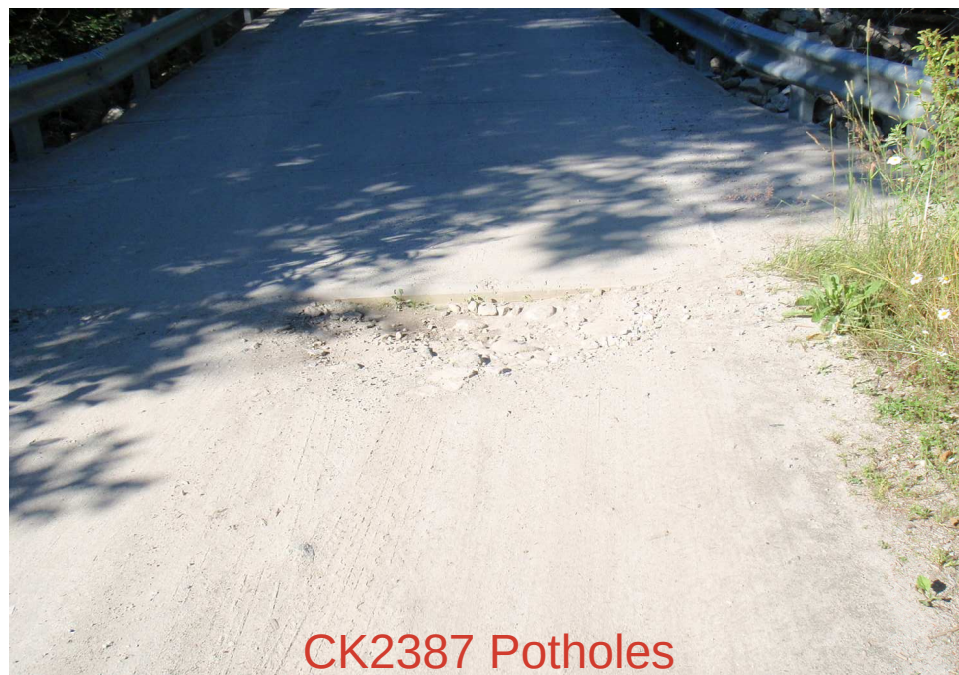
| GENERAL INFORMATION | | | | (enter either long/lat or UTM below - not both) | | | |
|---|---|---|---|---|--|--|--|
| Road Surface | E G <u>(F)</u> P UR | LEFT ABUT = PUT TIES AT APPROACH EXPOSING DECK EDGE. | | | | | |

CK2387 Potholes

| GENERAL INFORMATION | | | |
|---|---|---|---|
| 1 | H M (L) | | GRADE APPROACH |
