## Corporate Bridge Register (CBR) Structure Inventory Data Form "BRIDGES"

| GENERAL | |
|---|---|
| *Type/Class: <input checked="" type="checkbox"/> Permanent Bridge<br><input type="checkbox"/> Temporary Bridge | Crossing Name: <u>SECOND CANYON PITT RIVER</u> |

**Routine Condition Bridge Inspection Form**  
(except for log stringer or timber stringer bridges)

| GENERAL INFORMATION | | | |
|---|---|---|---|
| *Date of Inspection (yyyy/mm/dd)<br>2012-08-24 | *Inspection Company Name<br>Onsite Eng | *Inspector's Name (print)<br>Ali Sodeghin | Inspector's Signature<br> |

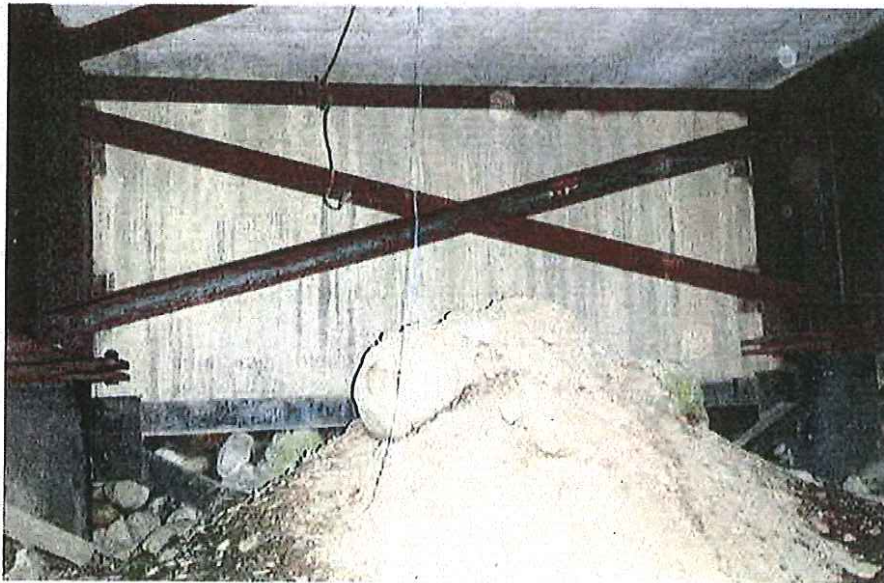
CK2231 Right Abutment

| GENERAL INFORMATION - multi span - | | (enter either long/lat or UTM below - not both) | |
|---|---|---|---|
| Piles or Posts | E <b>(G)</b> F P N/A UR | → Right abut. | |
| Wing Wall | E G <b>(F)</b> P N/A UR | OK right abut. | |

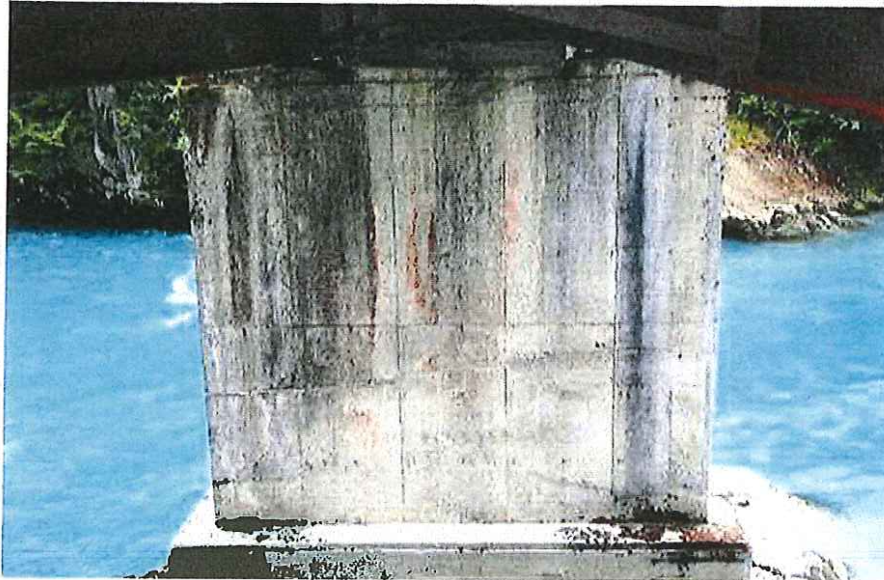
CK2231 pier2 (2)

| GENERAL INFORMATION | | |
|---|---|---|
| Rip Rap | E G F P <u>N/A</u> UR | new rip rap |

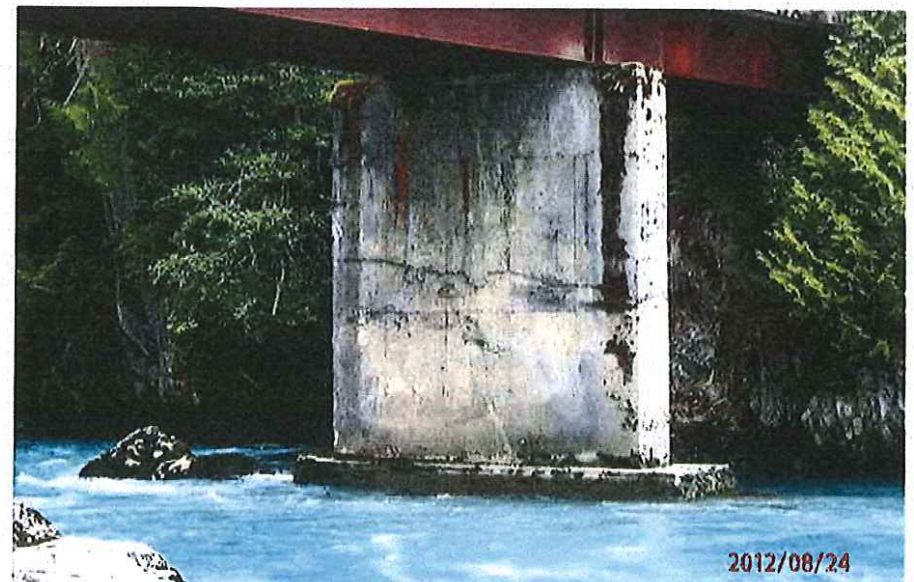
CK2231 pier1 (1)

| Item | Present Condition<br>(circle) | Comments<br>(a comment is mandatory if condition "Poor" is selected) |
|---|---|---|
| Rip Rap | E G F P <u>N/A</u> UR | no rip rap |

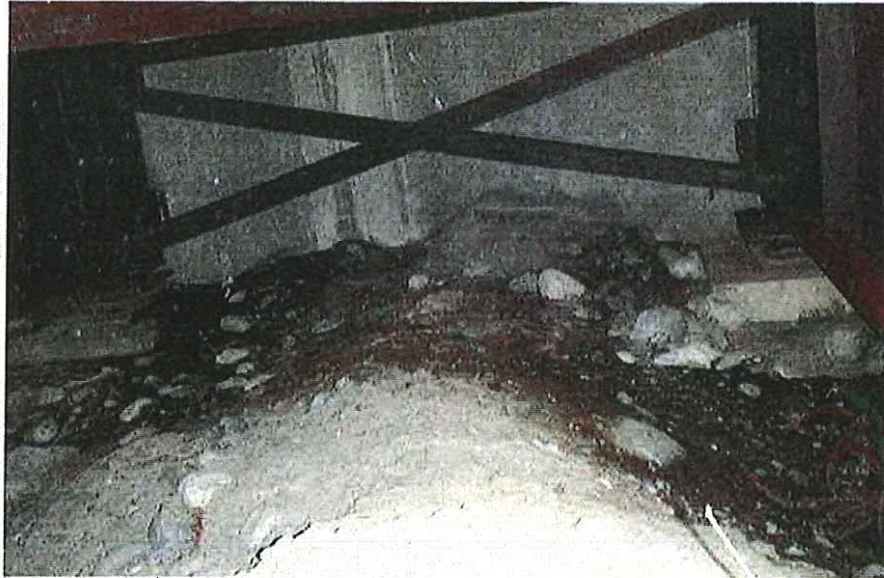
CK2231 Left Abutment (3)

| GENERAL INFORMATION - multi span - | | (enter either long/lat or UTM below - not both) | |
|---|---|---|---|
| Fill | E G F <b>(P)</b> N/A UR | The fill in front of left abut is failing. | |

| GENERAL INFORMATION | | | |
|---|---|---|---|
| Inspector's Comments<br>check asbuilt to ensure left footing installed on B/C. The fill in front of footing is failing (large hole present) | | | |

| GENERAL INFORMATION | | | |
|---|---|---|---|
| 1 | Footings Scour - Left abutment. | | |
