**Corporate Bridge Register (CBR)**  
**Structure Inventory Data Form "BRIDGES"**

**Routine Condition Bridge Inspection Form**  
(for log stringer or timber stringer bridges)**GENERAL INFORMATION**

| *Site #: CK2263 | *Crossing Name: SIDE CRK | *Type/Class: <input type="checkbox"/> Major Culvert<br><input checked="" type="checkbox"/> Woodbox/Log Culvert | *Project File ID# 8013 |
| *FSR Name: STAVE RIVER | *Forest District: CHILLIWACK | *Kilometres: 11.4 | Usar km: 11.4 |

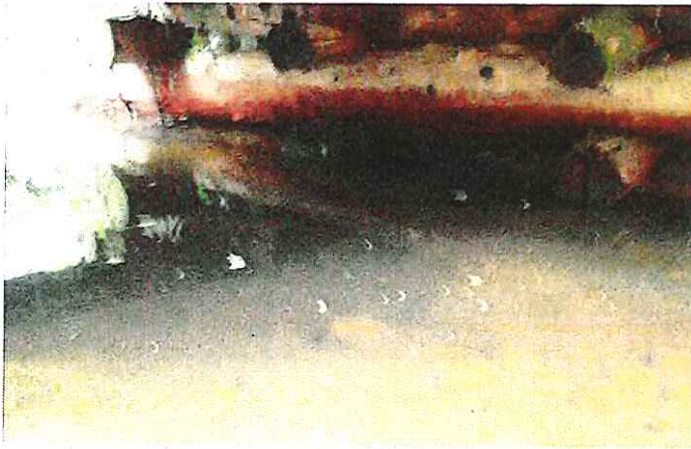
| Item | Present Condition<br>(circle) | Comments<br>(a comment is mandatory if condition "Poor" is selected) |
|---|---|---|
| Log/Timber Cribs | E G F (P) N/A UR | 3X CRIB on left abut. top log has a large horizontal fracture starting from mid tie back up toward U/S. |
| Bearings | E G F (P) N/A UR | Due to left abut crib. |

CK2263 Left Abutment

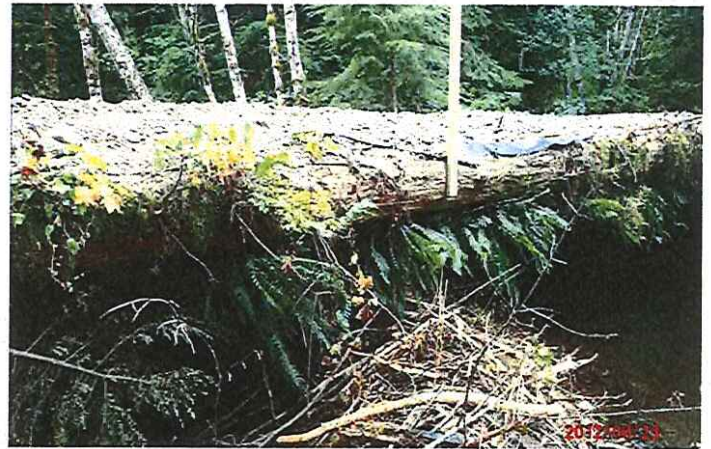
| GENERAL INFORMATION | | | | | | | | | | | | |
|---|---|---|---|---|---|---|---|---|---|---|---|---|
| Comments | | | | | | | | | | Washed debris from beaver dam. | | |

CK2263 Beaver dam

| GENERAL INFORMATION | | | | | | | | | | | | |
|---|---|---|---|---|---|---|---|---|---|---|---|---|
| 2 | <b>H</b> M L | | | clear inlet so stringers can be assessed. | | | | | | | | |
| Clean debris from under the structure and assess log stringers for an updated load rating. | | | | | | | | | | | | |

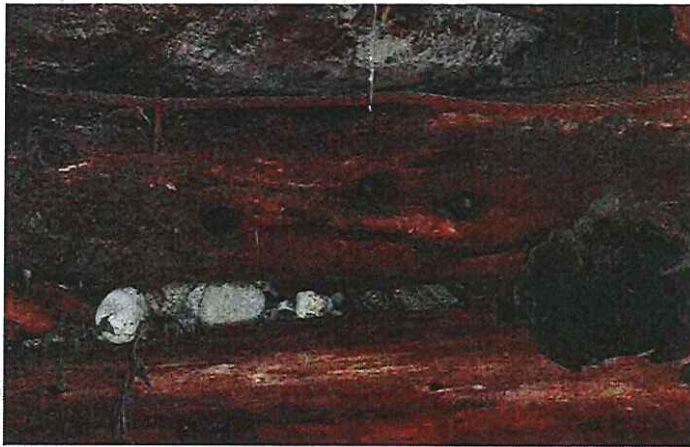
CK2263 Crib settling (2)

| GENERAL INFORMATION | | | | | | | | | | | | |
|---|---|---|---|---|---|---|---|---|---|---|---|---|
| 1 | left curb for settling. | | | | | | | | | | | |

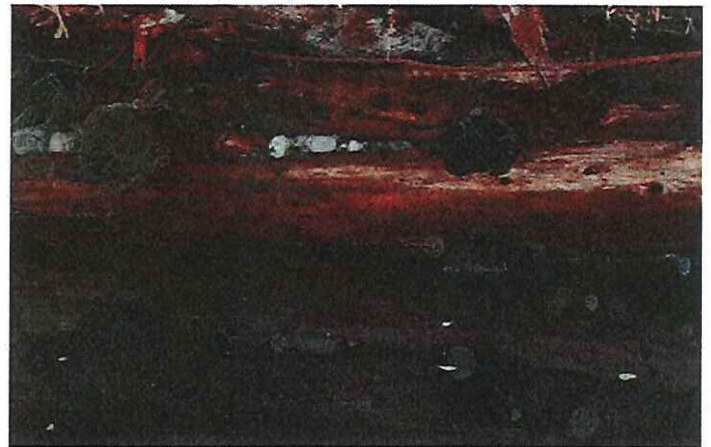
CK2263 Crib settling (3)

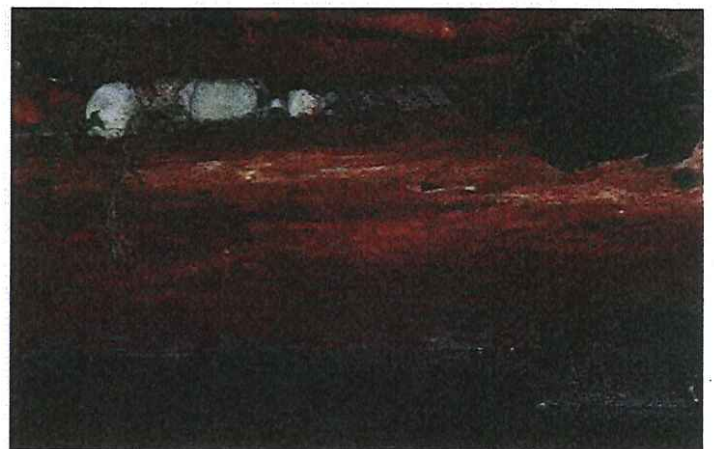
CK2263 Crib settling (1)
