BC Ministry of  
Forests and Range

## Corporate Bridge Register (CBR) SITE INVENTORY DATA FORM

| <b>*Crossing Name:</b> BOISE CRK | | Close Proximity Inspection Required? <input type="checkbox"/> Yes <input checked="" type="checkbox"/> No | |

**Routine Condition Bridge Inspection Form**  
(except for log stringer or timber stringer bridges)

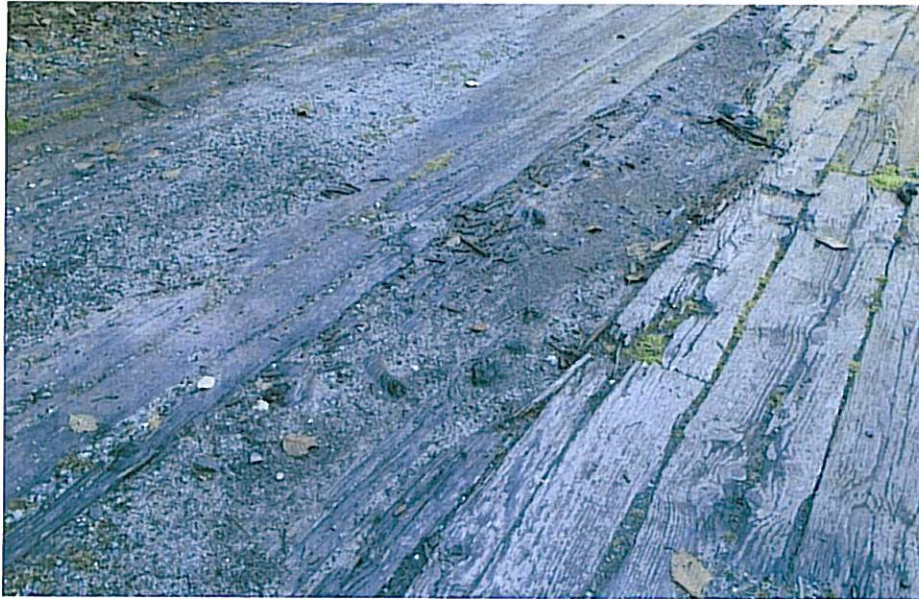
| GENERAL INFORMATION | | | | (enter either long/lat or UTM below – not both) | | | |
|---|---|---|---|---|---|--|--|
| Running Planks | E | G F <u>P</u> N/A UR | Rotten 3" x 12" planks | | | | |
| Overall Deck Condition | E | G F <u>P</u> UR | Rotten running planks + timber rails | | | | |

CK-2230 Deck

| GENERAL INFORMATION | | | |
|---|---|---|---|
| 1 | H M L | \$1.00 | Replace structures running planks and rails when industrial activity begins |
| PEng Reviewer's Comments Replace running planks and guardrail with industrial activity. Post bridge ahead signs and replace | | | |

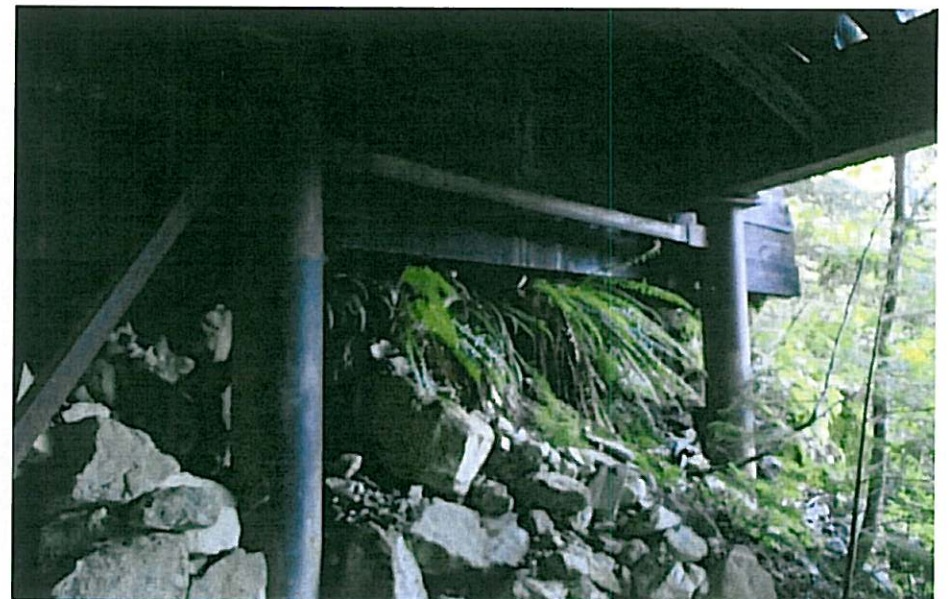
CK-2230 Left abutment close

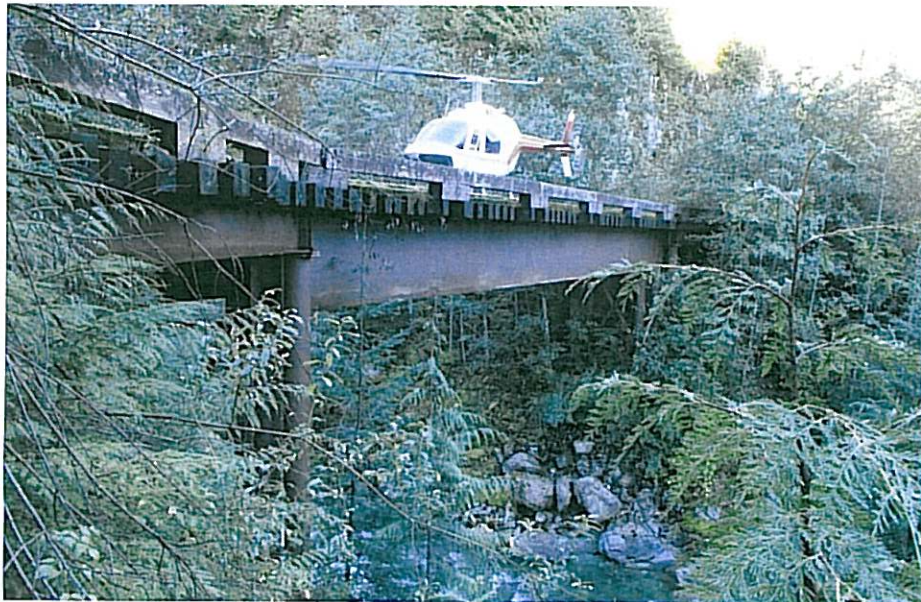
CK-2230 From downstream

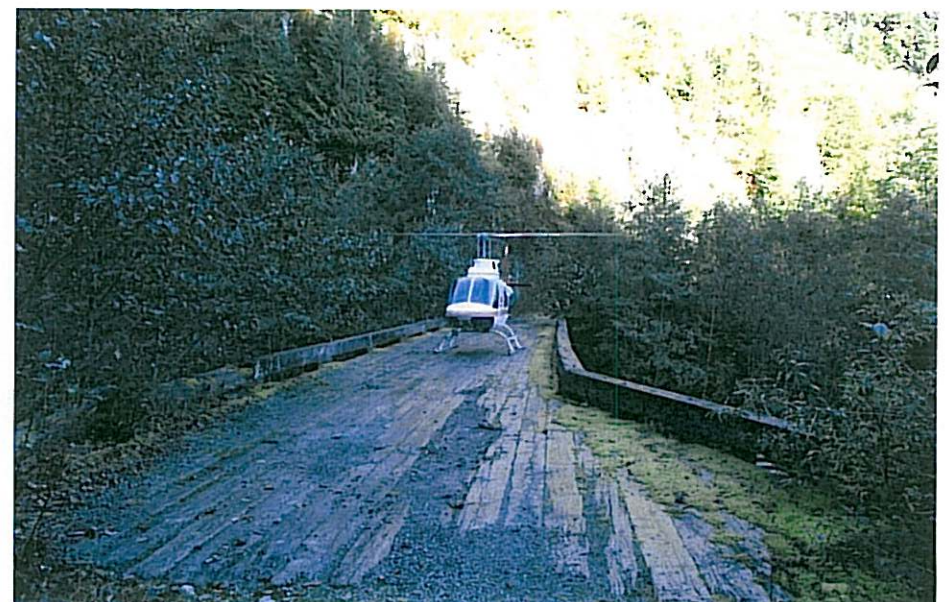
CK-2230 From right

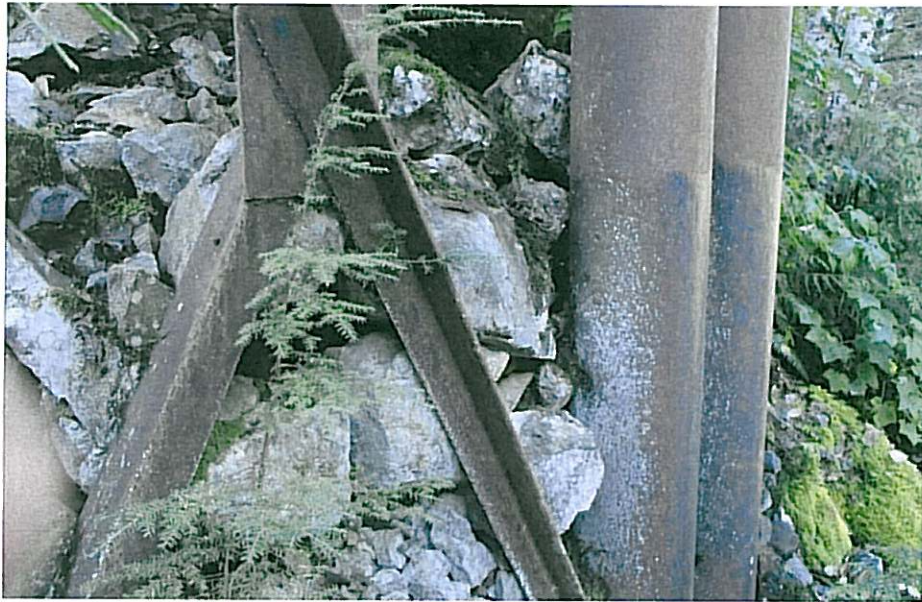
| GENERAL INFORMATION | | |
|---|---|---|
| Piles or Posts | E G <b>F</b> P N/A UR | Pipe risers x 5 some rock against |

CK-2230 Pier 2 rocks at bottom

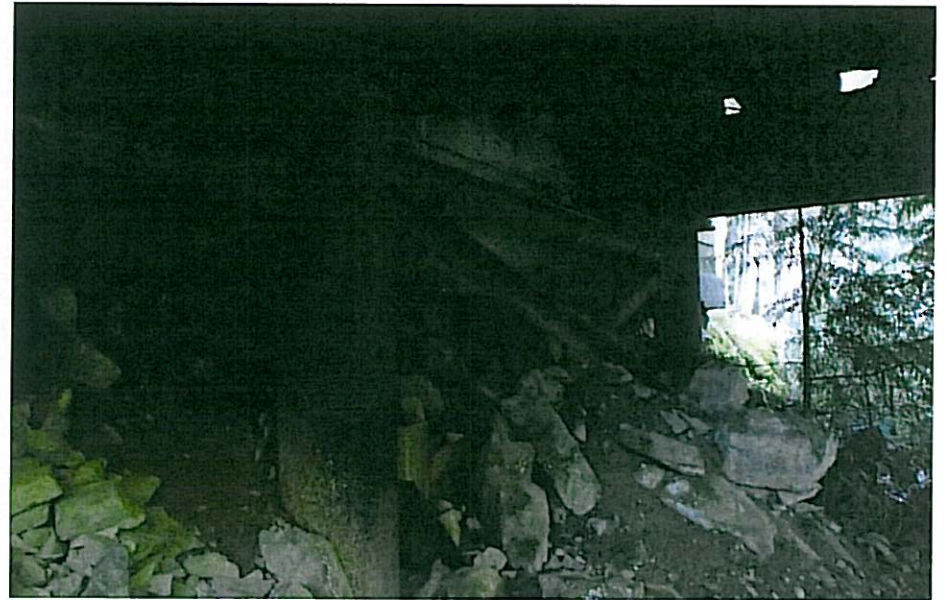
CK-2230 Right abutment

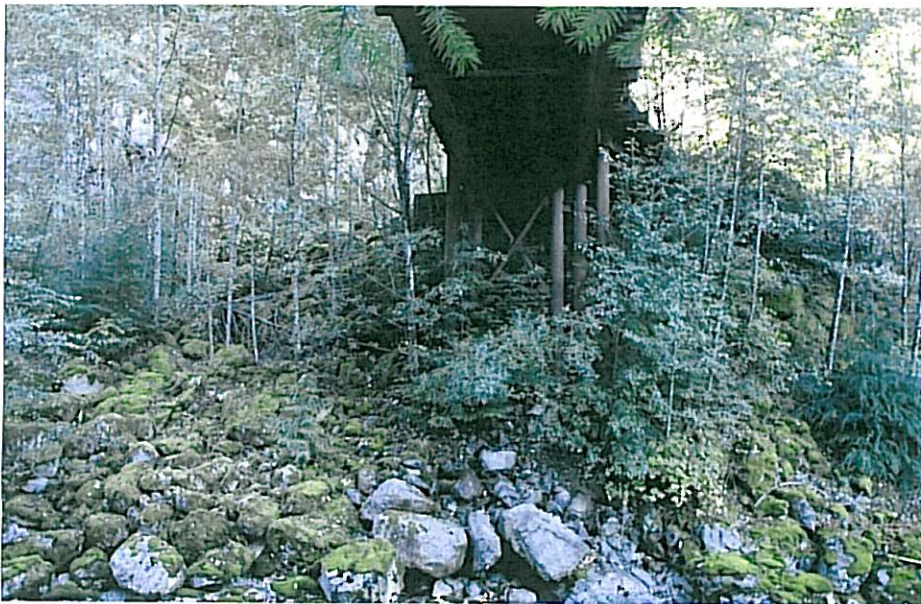
CK-2230 Left abutment

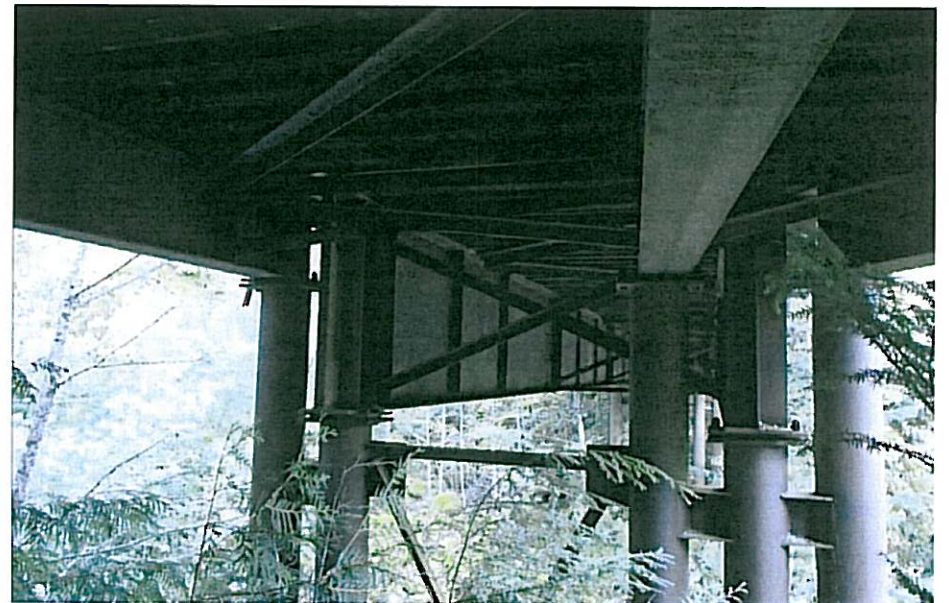
CK-2230 Pier 2

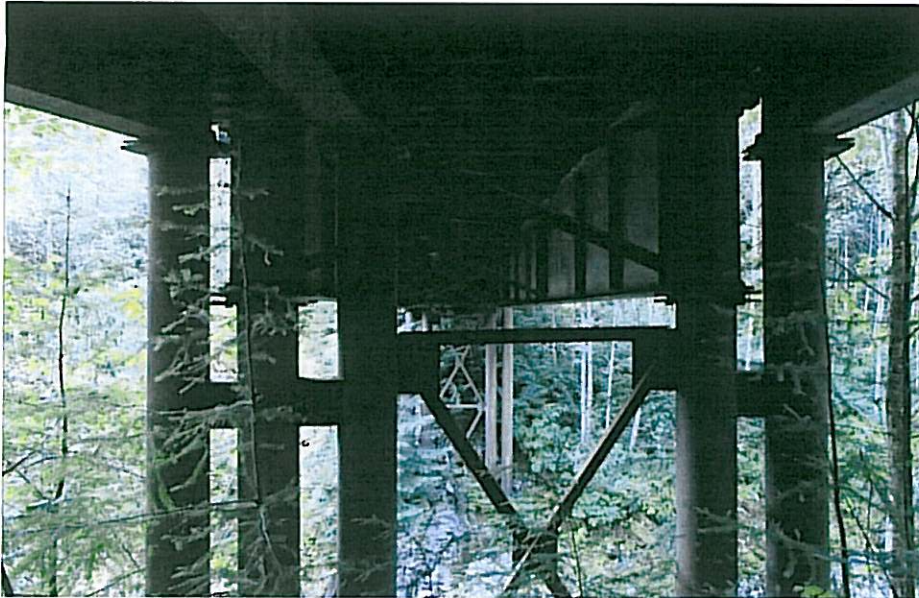
CK-2230 Pier 1

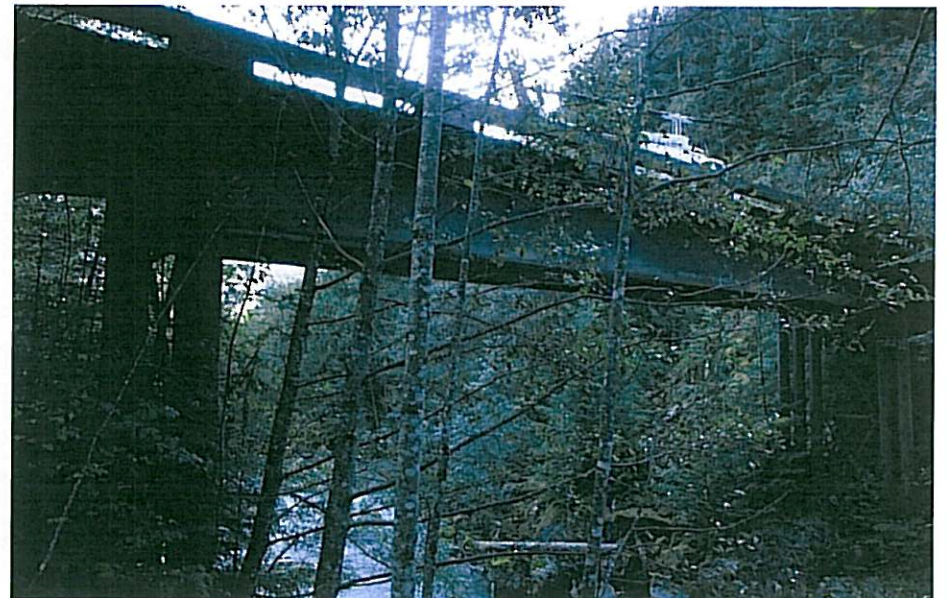
CK-2230 From upstream

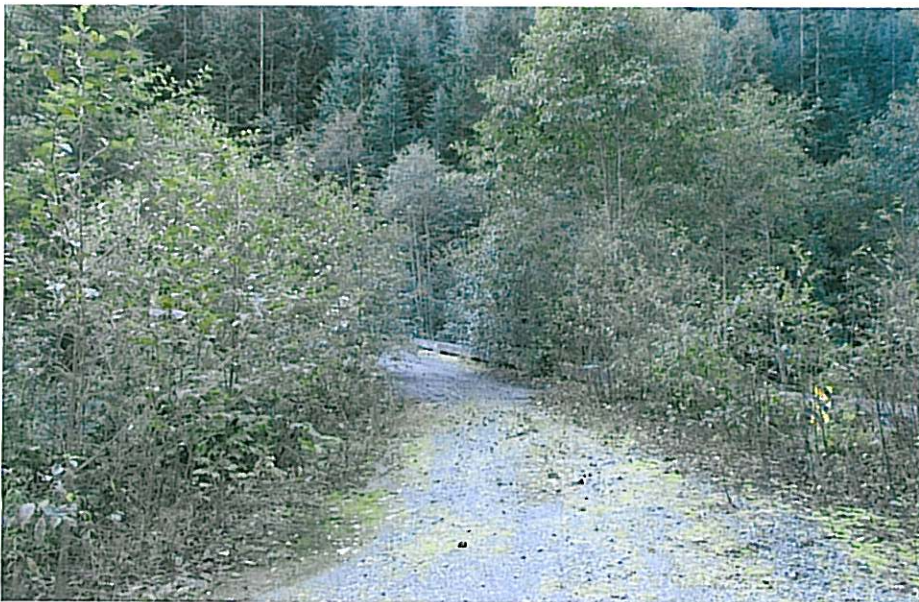
CK-2230 From left

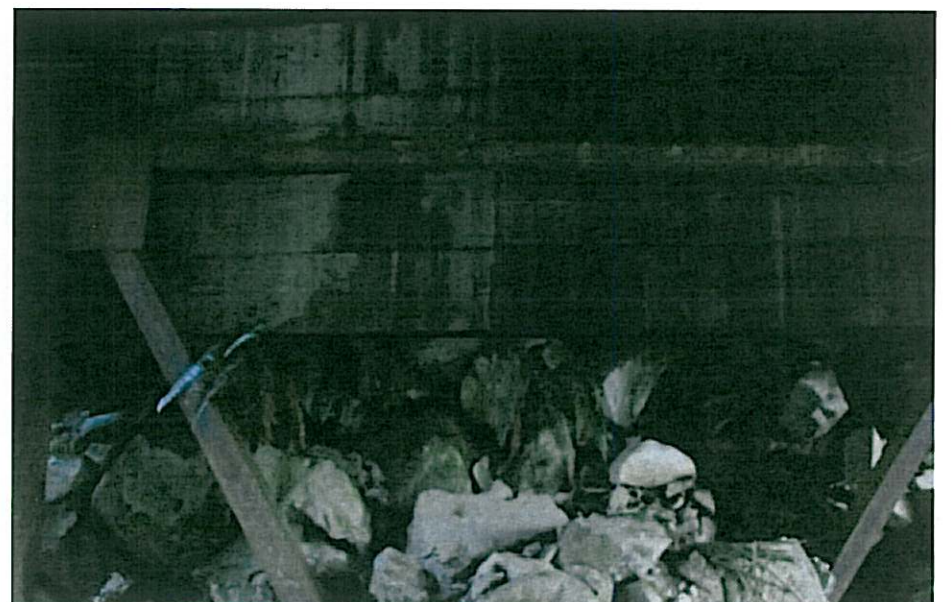
| GENERAL INFORMATION | | | | (enter either long/lat or UTM below – not both) | | | |
|---|---|---|---|---|---|--|--|
| Bearings | E | G <u>F</u> P N/A UR | Rubber pads | | | | |

CK-2230 Left bearing

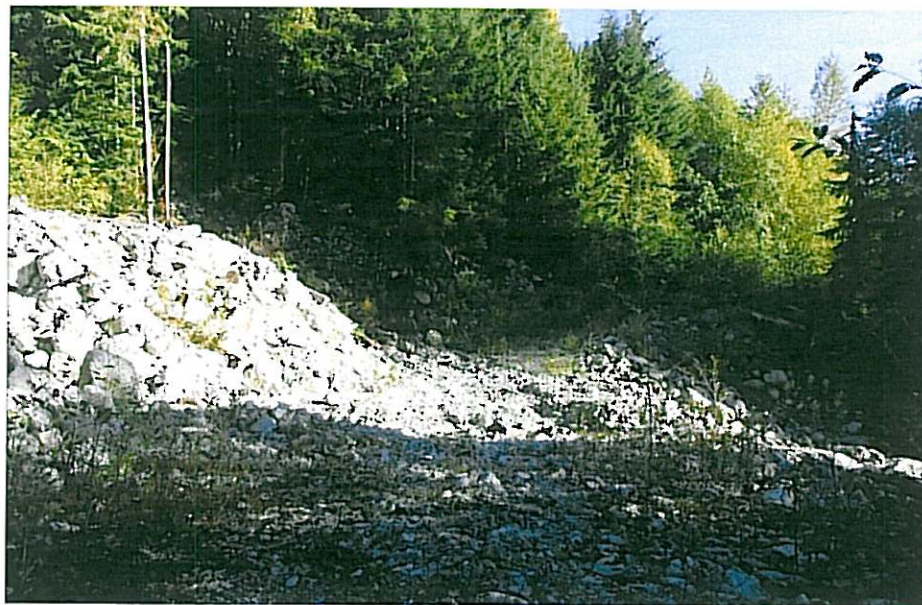
| GENERAL INFORMATION | | | | (enter either long/lat or UTM below – not both) | | | |
|---|---|---|---|---|---|--|--|
| Bridge Ahead Signs Missing | 0 | 1 <u>2</u> | Side of left approach, road washed out | | | | |
| Road Surface | E | G <u>F</u> P UR | Potholes on approaches / washed out on left approach | | | | |

CK-2230 Slide on left approach
