BC Ministry of  
Forests and Range

## Corporate Bridge Register (CBR) Structure Inventory Data Form "BRIDGES"

Routine Condition Bridge Inspection Form  
(for log stringer or timber stringer bridges)

CK-2263

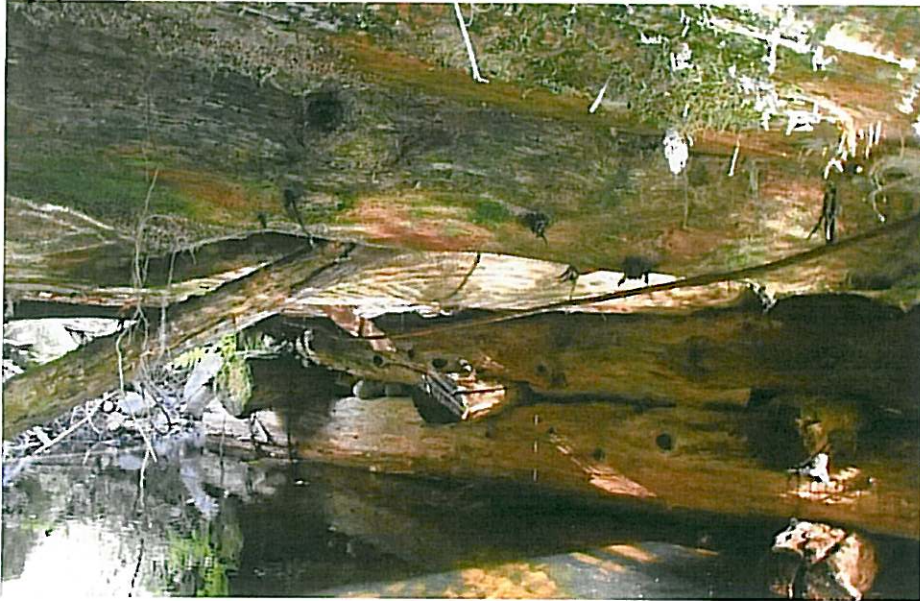
CK-2263 Left Crib

| Item | | Present Condition (circle) | | | | Comments (a comment is mandatory if condition "Poor" is selected) | | |
|---|---|---|---|---|---|---|---|---|
| Log Curbs | | E | G | F | (P) | UR | No curb logs | |

| Repair Item # | *Priority (circle) | *Estimate (\$) | *Repair Description |
|---|---|---|---|
| 1 | (H) M L | \$1.00 | Install curb logs |

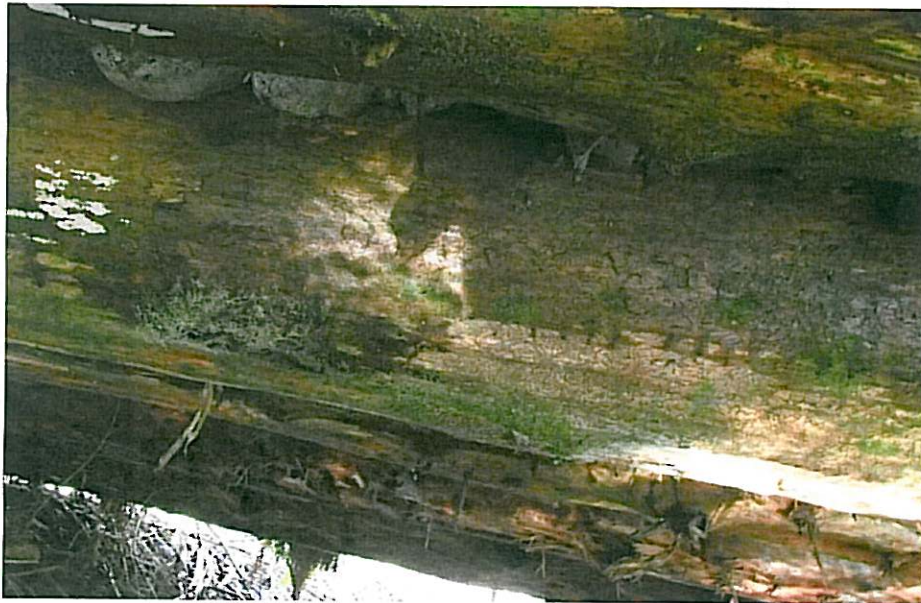
CK-2263 Stringer

| Item | | Present Condition (circle) | | | | Comments (a comment is mandatory if condition "Poor" is selected) | | |
|---|---|---|---|---|---|---|---|---|
| 1 | ? | (Y) N | ? | | ? | ? | ? | cannot access |
| 2 | | Y N | | | | | | stringers at |
| 3 | | Y N | | | | | | opening point due |
| 4 | | Y N | | | | | | to beaver dam. |

| Repair Item # | *Priority (circle) | *Estimate (\$) | *Repair Description |
|---|---|---|---|
| 2 | (H) M L | \$1.00 | Clear inlet so stringers can be assessed |

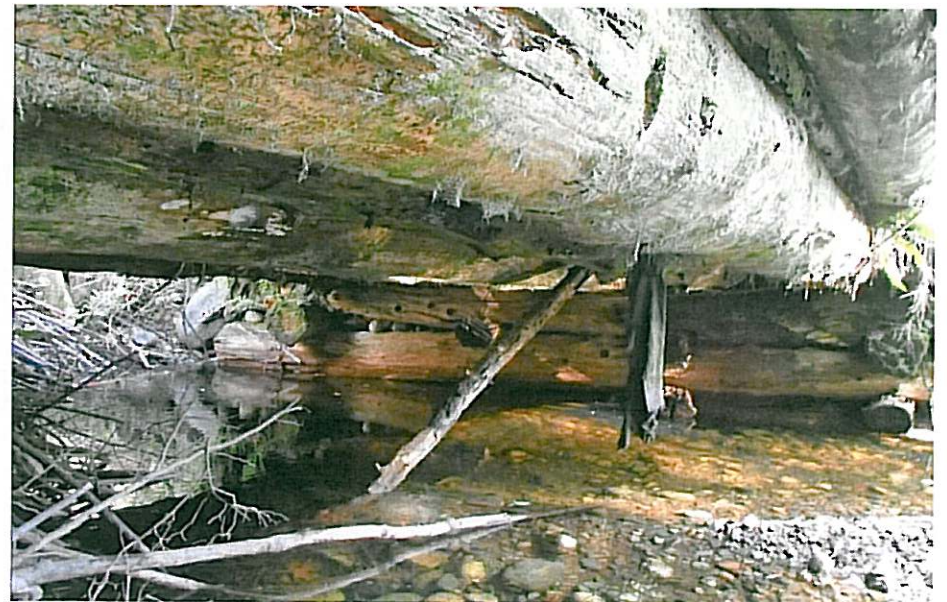
CK-2263 Left Abutment

| Item | Present Condition<br>(circle) | Comments<br>(a comment is mandatory if condition "Poor" is selected) |
|---|---|---|
| Log/Timber Crib | E G F <u>P</u> N/A UR | 5x on left abutment. Top 16' has a large horizontal fracture starting from mid tip back up towards upstream. No change in 2013 from 2012. |
| Tie-backs | E G F <u>P</u> N/A UR | 3x crushing and rotten |
| Hardware | E G <u>F</u> P N/A UR | crib lashed at ends - loose |
| Bearings | E G F <u>P</u> N/A UR | Due to left abutment crib |
