## Corporate Bridge Register (CBR) SITE INVENTORY DATA FORM

Routine Condition Culvert Inspection Form

| *Site #: CK-2273 | | *Crossing Name: | | *Type/Class: <input checked="" type="checkbox"/> Major Culvert<br><input type="checkbox"/> Woodbox/Log Culvert | | *Project File ID# 8013 | |
| *FSR Name: Stave River | | *Forest District: Chilliwack | | *Kilometres: 30.90 | | User km: 29.0 | |

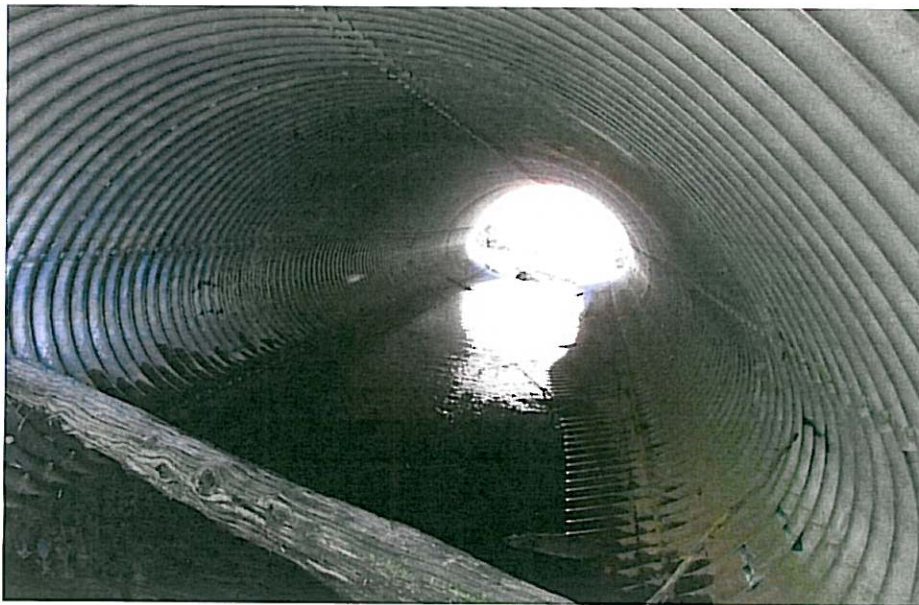
CK-2273 Inside

| Coating (N/A to woodbox/log culvert) | E | G | F | P | N/A | UR | Slight rust on floor |
| Floor | E | G | F | P | N/A | UR | some rust |
