## Corporate Bridge Register (CBR) SITE INVENTORY DATA FORM

| <b>*Forest Service Road:</b> STAVE | | | |

## Corporate Bridge Register (CBR) Structure Inventory Data Form "BRIDGES"

**Routine Condition Bridge Inspection Form**  
(except for log stringer or timber stringer bridges)

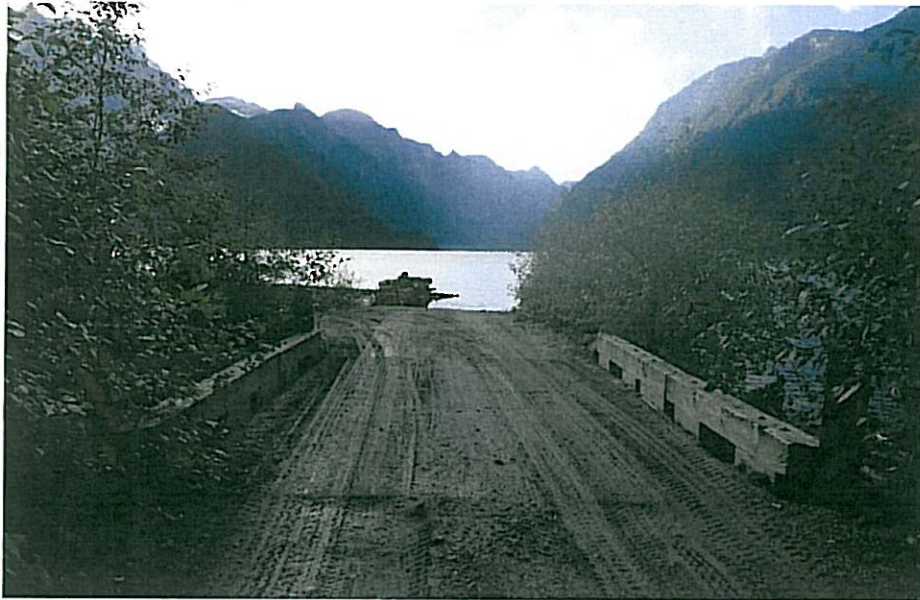
CK-2327 From Right

| GENERAL INFORMATION | | | |
|---|---|---|---|
| 1 | from right | | |

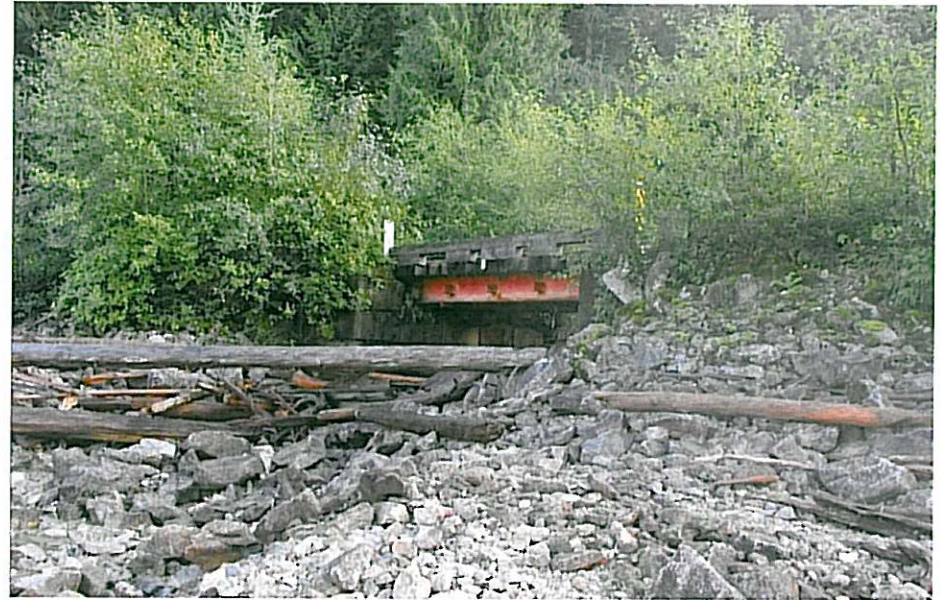
CK-2327 From downstream

| GENERAL INFORMATION | | | |
|---|---|---|---|
| Comments: Logs under bridge | | | |
| 2 | from downstream | | |

| GENERAL INFORMATION | | | |
|---|---|---|---|
| 3 | <u>H</u> M L | | Remove debris under bridge and at outlet |

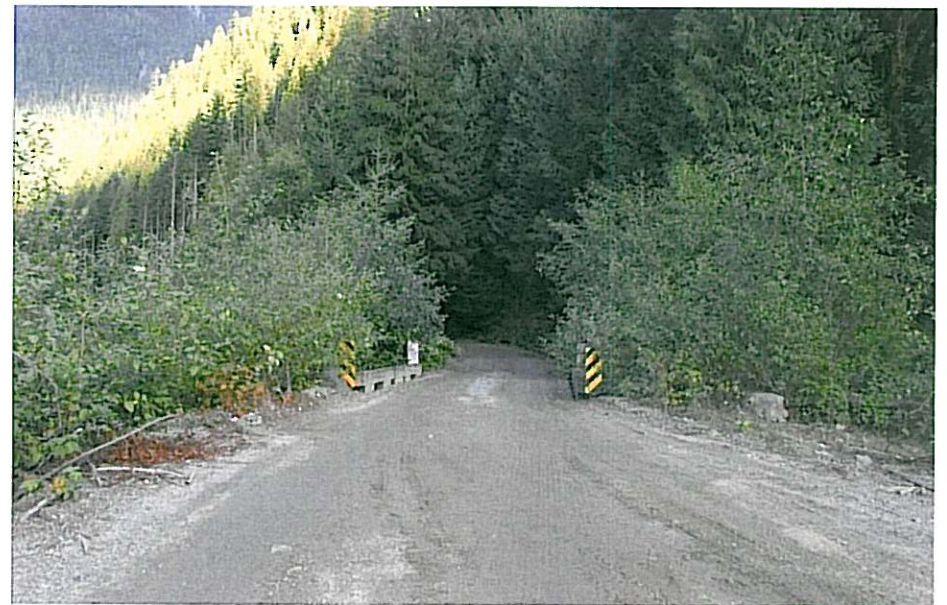
CK-2327 From Left

| GENERAL INFORMATION | | | |
|---|---|---|---|
| 3 | from left | | |
