## Corporate Bridge Register (CBR) SITE INVENTORY DATA FORM

## Corporate Bridge Register (CBR) Structure Inventory Data Form "CULVERTS"

BC Ministry of Forests and Range  
Routine Condition Culvert Inspection Form

Side Creek

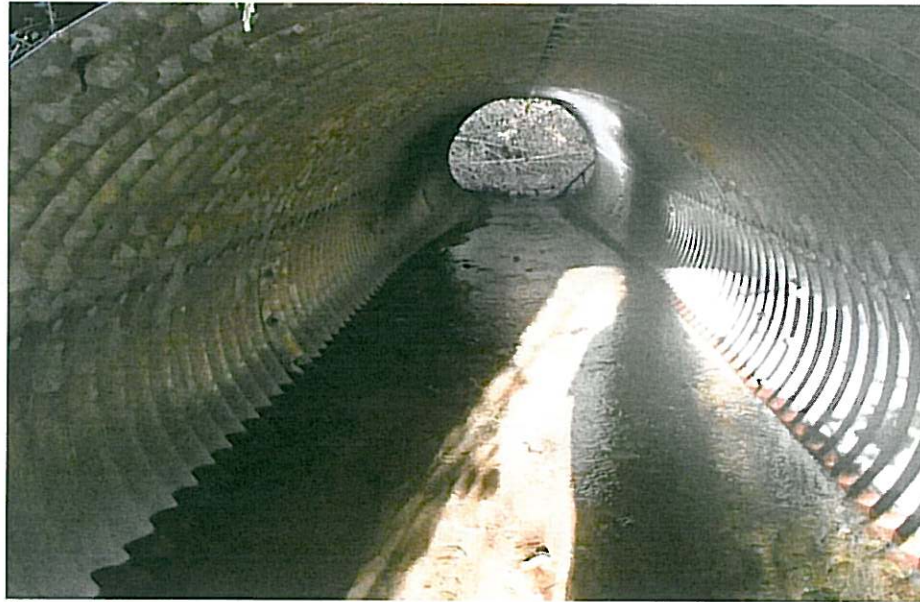
CK-2335 Inside

| Item | Present Condition<br>(circle) | Comments<br>(a comment is mandatory if condition "Poor" is selected) |
|---|---|---|
| Coating (N/A to woodbox/log culvert) | E G <b>F</b> P N/A UR | Heavy rust on floor |
| Floor | E G F <b>P</b> N/A UR | Heavy rust |
