## Corporate Bridge Register (CBR) SITE INVENTORY DATA FORM

Routine Condition Culvert Inspection Form

| GENERAL INFORMATION | | | | (enter either long/lat or UTM below- not both) | | | |
|---|---|---|---|---|---|---|---|
| *Site #: CK-2343 | | *Crossing Name: Side Creek | | *Type/Class: <input checked="" type="checkbox"/> Major Culvert<br><input type="checkbox"/> Woodbox/Log Culvert | | *Project File ID# 8013 | |
| *FSR Name: Stave River | | *Forest District: Chilliwack | | *Kilometres: 28.10 | | User km: 26.5 | |

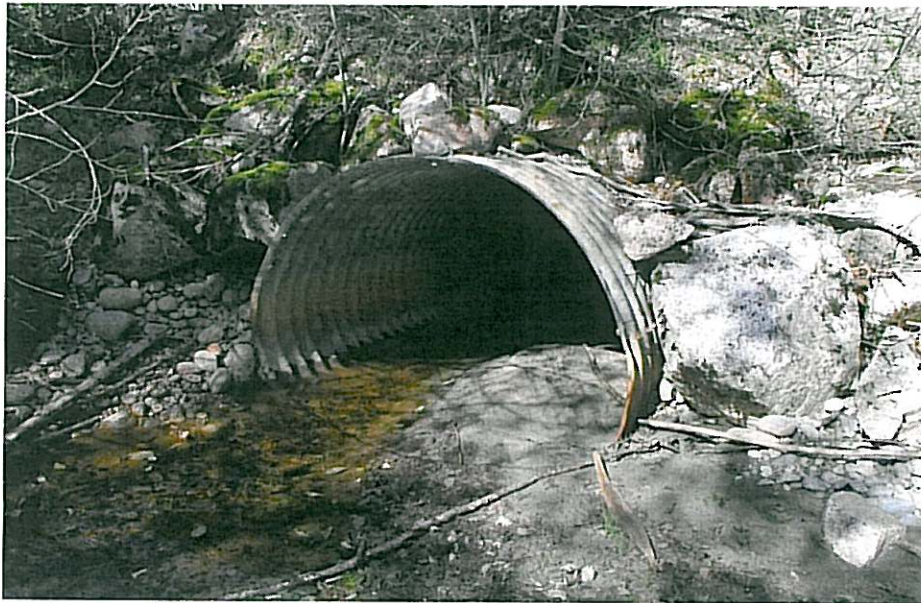
CK-2343 Outlet

Comments Sand collecting at outlet, beaver dam at inlet
