## Corporate Bridge Register (CBR) SITE INVENTORY DATA FORM

# Corporate Bridge Register (CBR) Structure Inventory Data Form "CULVERTS"

Routine Condition Culvert Inspection Form

| GENERAL INFORMATION | | | | (enter either long/lat or UTM below- not both) | | | |
|---|---|---|---|---|---|---|---|
| *Site #: CK-2349 | | *Crossing Name: Sirio Creek | | *Type/Class: <input checked="" type="checkbox"/> Major Culvert<br><input type="checkbox"/> Woodbox/Log Culvert | | *Project File ID# 8013 | |

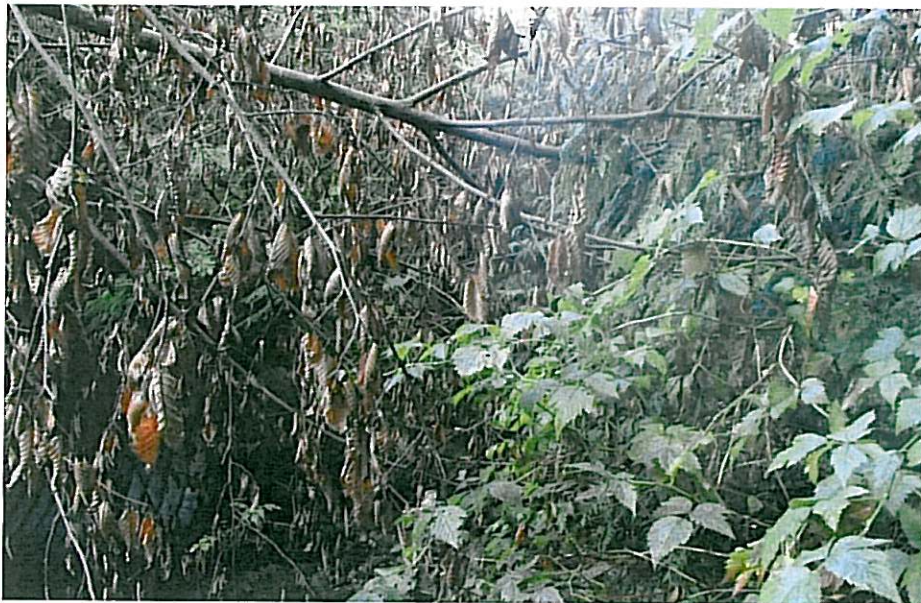
CK-2349 Inlets

| GENERAL INFORMATION | | | | (enter either long/lat or UTM below- not both) | | | |
|---|---|---|---|---|---|---|---|
| Riprap | E | G | F | P | N/A | UR | Too steep and falling into stream on upstream left side |

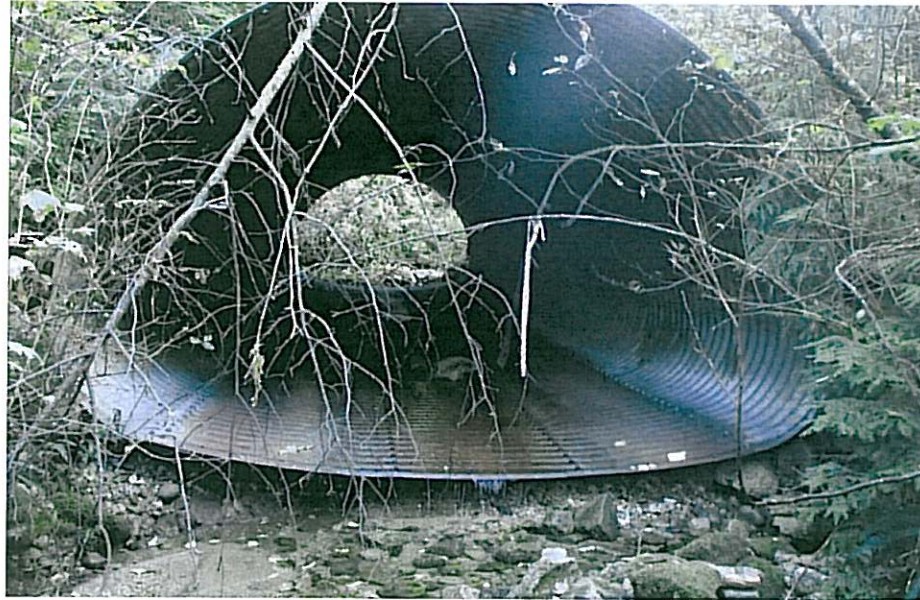
CK-2349 Outlet

| GENERAL INFORMATION | | | | (enter either long/lat or UTM below- not both) | | | |
|---|---|---|---|---|---|---|---|
| Outlet | E | G | F | P | UR | Erosion on downstream left corner | |

Comments Erosion on downstream left side
