## Corporate Bridge Register (CBR) SITE INVENTORY DATA FORM

| <b>*Site #</b><br>CK-2390 | | <b>*Site Status</b><br><input type="checkbox"/> Active<br><input type="checkbox"/> Barricaded/Closed<br><input checked="" type="checkbox"/> Deactivated/Closed<br><input type="checkbox"/> Proposed<br><input type="checkbox"/> Transferred<br><input type="checkbox"/> Under Construction |

## Corporate Bridge Register (CBR) Structure Inventory Data Form "BRIDGES"

**Routine Condition Bridge Inspection Form**  
(except for log stringer or timber stringer bridges)

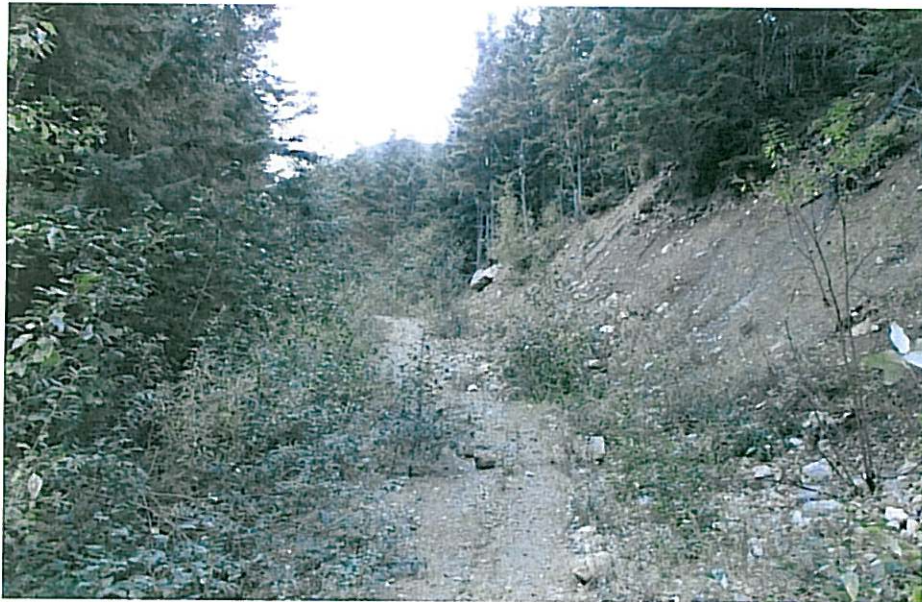
| GENERAL INFORMATION | | | | (enter either long/lat or UTM below – not both) | | |
|---|---|---|---|---|--|--|
| Alignment | E | G F P UR | Tight vertical curve | | | |
| Road Surface | E | G F P UR | Very bumpy road, large amount of debris on road | | | |

CK-2390 Right approach

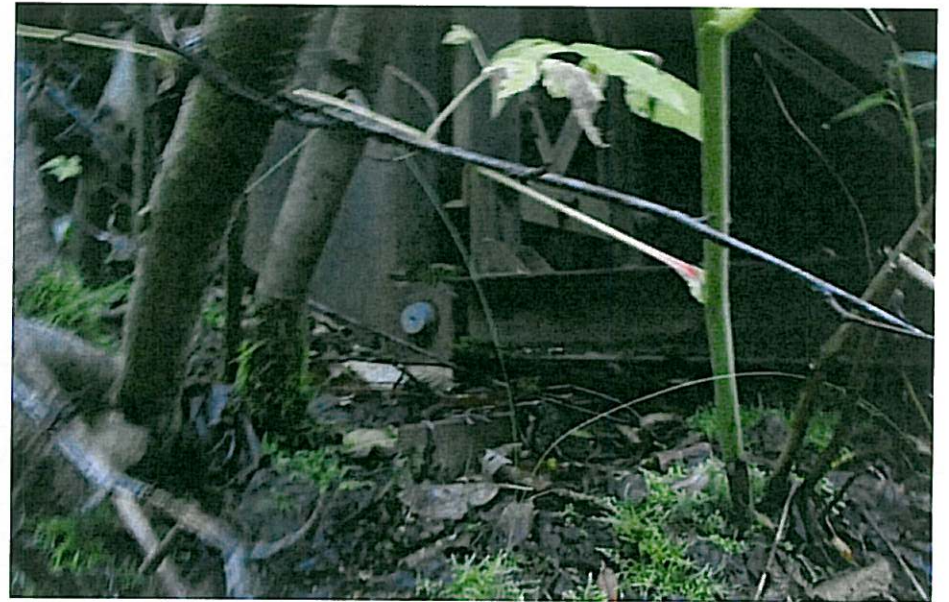
| GENERAL INFORMATION | | | | (enter either long/lat or UTM below – not both) | | |
|---|---|---|---|---|--|--|
| Bearings | E | G F P N/A UR | Upstream right abutment bearing | | | |

CK-2390 Left bearing

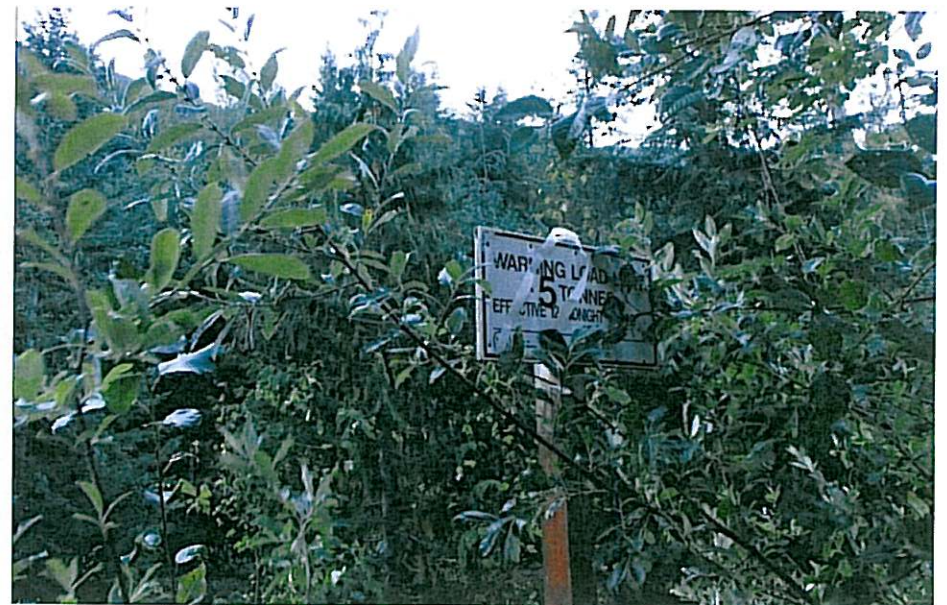
CK-2390 Load sign on right

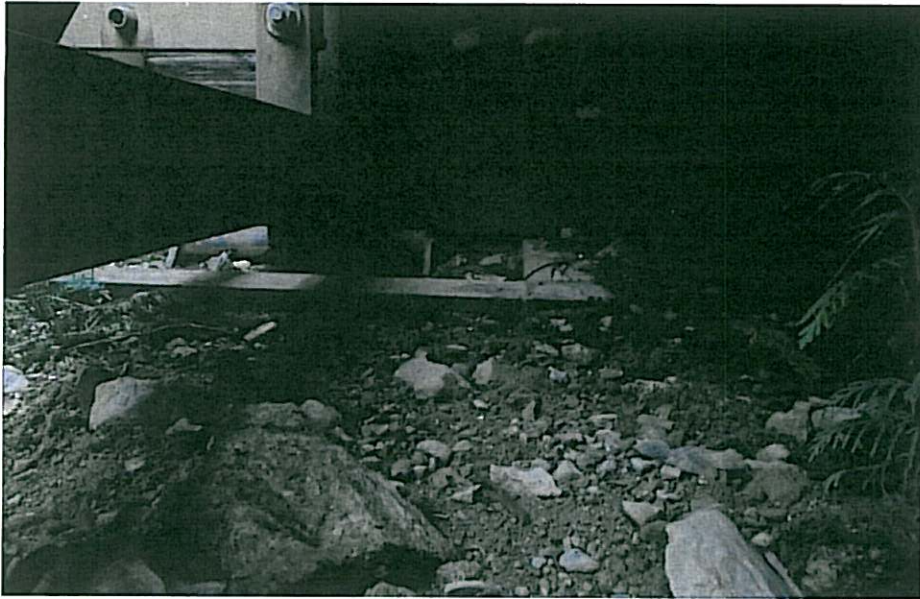
| GENERAL INFORMATION | | | | (enter either long/lat or UTM below – not both) | | |
|---|---|---|---|---|--|--|
| Concrete (cast in place, lock blocks, precast) | E | G F P N/A UR | Right abutment - the load bearing lock block is leaning up + has shifted. It's missing a lock block at centre + 1 lock block is deteriorating. | | | |

CK-2390 Right abutment 2

| GENERAL INFORMATION | | | |
|---|---|---|---|
| 1 | <b>H</b> M L | \$1.00 | Monitor the footing if there is vehicle access (yearly monitor) |

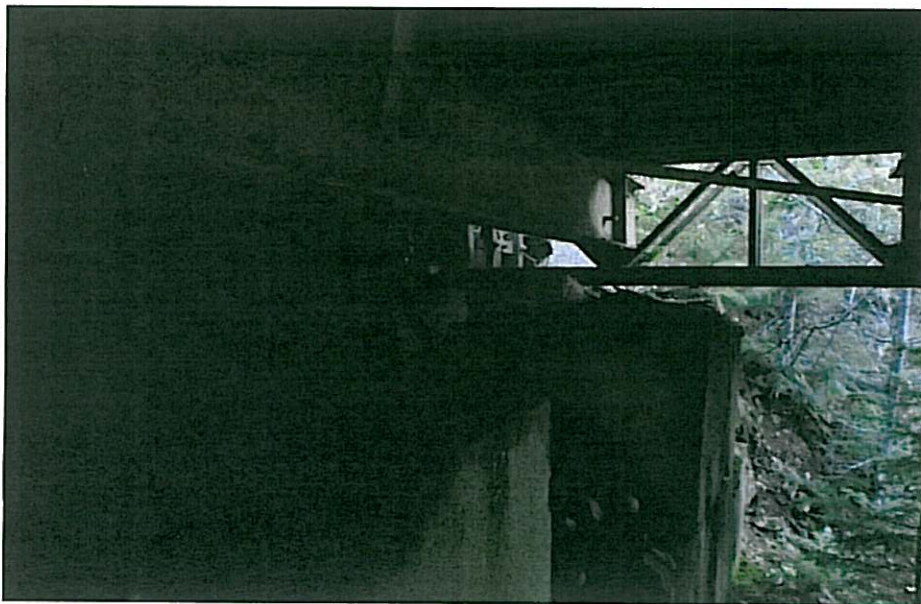
CK-2390 Right abutment 3

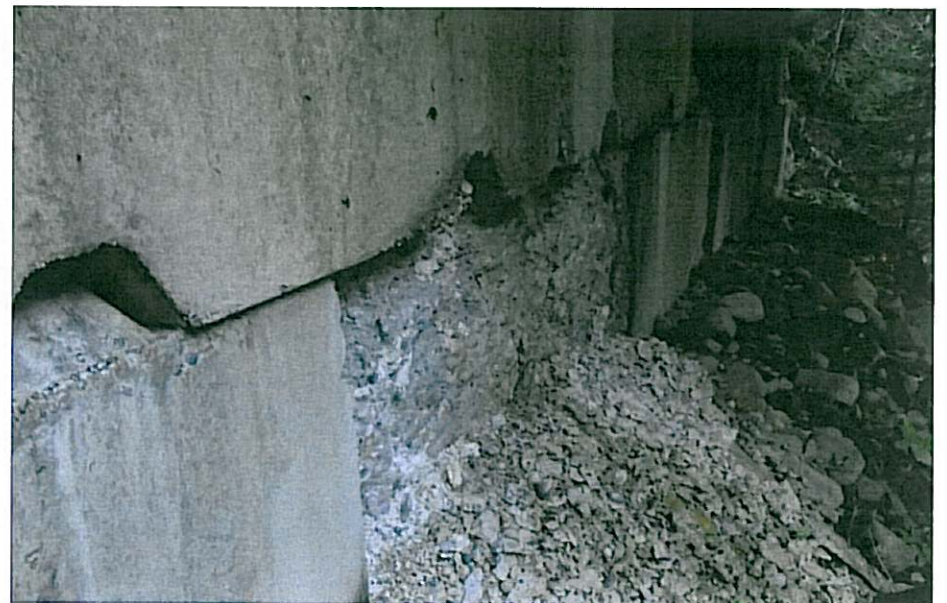
CK-2390 Right abutment 1

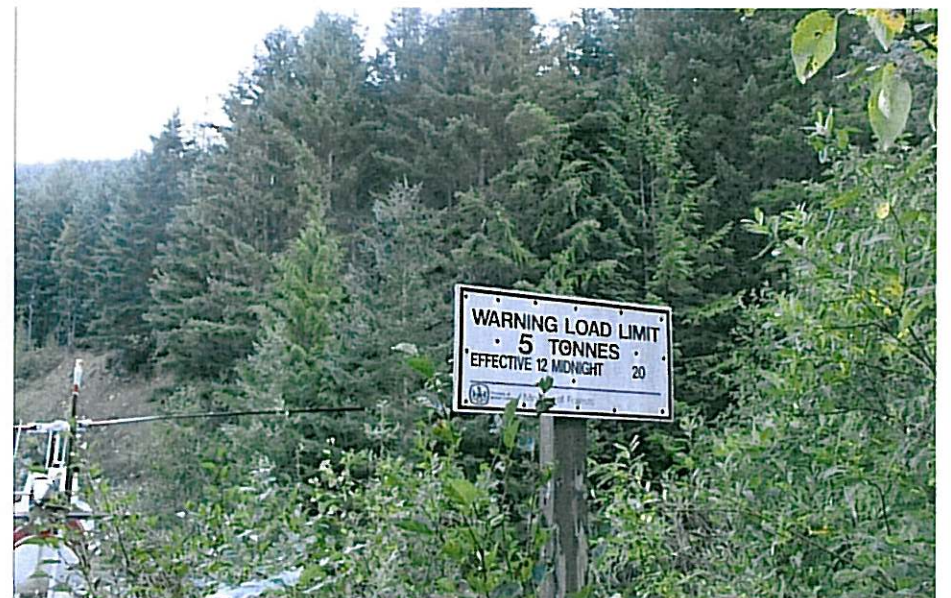
CK-2390 Left approach sign

| GENERAL INFORMATION | | | |
|---|---|---|---|
| 2 | <b>H</b> M L | \$1.00 | Install delineators & bridge ahead signs |

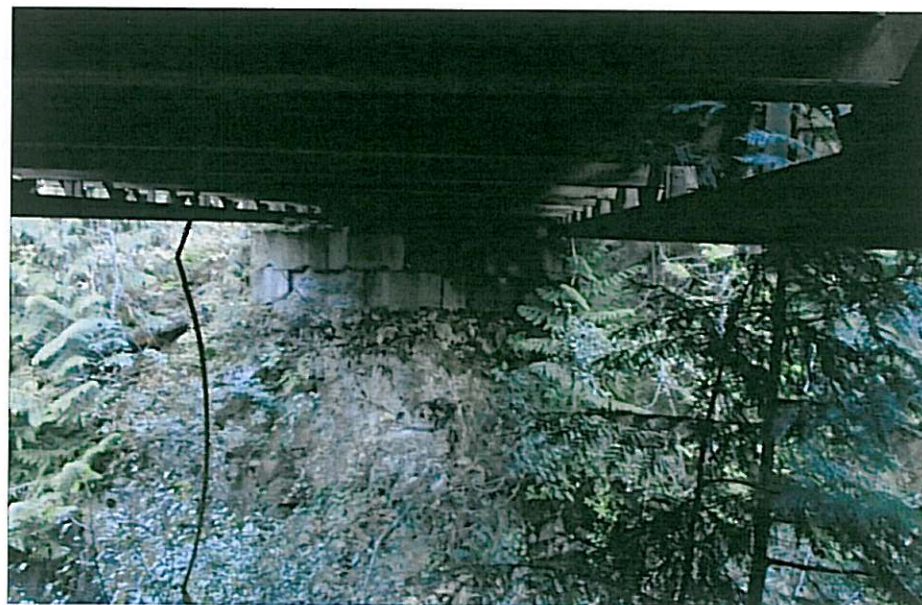
| GENERAL INFORMATION | | | |
|---|---|---|---|
| PEng Reviewer's Comments<br>The substructure is in very poor shape, monitor annually. Present load rating of 1 tonnes to continue. | | | |

CK-2390 Right abutment 5
