## Corporate Bridge Register (CBR) SITE INVENTORY DATA FORM

| <b>*Site #</b><br>CK-2406 | | <b>*Site Status</b><br><input checked="" type="checkbox"/> Active<br><input type="checkbox"/> Barricaded/Closed<br><input type="checkbox"/> Deactivated/Closed<br><input type="checkbox"/> Proposed<br><input type="checkbox"/> Transferred<br><input type="checkbox"/> Under Construction | |
| <b>*Forest Service Road:</b> PITT | | | |

**Routine Condition Bridge Inspection Form**  
(for log stringer or timber stringer bridges)

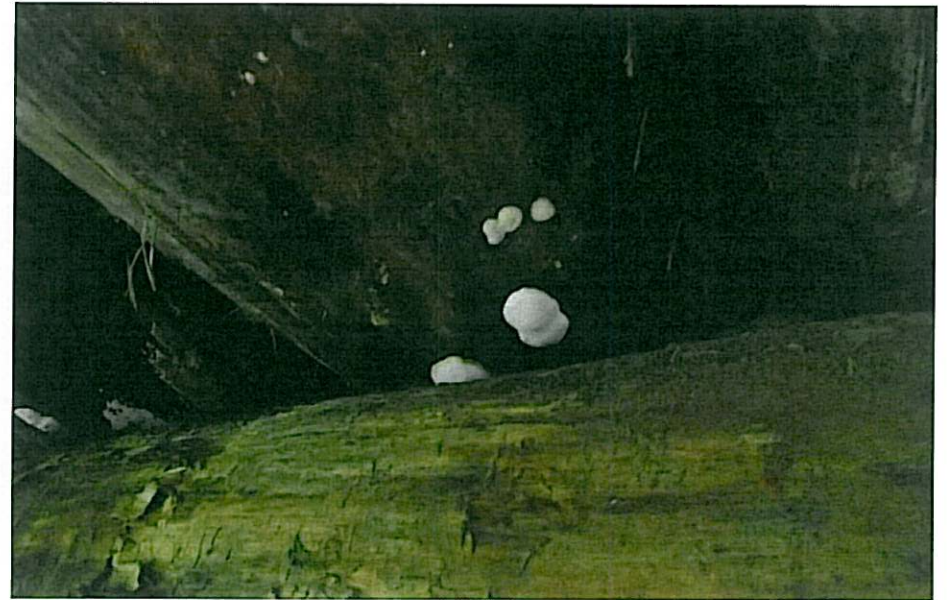
| GENERAL INFORMATION | | | | | | | |
|---|---|---|---|---|---|---|---|
| 8 | ? | (Y) N | 580 | 0 | 0 | 0 | fruiting bodies but cored okay |

CK-2406 Conk starting core ok

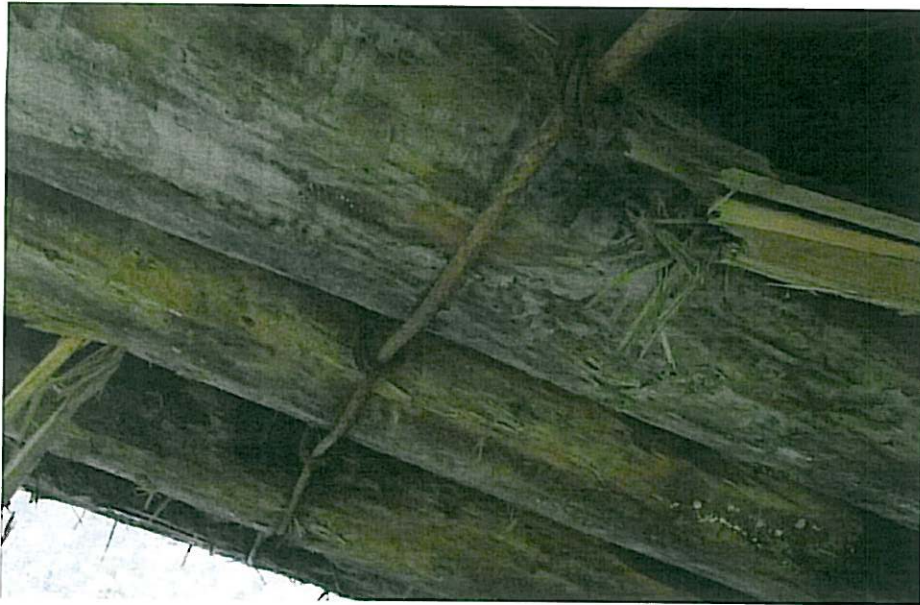
| GENERAL INFORMATION | | | | (enter either long/lat or UTM below – not both) | | | |
|---|---|---|---|---|---|--|--|
| Hardware | E <u>G</u> F P N/A UR | Stringers all lashed at mid-span | | | | | |

CK-2406 Lashing

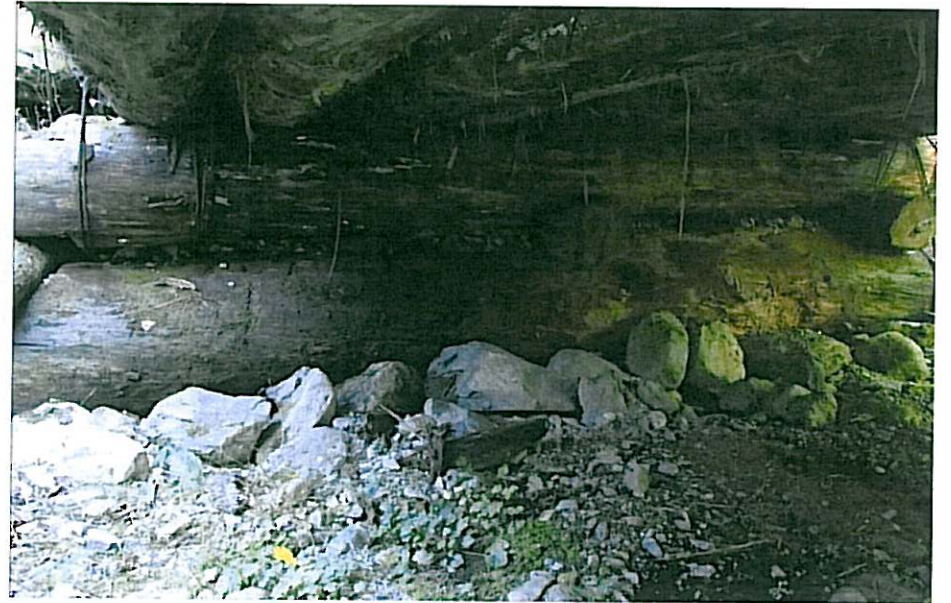
| GENERAL INFORMATION | | | | (enter either long/lat or UTM below – not both) | | | |
|---|---|---|---|---|---|--|--|
| Log/Timber Crib | E <u>G</u> F P N/A UR | 2x open faced on left abutment. 3x open faced on right abutment. | | | | | |

CK-2406 Left abutment

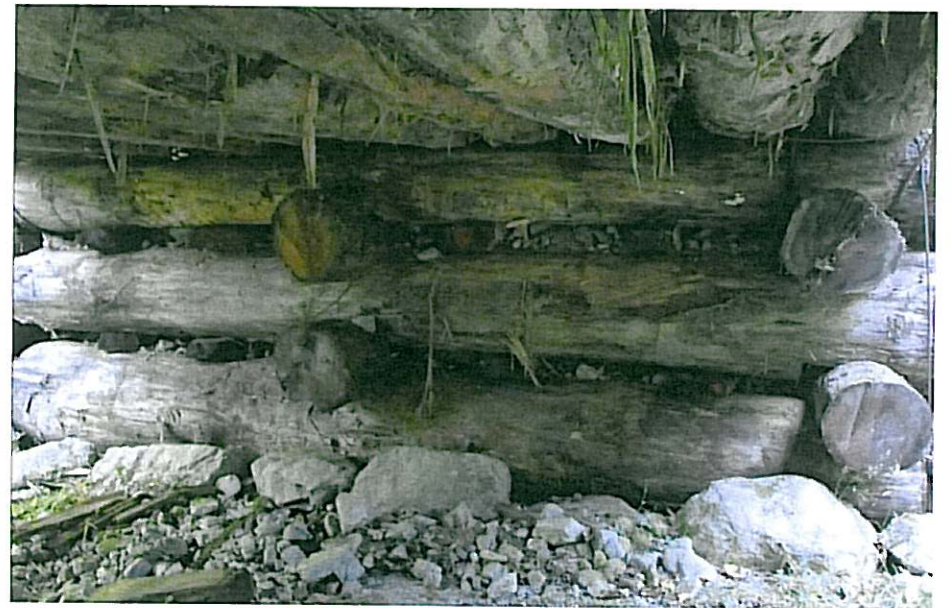
CK-2406 Right abutment
