**SENECA ENTERPRISES LTD.**

**SPRUCE BARK BEETLE REPORT  
FH17DPG218**STAR PROBE# **2016-PHI-0171**

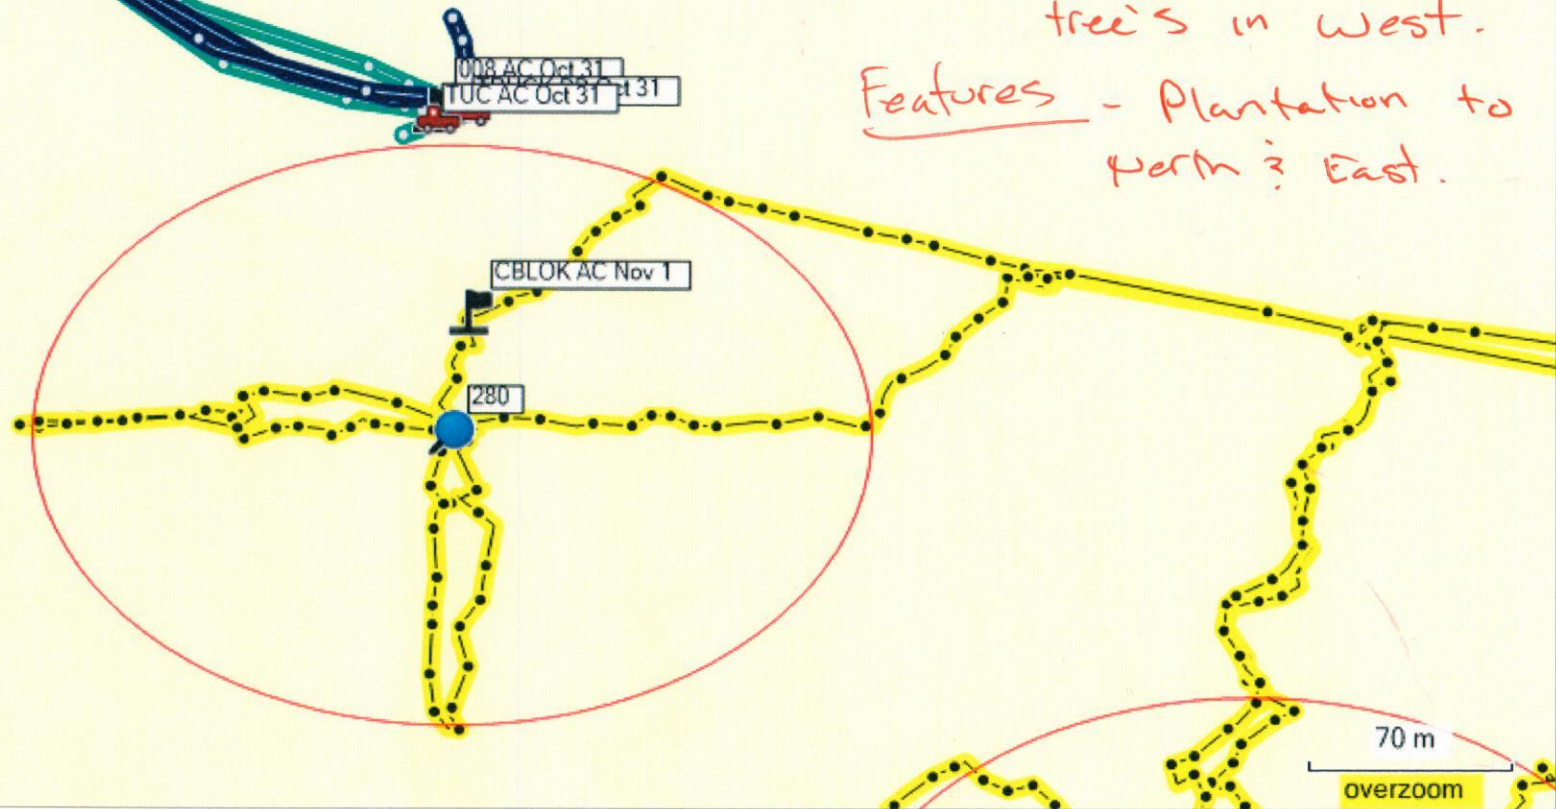
280

Attack = No signs,  
but a few ~~BA~~  
unsuccessful attacked  
tree's in west.

Features - Plantation to  
North & East.

⊕ Some pitchants present West line  
Stream @ 25m South  
Cutback @ 40m North
