# SENECA ENTERPRISES LTD.

## SPRUCE BARK BEETLE REPORT FH17DPG218

STAR PROBE# 2016-PHI-0195

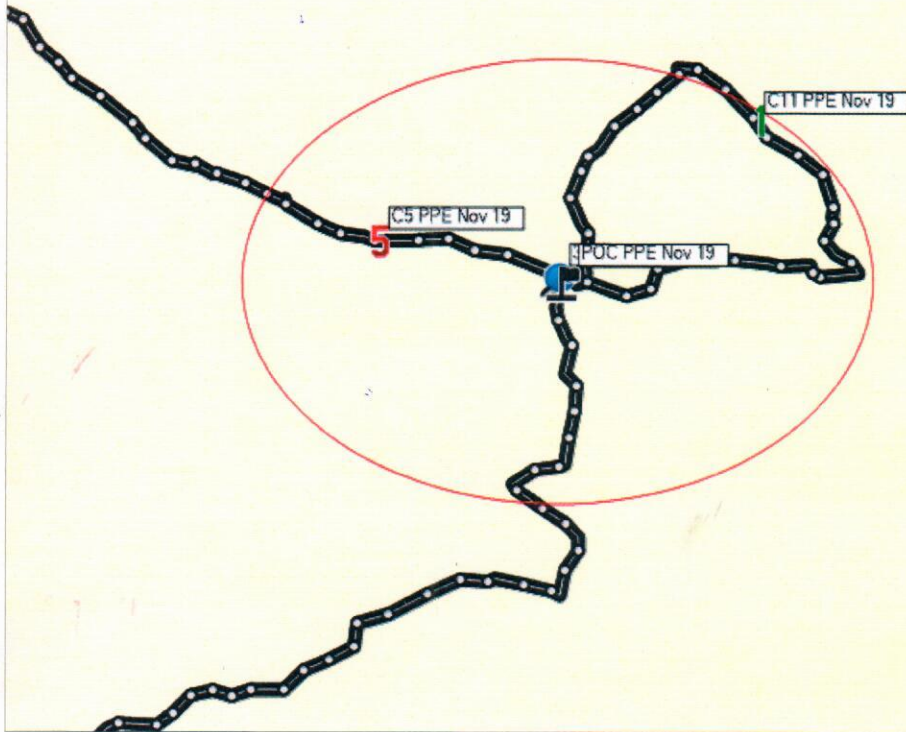
Attack - C5=1

\* C1 NOTICED ON  
WALK AROUND.

Feature - 0-10% slope.

- Bl 60%  
Sk 40%
