**RT-GPS Mapping of Fish  
Habitat and Fish Distribution  
Of Cheewhat Lake Tributaries;  
S2 (and Distributary S1), S3  
S4 and S5, September 2001.**

May 30,2002

**Nuu-chal-nulth Tribal Council  
Port Alberni, BC**

M.C. Wright and Associates  
2231 Neil Drive,  
Nanaimo, BC  
V9R 6T5  
Phone/Fax: (250)753-1055  
Email: [mcw-assoc@shaw.ca](mailto:mcw-assoc@shaw.ca)

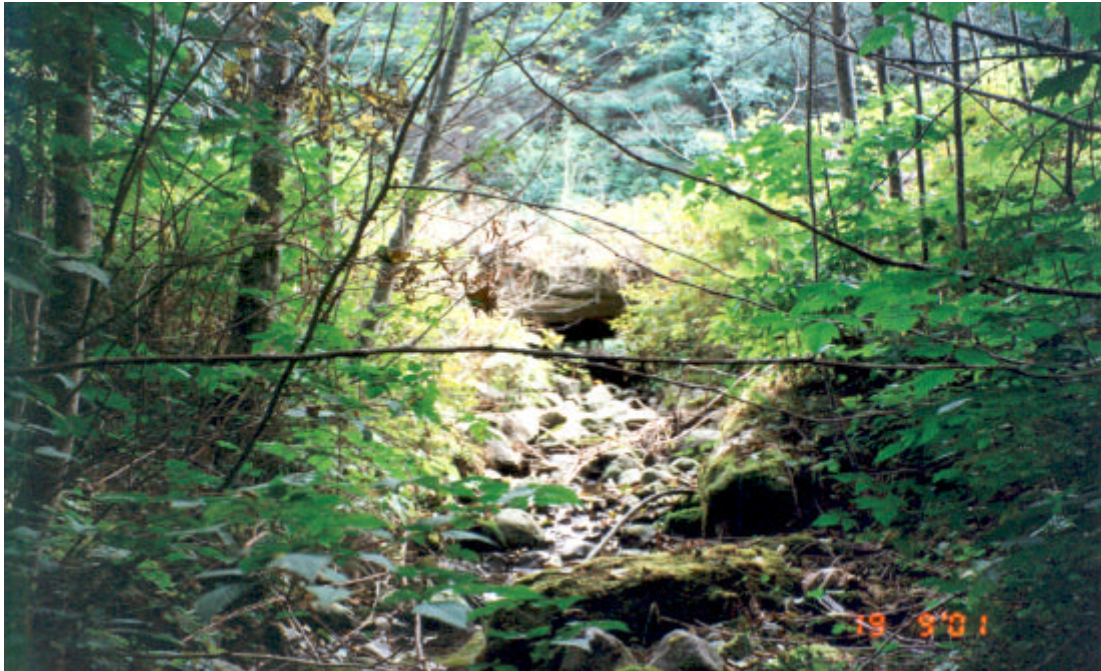
**Plate 1.15**

| <b>Description:</b> This photograph was taken looking upstream at a riffle and wood culvert on the Rosander Main Logging Road. | | | |

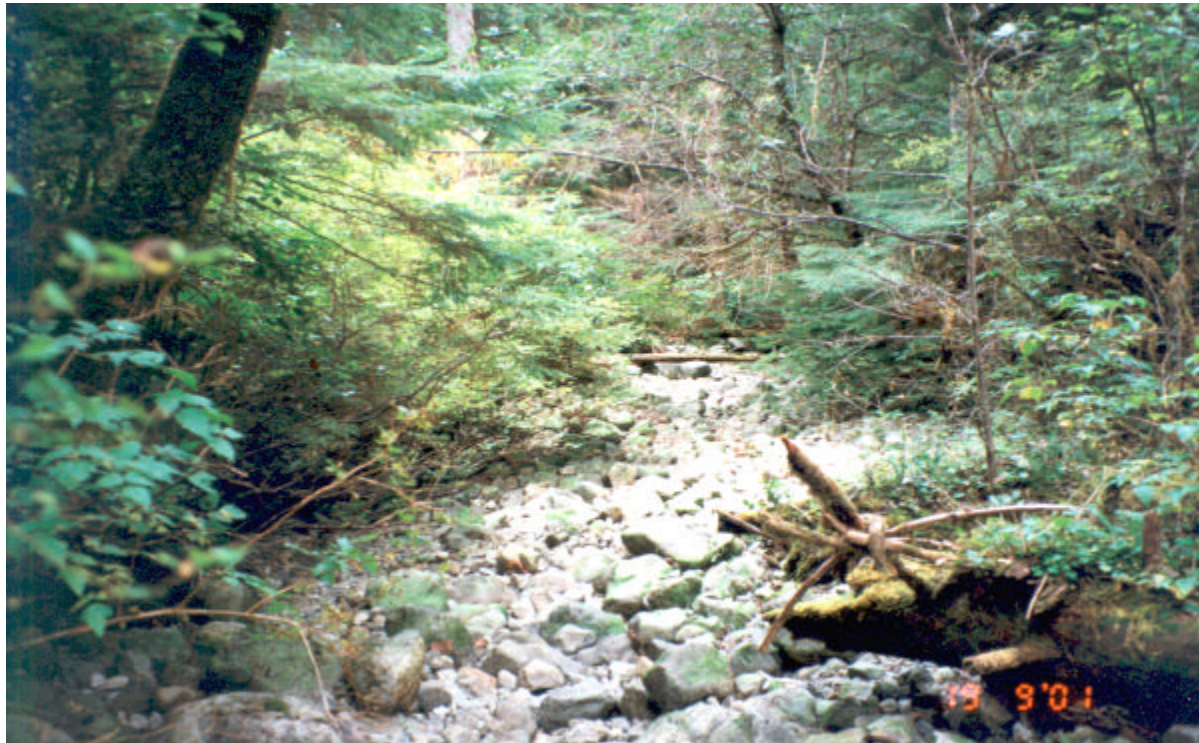
**Plate 1.17**

| <b>Description:</b> This photograph was taken looking at a de-watered section of S-2.1. | | | |

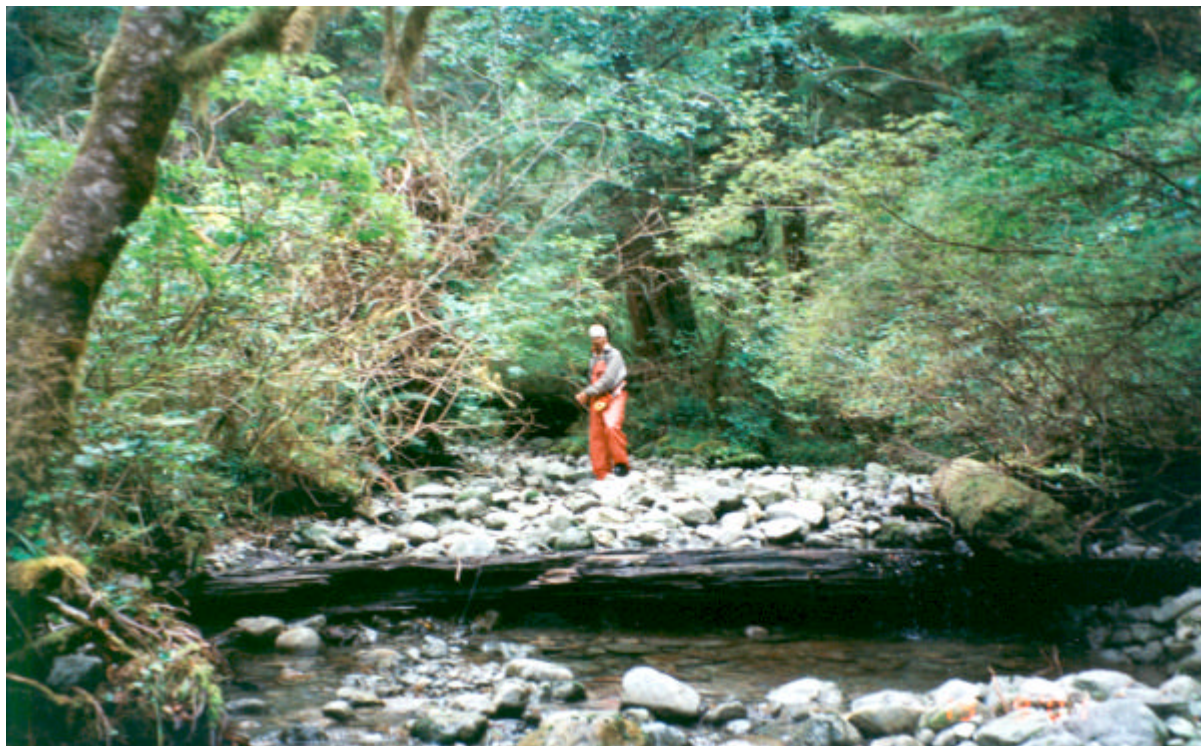
**Plate 1.18**

| <b>Description:</b> This photograph was taken looking upstream at S-2.1 and shows boulder/cobble substrate built up behind a piece of LWD. Note the presence of a shallow pool downstream of the LWD. | | | |

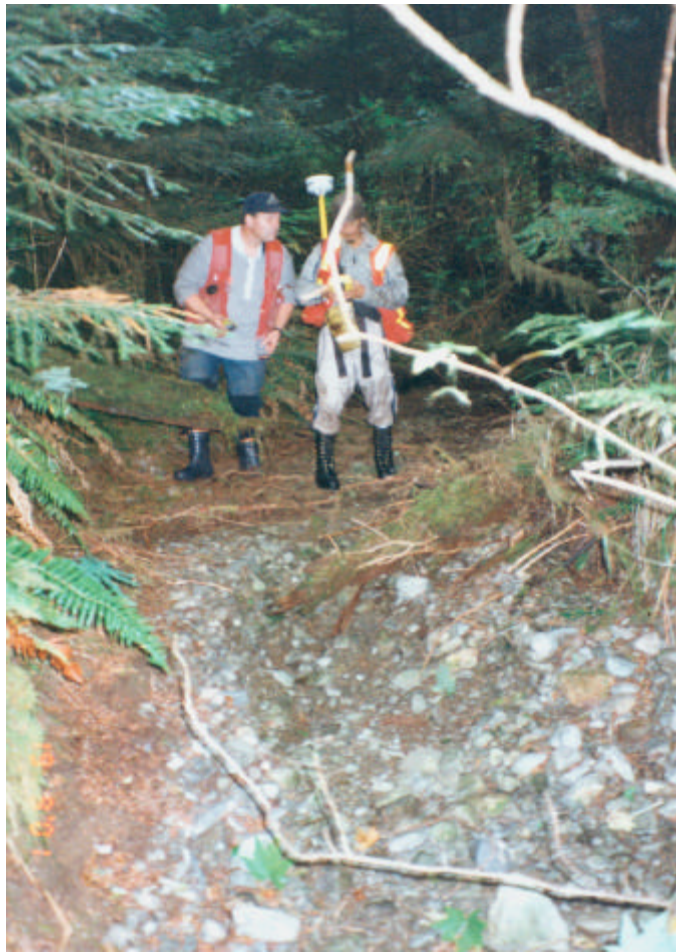
**Plate 1.24**

| <b>Description:</b> This photograph was taken looking upstream at a section of S-2. There has been extensive downcutting. The banks have a good mix of gravel and small cobble substrate. | | | |

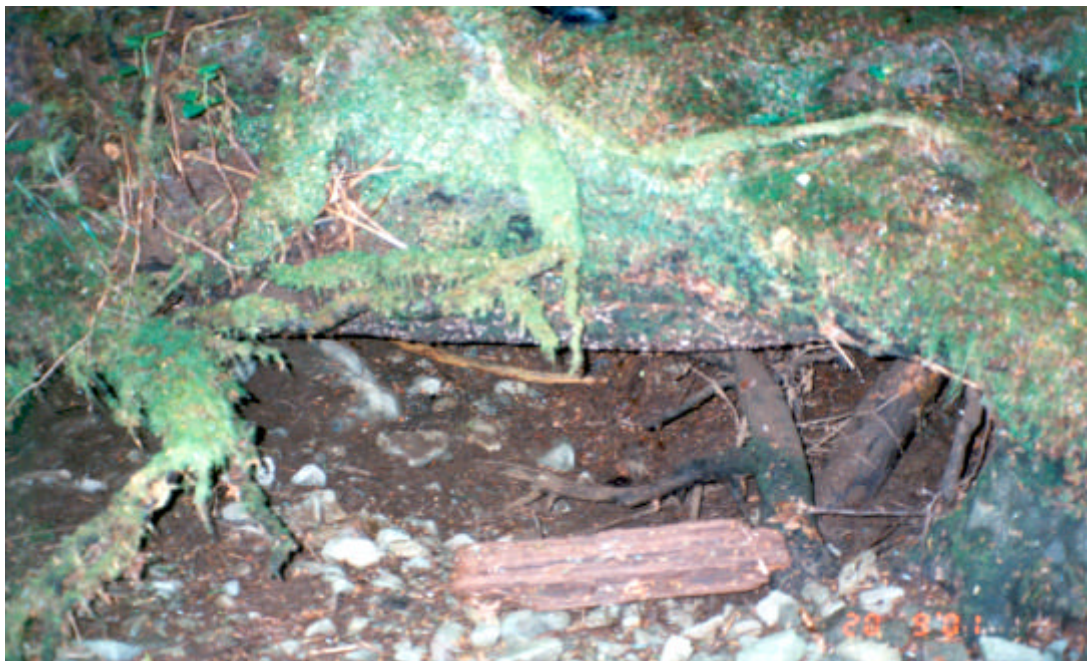
**Plate 1.25**

| <b>Description:</b> This photograph was taken looking upstream to show the de-watered pool associated with the root system of a spruce tree on S-2. | | | | |

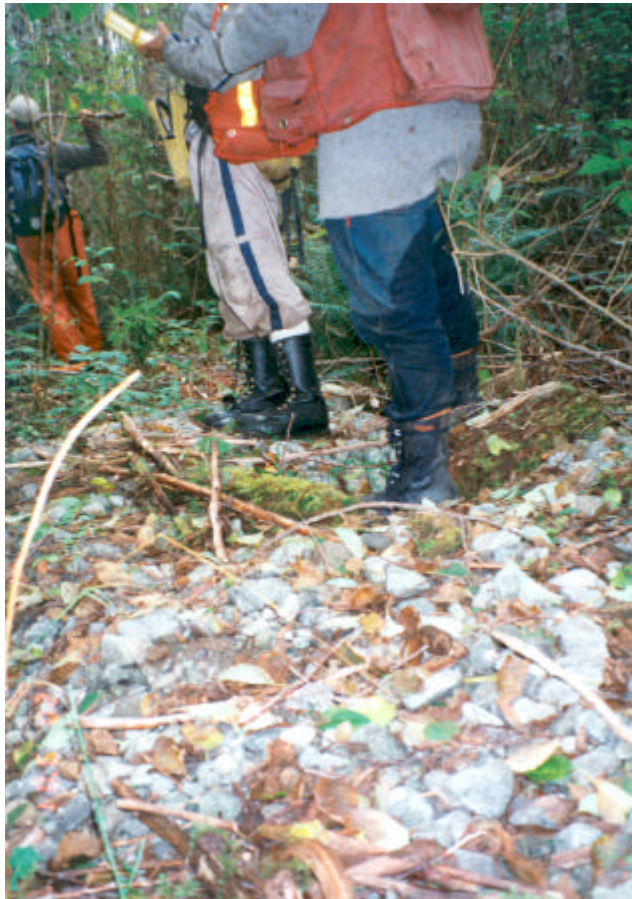
**Plate 1.26**

| <b>Description:</b> This photograph shows a severely aggraded area of S-2 which has an accumulation of cobble, gravel cobble and fines over woody debris. The channel has little or no definition and is a major flood plain area. The channel is braided and has been severely impacted by past logging practices. There are indications that a landslide has caused several avulsions. This picture was taken looking upstream. | | | |

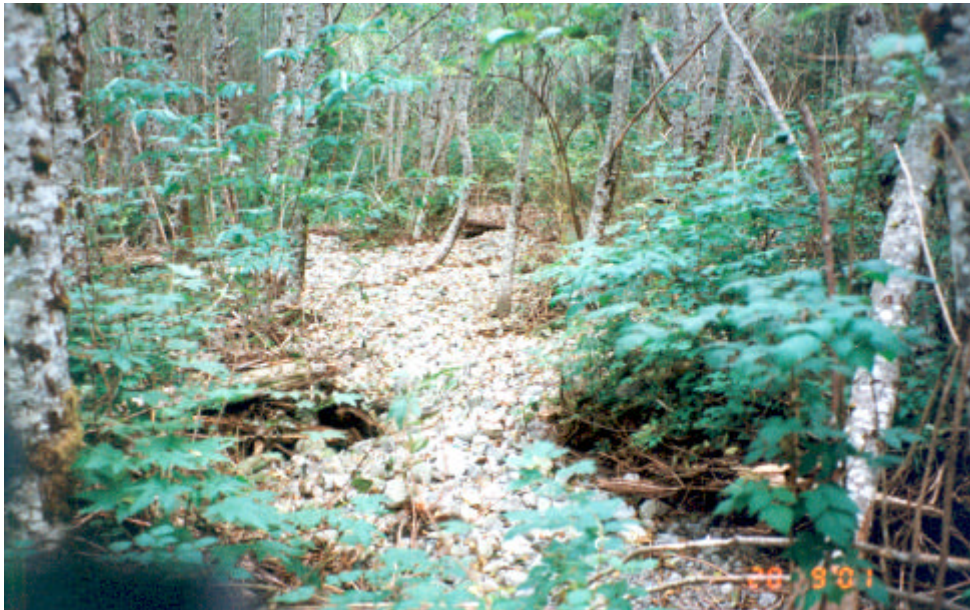
**Plate 1.27**

| <b>Description:</b> This photograph was taken looking northwest towards Sprise Lake and shows the area where S-2 splits and part of it flows to Sprise Lake. Cobble and gravel were dispersed throughout this area. Very high flows have occurred in this area and it is severely aggraded. Past logging has had a major impact. Flows are generally sub-surface during low flow periods. | | | |

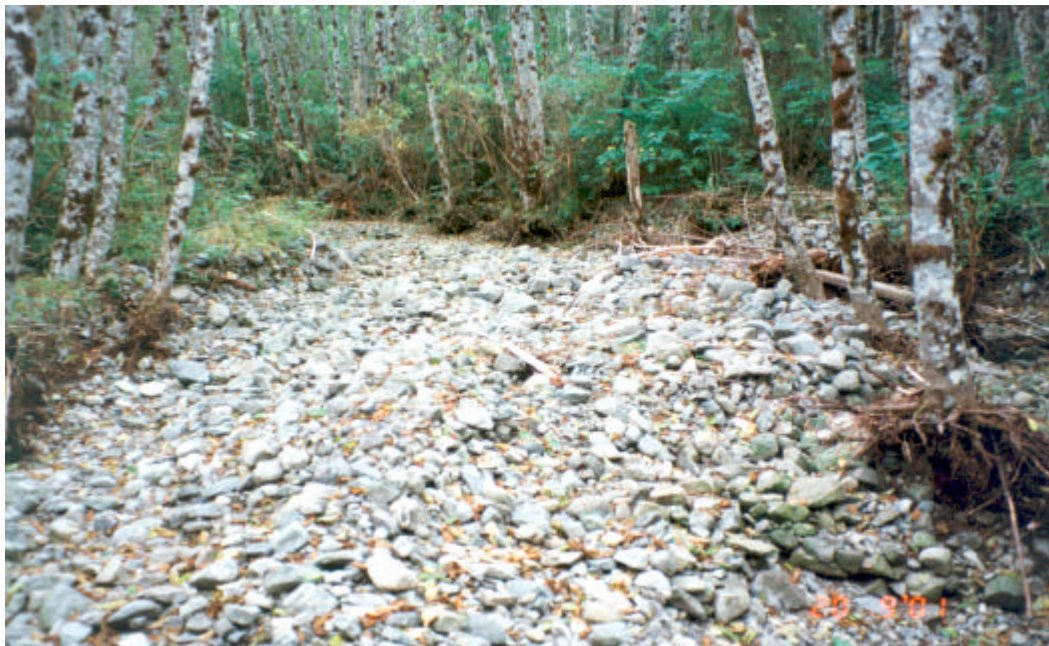
**Plate 1.28**

| <b>Description:</b> This is a high energy area of S-2. There has been signs of down-cutting of the channel. This area has been severely impacted by past logging. A berm could be built to focus flows down S-2 instead of loosing some of the flow to Sprise Lake. A prescription is required. | | | |

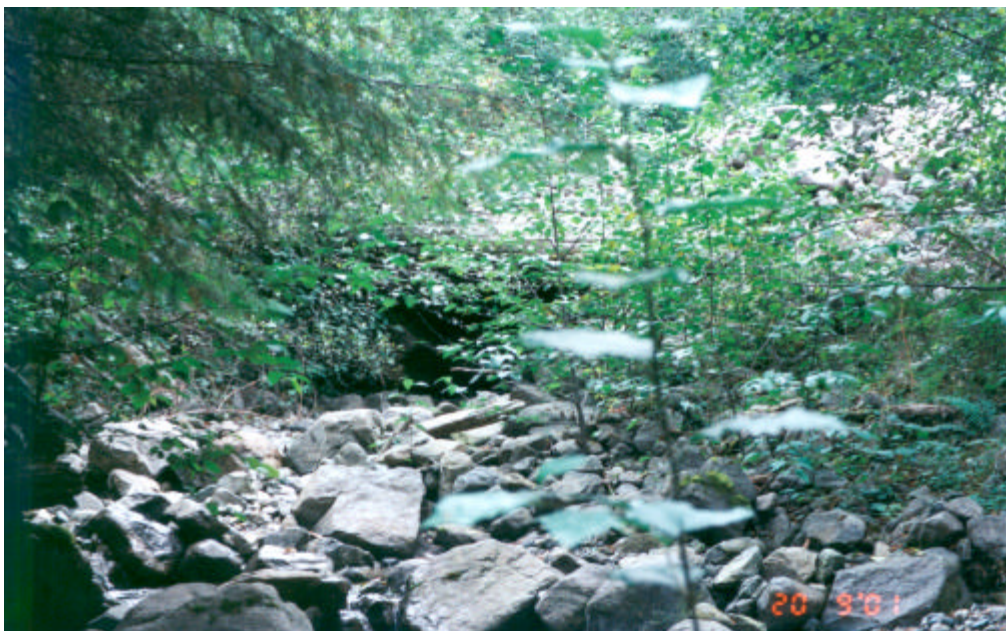
**Plate 1.30**

| <b>Description:</b> This photograph was taken looking upstream at the wood culvert on the Rosander Main Logging Road above Cheewhat Lake. The culvert is under sized for the channel. The culvert measurement was 1.5 meters high by 2.9 meters wide. | | | |

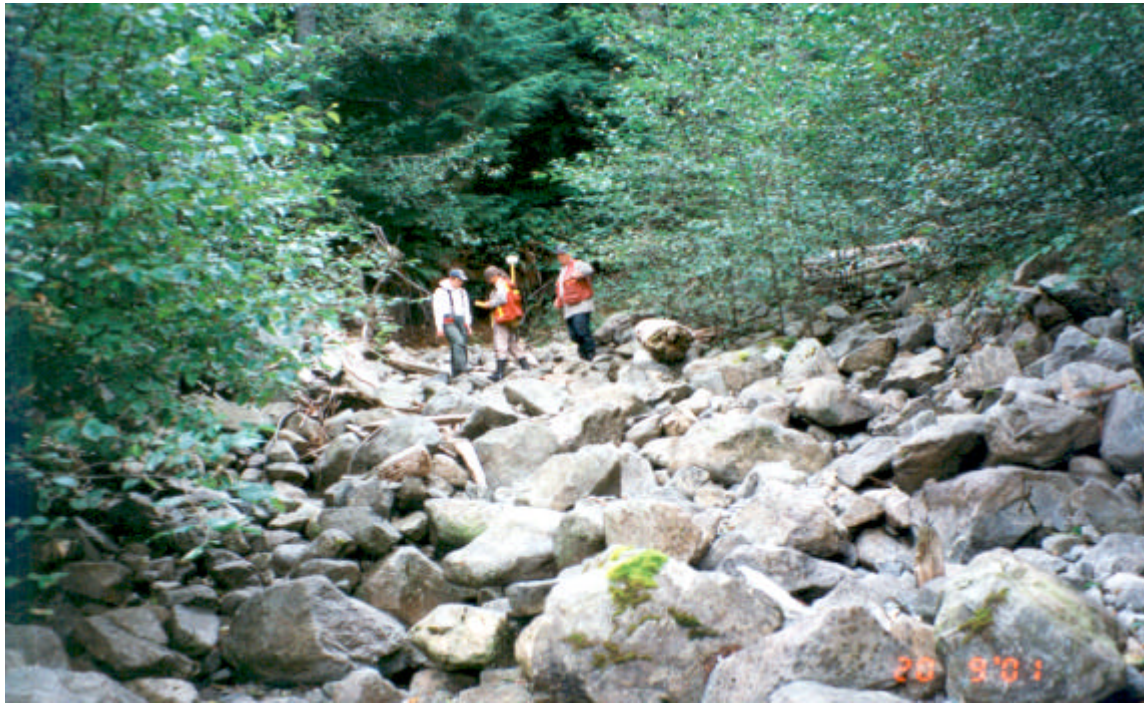
**Plate 1.31.**

| <b>Description:</b> This photograph shows a de-watered section of Upper S-2 above the Rosander Main Logging Road.<br>Flow is sub-surface for a distance of 223 meters upstream of the culvert crossing. | | | | |

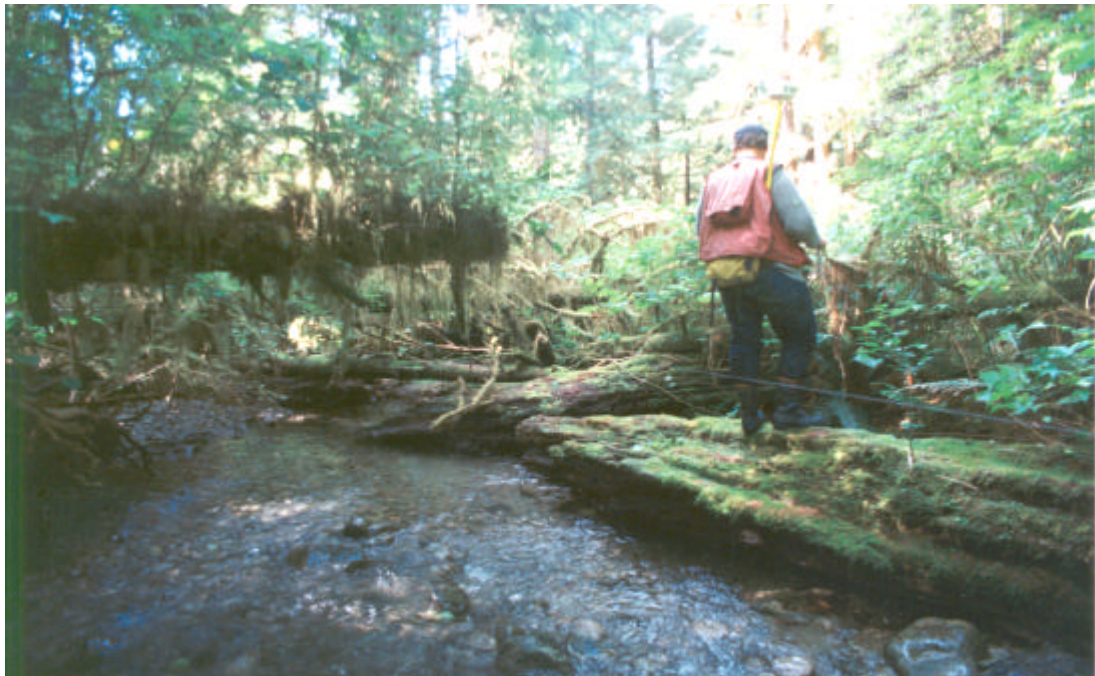
**Plate 2.26.**

| <b>Description:</b> This photograph was taken looking downstream at the debris jam at the confluence of S-1 and S-2. The photograph was taken ~ 5.0 meters upstream of the debris jam. The riparian zone consists of first growth cedar and hemlock. Streamside vegetation consists of devils club, salmon berry and fern. | | |

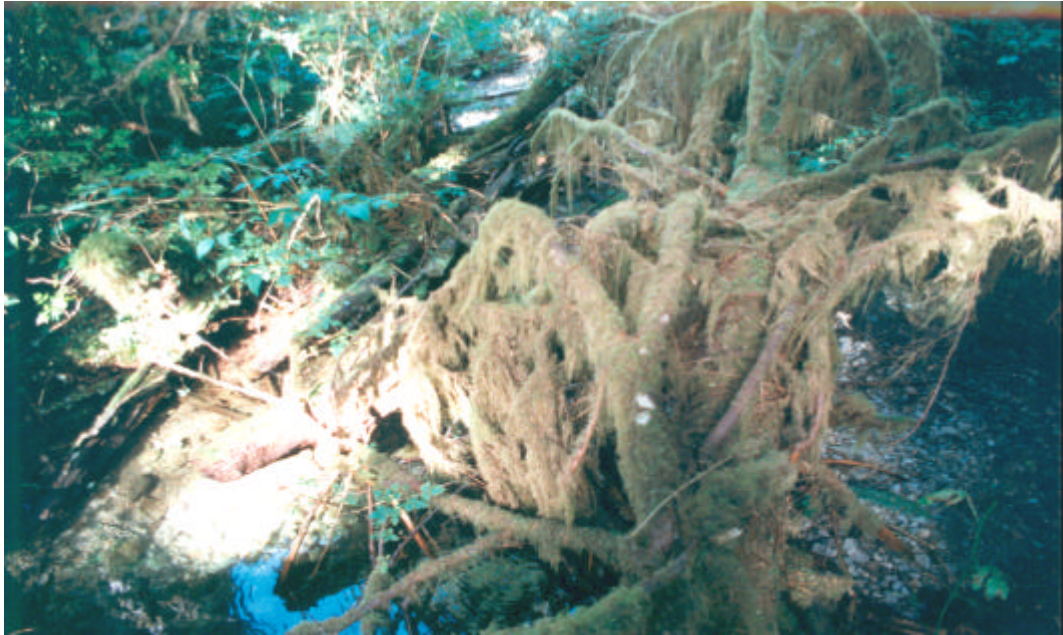
**Plate 2.28**

| <b>Description:</b> | This photograph was taken looking left to right and down onto the debris jam at the confluence of S-1 and S-2. | |

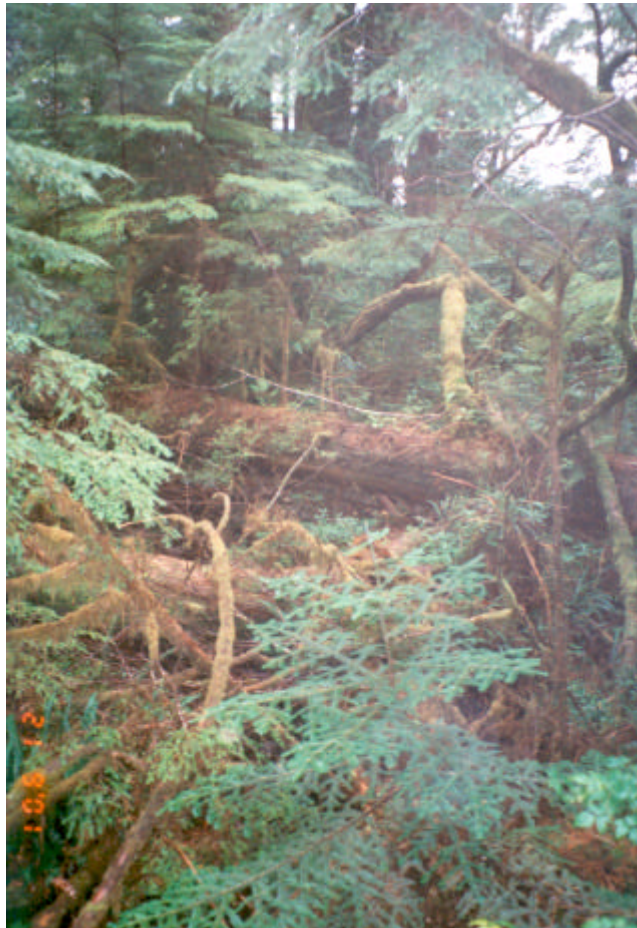
Plate 3.07

| <b>Description:</b> This photograph was taken looking downstream at a debris jam of S-5. | | |
