# Aquatic Environmental Assessment for the North Harrison Lake Log Handling Facility Re-activation

## North Harrison Log Handling Facility

January 2019

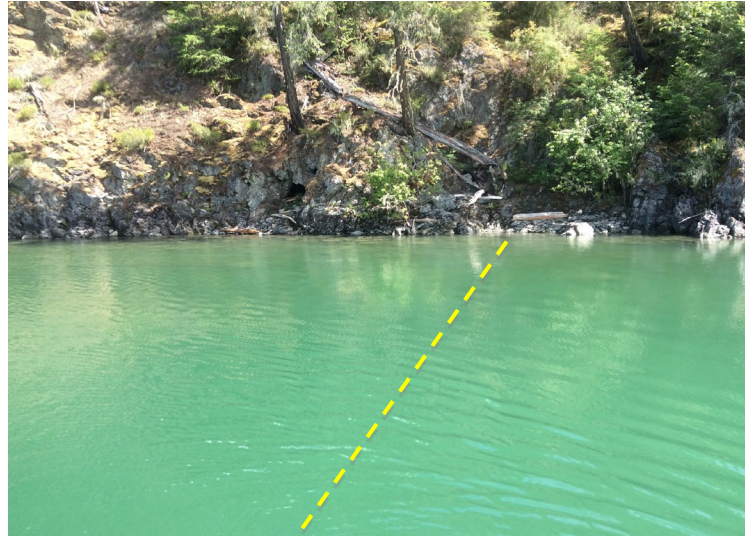
**Figure 3. Transect 1, South Boundary – Outside Proposed Log Storage Area**

Transect 1 was located at the southern boundary of the LOO (Figure 3). The survey commenced at 1.8m above stage height. From the point of commencement (POC) to  $\Delta$  0+010m (the flood zone), the beach area consisted predominantly of gently sloping angular fractured boulders, gravel and driftwood. Between  $\Delta$  0+010m and  $\Delta$  0+025m the substrate transitions to fine sediment (various thickness) over gravel and coarse wood debris. This section also displayed various species and densities of aquatic grasses. Aquatic grasses ended at  $\Delta$  0+025m and the fine sediment substrate

continues to  $\Delta$  0+060m where large angular boulders and fractured bedrock become visible. At  $\Delta$  0+080m the benthos becomes steep to vertical fractured bedrock with fine sediments on rock ledges. There was no-low wood debris impact noted along the transect. The aquatic vegetation observed along Transect 1 included; pondweed, quillwort and green mat algae. Aquatic invertebrates noted along the transect included; freshwater mussels (*Anadonta* spp.) and small opaque shrimps (*Mysis* spp). One unidentified fish was observed along the transect. The transect ended at a depth of -19.8m below stage height at station 0+090m.

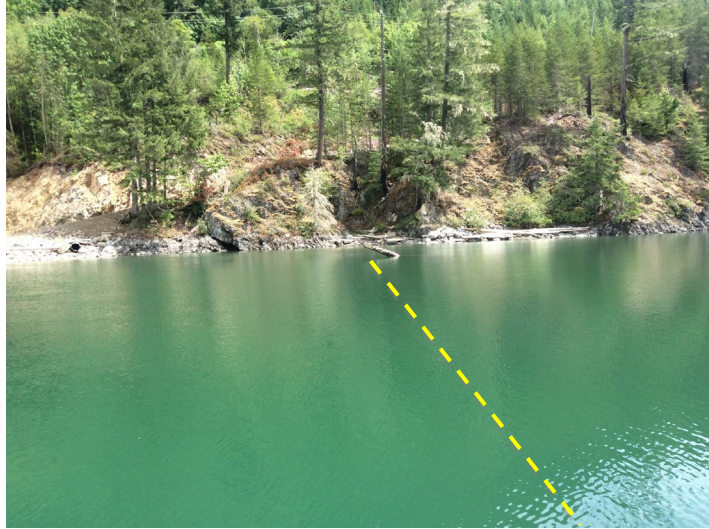
Figure 4. Transect 2, South Boundary – Inside Propose Log Storage Area

Transect 2 was located approximately 50m north of Transect 1 and is inside the proposed south boundary of the LOO. The survey started at 1.8m above stage height. The beach consisted steeply sloping fractured bedrock and angular boulders and driftwood debris (Figure 4). The upland substrate transitioned to gently sloping gravel / boulder with a dusting or fine sediments and sparse woody debris at  $\Delta$  0+005m. Aquatic plants first appeared at  $\Delta$  0+015m and continued until  $\Delta$  0+025m. The substrate became thick fine sediments

until  $\Delta$  0+085m where a fractured bedrock wall continued to depth. Occasional sticks and a few pieces of large wood debris were scattered throughout the thick fine sediment area. The wood debris impact along Transect 2 was found to be in the no-low range. The aquatic vegetation observed along Transect 2 included; quillwort, waterweed and green filamentous algae near the deep margin at  $\Delta$  0+025m. Aquatic invertebrates noted along the transect included; freshwater mussels and a single snail (shell only). No fish were observed along the transect. The depth at  $\Delta$  0+90m was -20.4m below stage height.

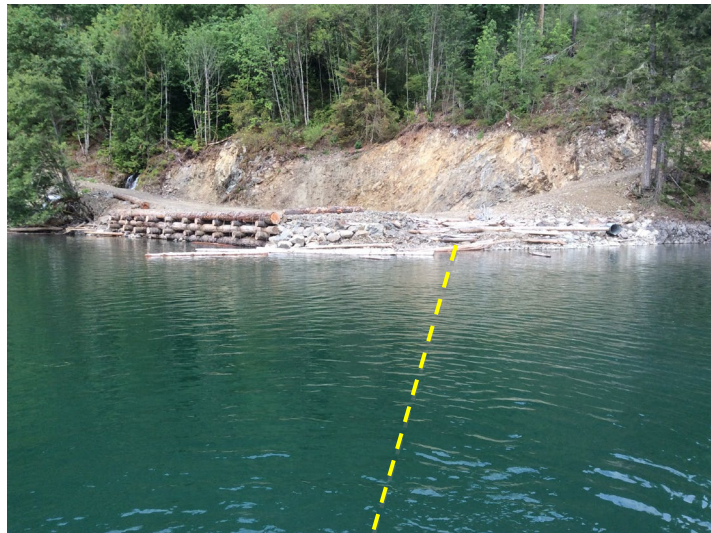
Figure 5. Transect 3, South of Proposed Log Dump – Historical Dump / Barge Ramp Location

Transect 3 was located along the south side of the historical log dump and barge loading location (Figure 5). The upper flood zone beach area consisted of steep sloping cobble, blast rock and boulder fill. The transect began at 1.8m above stage height. The fractured angular boulder substrate transition to gravel at  $\Delta$  0+005m. This quickly transitioned to thick fine sediments. Fine wood debris and occasional discarded metal (cable, tire rims) were observed near the beach. Sparse grasses were observed only at  $\Delta$  0+07.5m. Beyond  $\Delta$  0+085m the

substrate became steep / vertical fractured bedrock with a covering of thick fine sediments. Impact from wood debris was in the no-low to moderate impact range with fine wood debris near the beach and larger woody debris (mostly buried) at depth. Aquatic vegetation observed along Transect 3 was sparse quillwort (at  $\Delta 0+07.5\text{m}$  only) and thin green mat algae to  $\Delta 0+020\text{m}$ . No invertebrates or fish were observed along this transect. The depth at  $\Delta 0+090\text{m}$  was  $-20.1\text{m}$  below stage height.

**Recommendation #2:** Skidways should be adjusted (angled) more perpendicular to the general beach. Steep sloping near-shore for the shortest distance of log bundles to access deep water should be the focus of design. This would be achieved by anchoring the skids just north of Transect #3 at the historic dump and barge ramp.

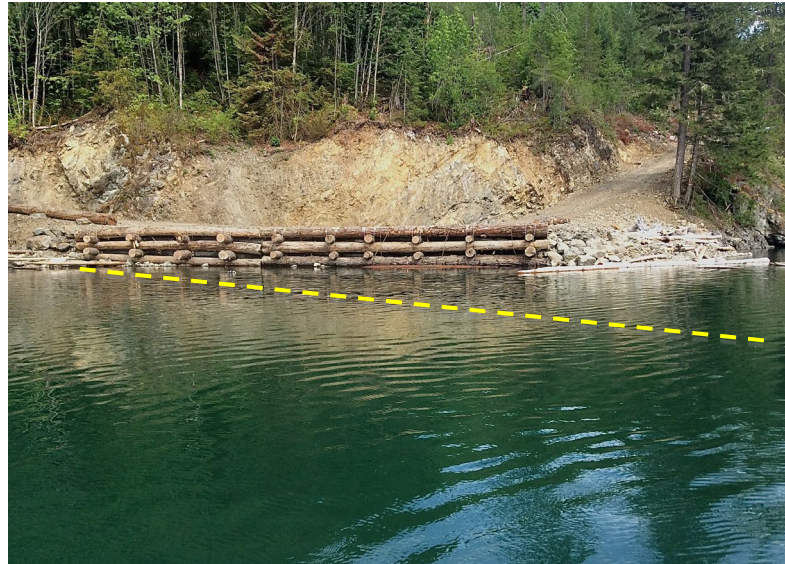
Figure 6. Transect 4, Mid Station of Proposed Storage Area – Across Proposed Skidway.

Transect 4 was attached to the northeast end of the recently constructed log cribbing and proposed skidway anchor location. The survey started at  $1.8\text{m}$  above stage height. The beach consisted of vertical constructed intersecting logs with small rip-rap and boulder fill (Figure 6). The base of cribbing is constructed on steep angular boulder fill. The fill zone transitioned to clean gravel and thick fine sediments at  $\Delta 0+010\text{m}$ . This is also the commencement of pondweed.

Gentle sloping thick fine sediments, fine wood debris and dense tall pondweed continue across the face of the recently constructed crib area until  $\Delta 0+035\text{m}$ . The thick fine sediment slopes more steeply from  $\Delta 0+040\text{m}$  to  $\Delta 0+080\text{m}$ . Fractured bedrock outcrops with a few buried sticks are observed at the deeper sections beyond  $\Delta 0+070\text{m}$ . Transect 4 wood debris was in the no-low to moderate impact range with fine/coarse wood debris impact being concentrated along the constructed cribbing  $\Delta 0+030\text{m}$  to  $\Delta 0+045\text{m}$ . Sparse large wood debris and a few buried sticks were present along the fine sediments slope. Aquatic vegetation included pondweed/waterweed. Aquatic invertebrates observed included; freshwater mussels and opaque shrimps. No fish were noted on Transect 4. The depth at  $\Delta 0+80\text{m}$  was  $-18.9\text{m}$  below stage height.

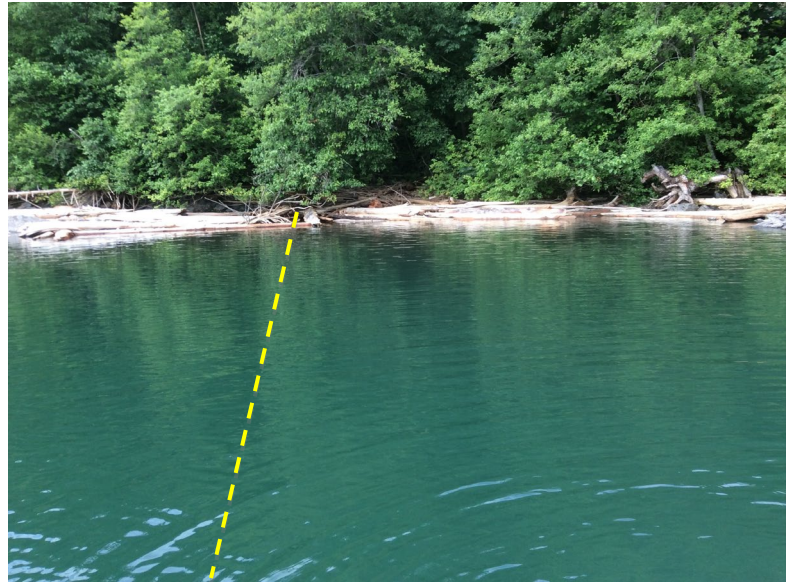
Figure 7. Transect 5. North of Proposed Log Dump Area

Transect 5 was located approximately  $50\text{m}$  north of the proposed log dump skidway and recently constructed log cribbing / fill area. It started at  $1.8\text{m}$  above stage height. The beach consisted of clean gravel and dense floating driftwood, logs and large woody debris. (Figure 7).

Gravel with varying thickness of fine woody debris continued from  $\Delta$  0+005m to  $\Delta$  0+020m where a narrow band of sparse grass continued to  $\Delta$  0+025m. Thick fine sediments continued to depth with large wood debris being observed between  $\Delta$  0+025m to  $\Delta$  0+045m. Beyond  $\Delta$  0+045m the substrate is thick fine sediments to the end of the transect at  $\Delta$  0+065m. The wood debris impact along Transect 5 was moderate to high/severe with areas of 100% coverage (near-shore)

stacked / semi buried from  $\Delta$  0+035m to  $\Delta$  0+045m. Aquatic vegetation covered a narrow band and included quillwort, waterweed and fine filamentous algae. Dense numbers of small opaque shrimp were the only aquatic invertebrates. There was a small unidentified fish (sculpin) observed among some buried sticks near the end of Transect 5. The depth at  $\Delta$  0+070m was -20.7m below stage height.

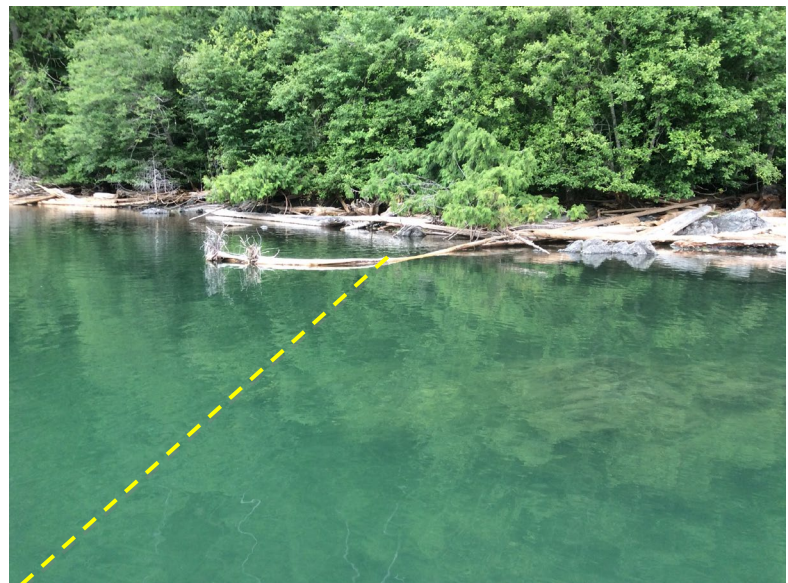
Figure 8. Transect 6, North Boundary – Inside Proposed Log Dump Storage Area

Transect 6 was located at the northern boundary of the proposed storage area of the LOO and started at 1.8m above stage height. The beach consisted of gently sloping fractured bedrock and boulders with dense logs and driftwood. (Figure 8). Clean gravel with a few angular boulders continued from  $\Delta$  0+005m to  $\Delta$  0+020m. Several species of aquatic vegetation were also observed in this region from  $\Delta$  0+010m to  $\Delta$  0+020m. From this distance to  $\Delta$  0+065m (end of

survey) the bottom was steeply sloping thick fine sediments with patchy semi-buried woody debris. The wood debris impact along Transect 6 was in the no-low range. Aquatic vegetation included pondweed and quillwort. Aquatic invertebrates observed included;

freshwater mussels and opaque shrimps. No fish were observed on Transect 6. The depth at  $\Delta$  0+50m was -19.2m below stage height.

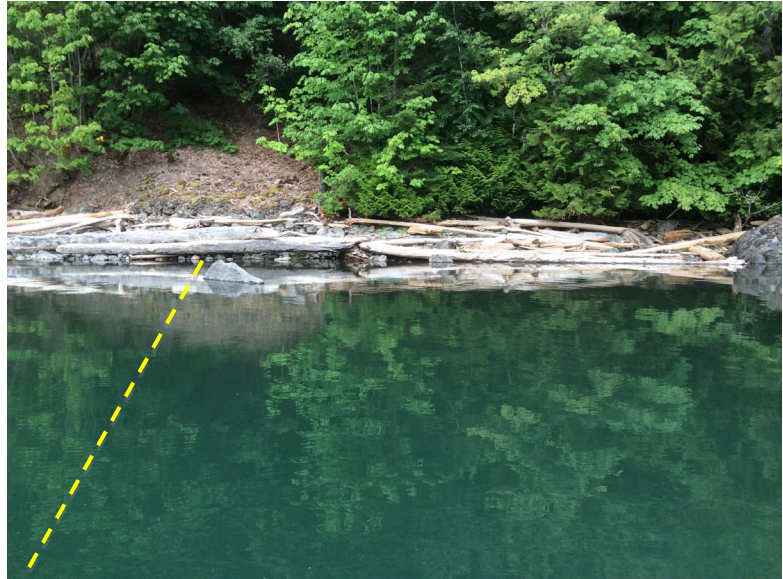
**Figure 9. Transect 7, North Boundary – Outside Proposed Log Dump Storage Area**

Transect 7 was located at the northern end of the survey, just outside the proposed boundary of the LOO log storage area. The survey started at 1.8m above stage height. The beach was gently sloping gravel and boulders with thick driftwood above water level. (Figure 9). Gravel/angular boulder substrate with a dusting of fine sediments and woody debris continued to  $\Delta$  0+020m. From  $\Delta$  0+020m, the sloping gravel bank had thick leaf deposits along with coarse and large woody debris. Aquatic grasses began at  $\Delta$  0+022m and ended at  $\Delta$  0+035m. From  $\Delta$  0+040m

to the end of the transect at  $\Delta$  0+070m the dominant substrate was thick fine sediments with large wood debris and a few buried sticks. The wood debris impact along Transect 7 was in the moderate to severe range with the majority being buried in fine sediment or having a complete dusting when suspended. Aquatic vegetation included; waterweed, filamentous green algae, and tall pondweed. Aquatic invertebrates observed were; freshwater mussels and opaque shrimp. One juvenile trout/salmonid was noted near the buried large wood debris on this Transect. The depth at  $\Delta$  0+070m was -18.9m below stage height.

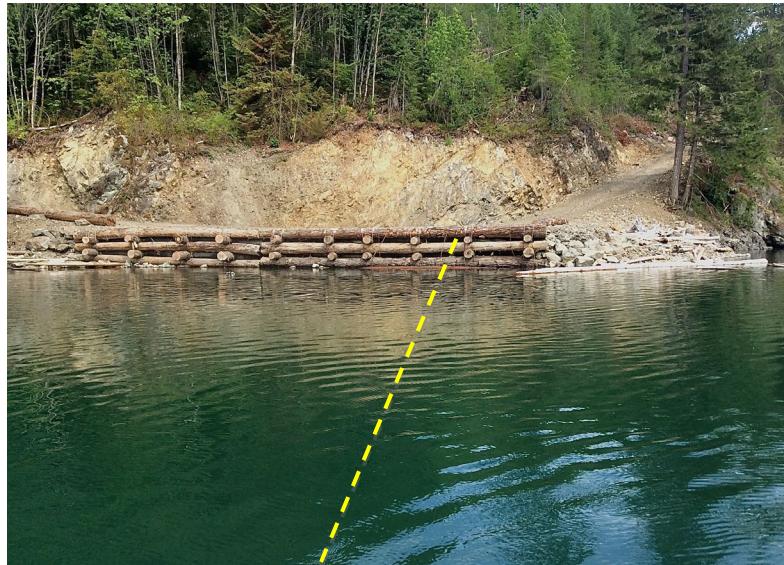
Figure 10. Transect 8, North Boundary – Outside Proposed Log Dump Storage Area

Transect 8 was located at the proposed skidway location along the recently constructed beach cribbing. This location was observed in order to document the proposed pathway/corridor for the movement of processed and bundled logs. The survey started at 1.8m above stage height along the face of the log cribbing. The beach consisted of a log cribbing (vertical constructed intersecting logs) with small rip-rap and boulder fill (Figure 10). The base of cribbing is constructed on steep angular boulder and gravel fill. The gravel fill zone transitioned thick fine sediments with coarse wood debris and dense tall pondweed/waterweed from  $\Delta$  0+005m to  $\Delta$  0+025m. From  $\Delta$  0+025m, gently sloping thick fine sediments, with varied amount of large wood debris, continued until the intersection of Transect 5 at  $\Delta$  0+070m. The wood debris impact along Transect 8 was in the moderate to severe range with the majority being buried in fine sediment or having a complete dusting when suspended. Aquatic vegetation included; tall pondweed and waterweed. Freshwater sponge (encrusting and finger-type) were the only aquatic invertebrates observed. No fish

species were observed on this transect. The depth at  $\Delta$  0+070m was -20.7m below stage height.

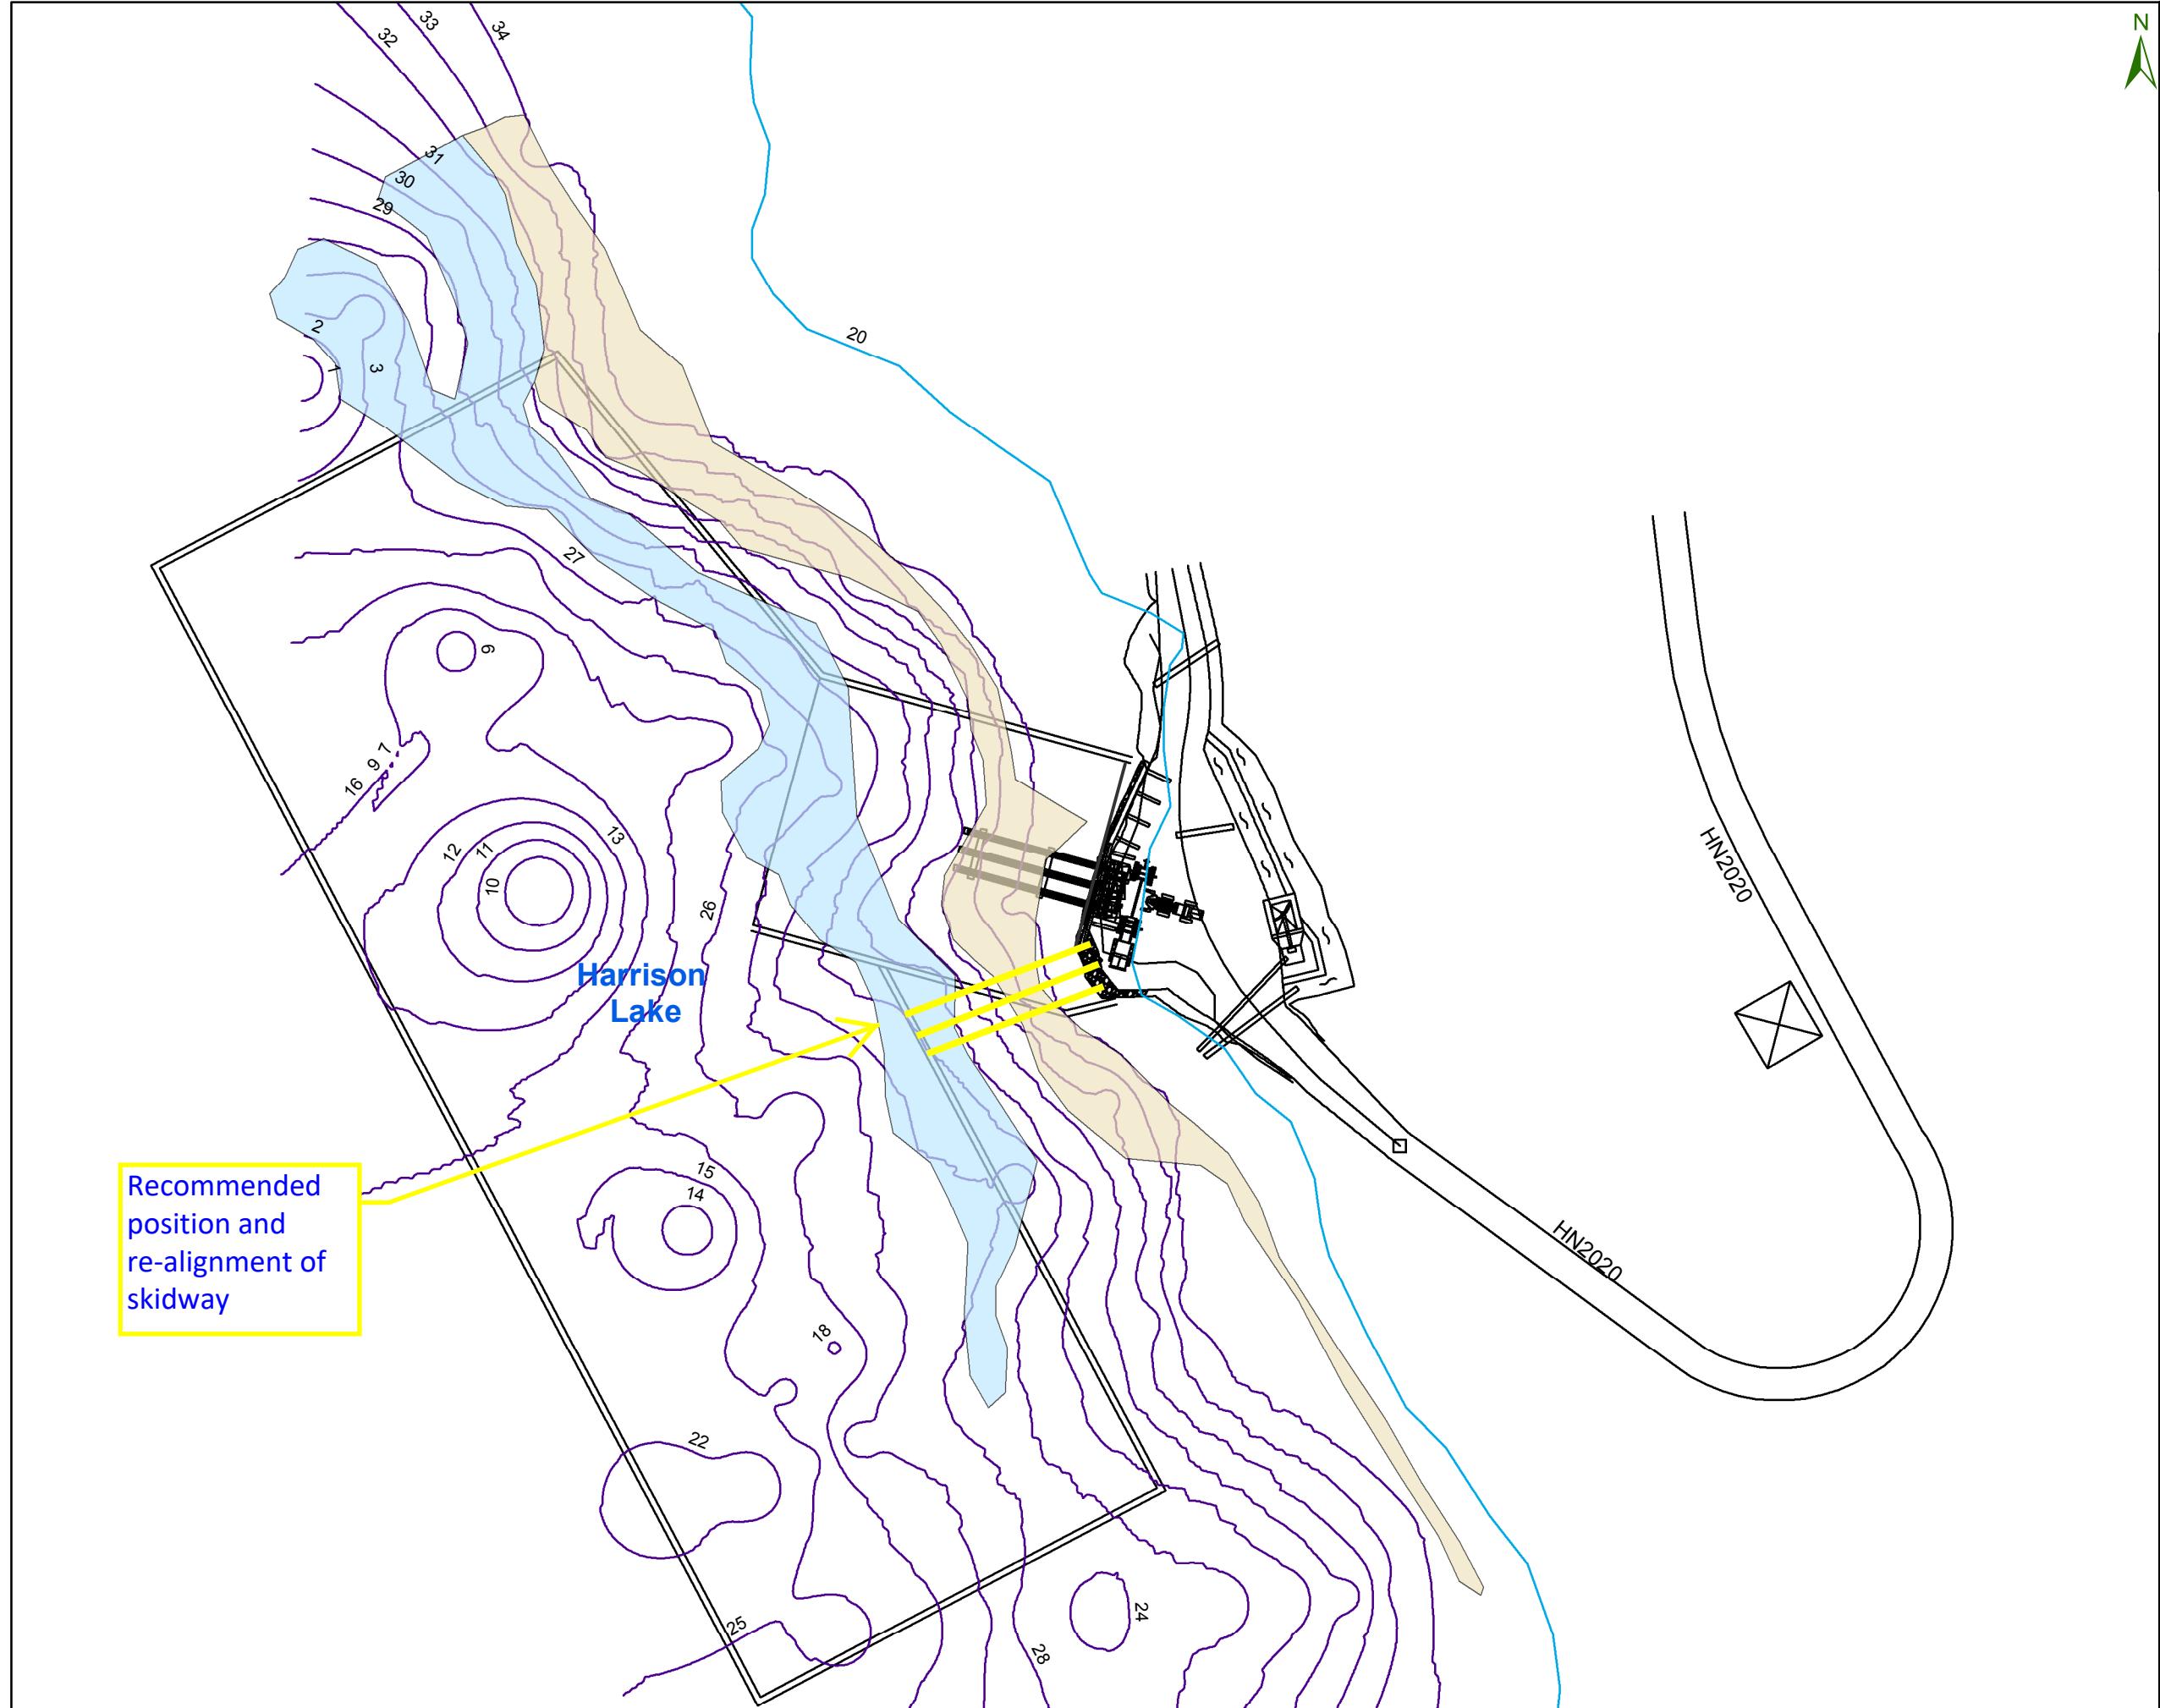
## HISTORIC WOOD DEBRIS

The site conditions observed during the July 4<sup>th</sup>, 2018 assessment demonstrated the extent of the near-shore impact and recovery to the benthic habitat at this site since last operations ceased. The site in this area remains moderately impacted with the high/severe impact zone being more concentrated in the areas north of the proposed skidway location. The southern section of the near-shore and LOO area is in the no-low impact range. Recent construction of a cribbing and dump facility appears to have deposited clean fill (angular boulders and shot rock) up to the historically impacted sub-aquatic area. Appendix 4 – Historical Woody Debris area map outlines the observed locations for various categories of observed debris.

In summation, the impact assessment found wood debris impact to be no-low impact for much of the southeast LOO area with high/severe impact noted near-shore from Transect 4 through Transect 7, northwest of the historic skidway location. Lack of water movement, combined with continued fine sediment input, allows deposited woody debris to be buried and colonized with freshwater plants, invertebrates and fish. There is no land use plan for the Harrison Lake area (Mosher, 2017) however, historical operations and recent management direction in Living with the Harrison Salmon Stronghold – A Strategic Plan (2013) acknowledge that log booming and handling has occurred and is considered appropriate for the area. With implemented recommendations and adequate environmental awareness, there is no biological reason why the re-activation of the facility should not be approved for the proposed volume of projected use.
