# **Terrain Stability Assessment**

**REVELSTOKE FOREST DISTRICT**

**BIGMOUTH CREEK**

**TSL: A84538 – CUTBLOCKS K670, K 671, K672, K68Q  
AND ASSOCIATED ACCESS ROADS**

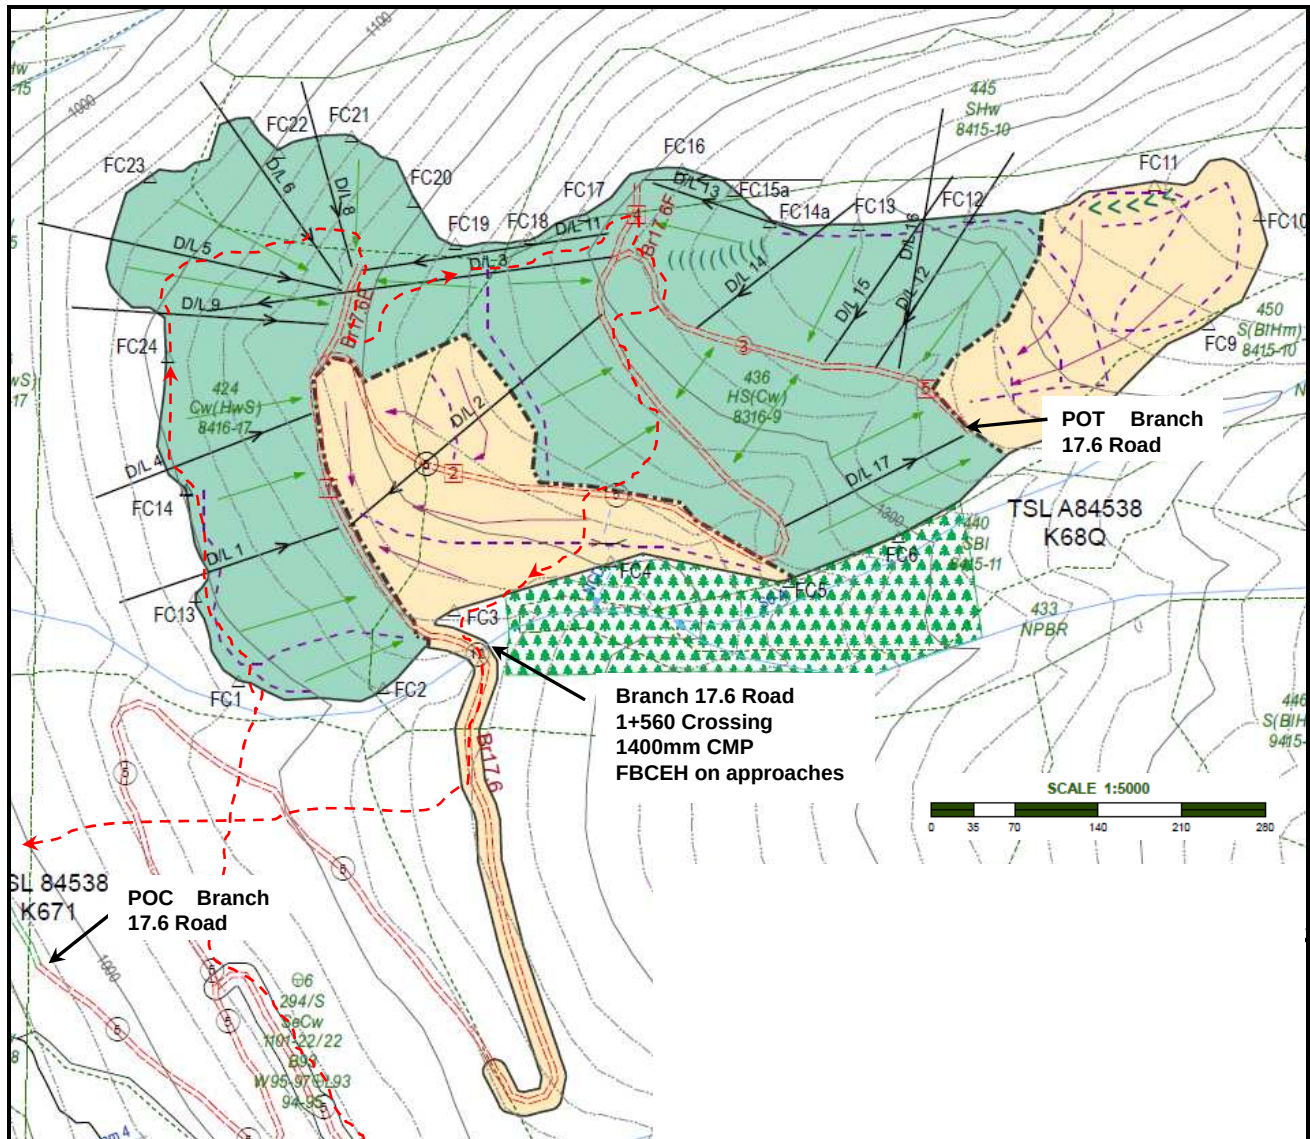
**Figure 2** A copy of the Harvest Plan map for the proposed cutblock K68Q. North is to the top of the page and the original map scale was 1:5000. The traverse route is depicted by the red dashed line.

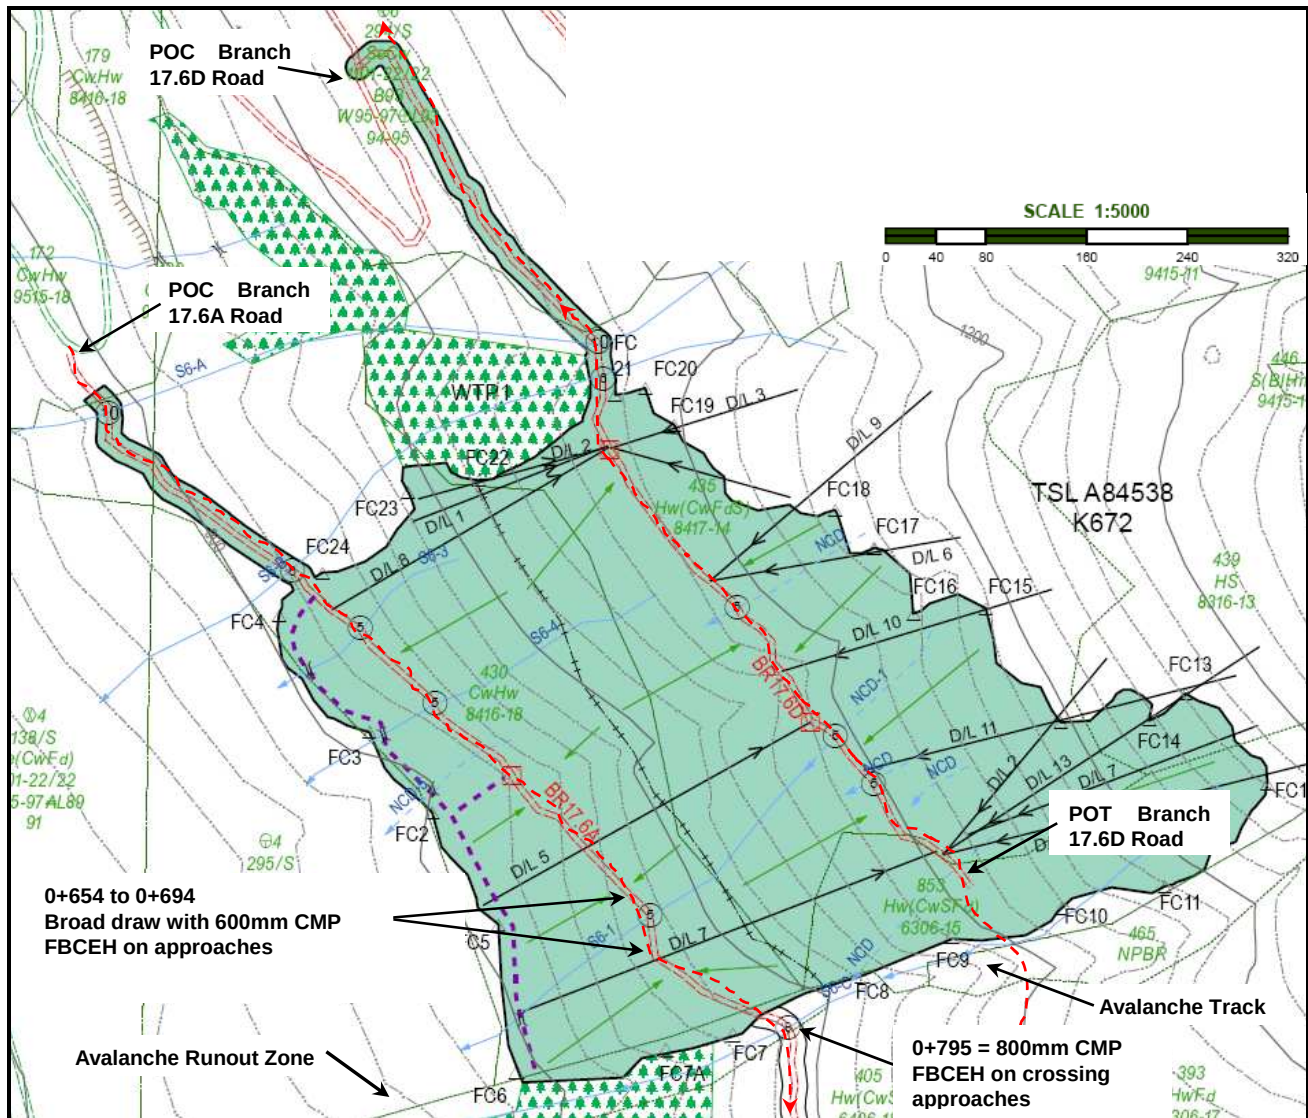
**Figure 3** A copy of the Harvest Plan map for the proposed cutblock K672. North is to the top of the page and the original map scale was 1:5000. The traverse route is depicted by the red dashed line.

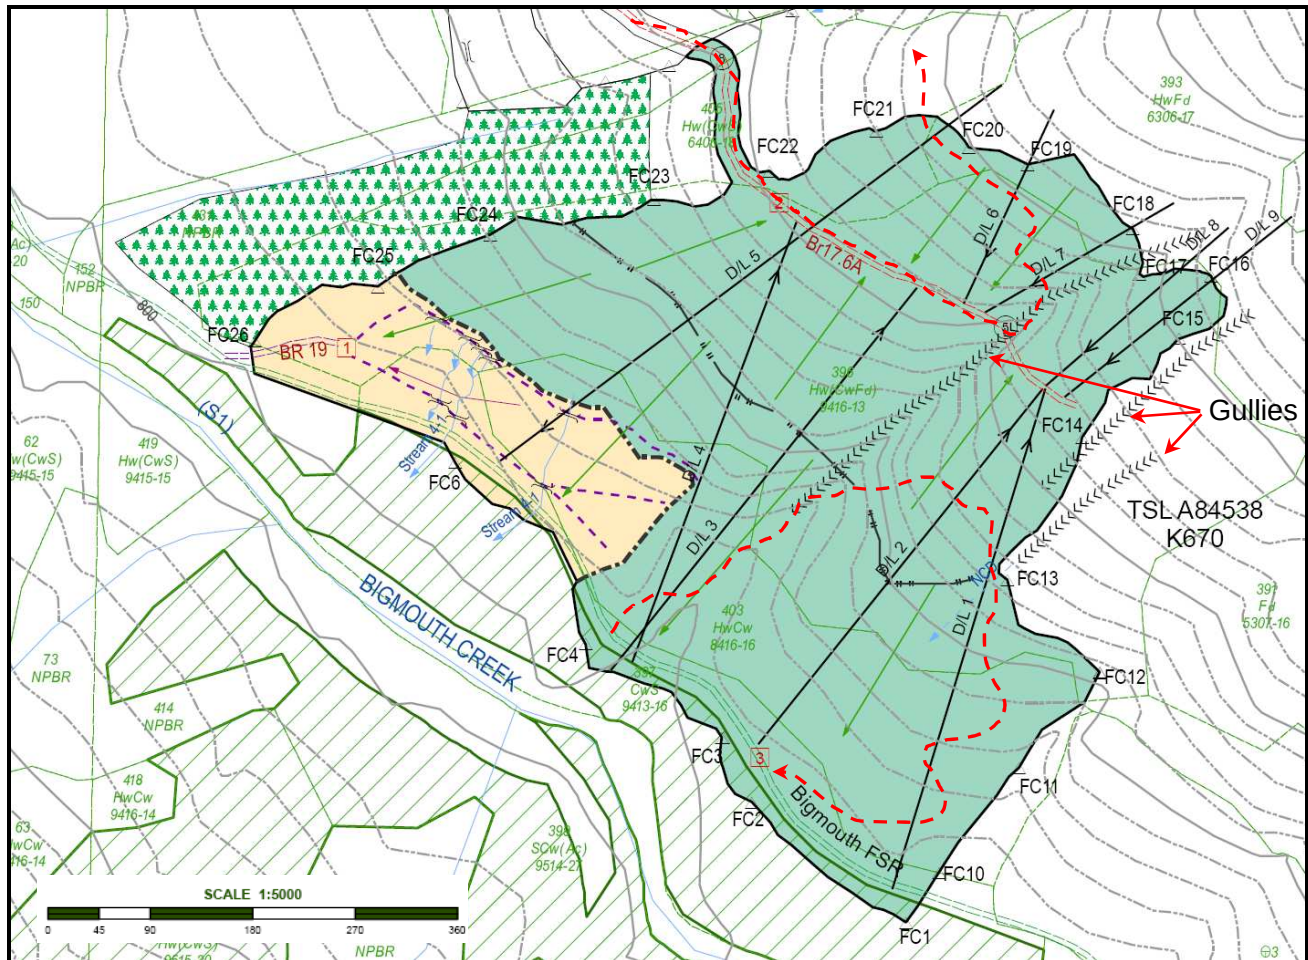
One prominent gully (see Figure 4) extends down into the cutblock area from the steep terrain upslope of the cutblock. This gully had very little vegetation in the lower reaches and led down to a fan-like depositional area with primarily deciduous (cottonwood) stems. The gully is timbered further upslope. It is likely that the lower reach experiences frequent snow accumulation and small avalanche events. Two additional gullies extend down to the upper falling boundary near FC 13 and FC 14. These features are bedrock controlled with steep bedrock sidewalls. A less pronounced fan or cone depositional area is found at the base of these features.

**Figure 4** A copy of the Harvest Plan map for the proposed cutblock K670. North is to the top of the page and the original map scale was 1:5000. The traverse route is depicted by the red dashed line.

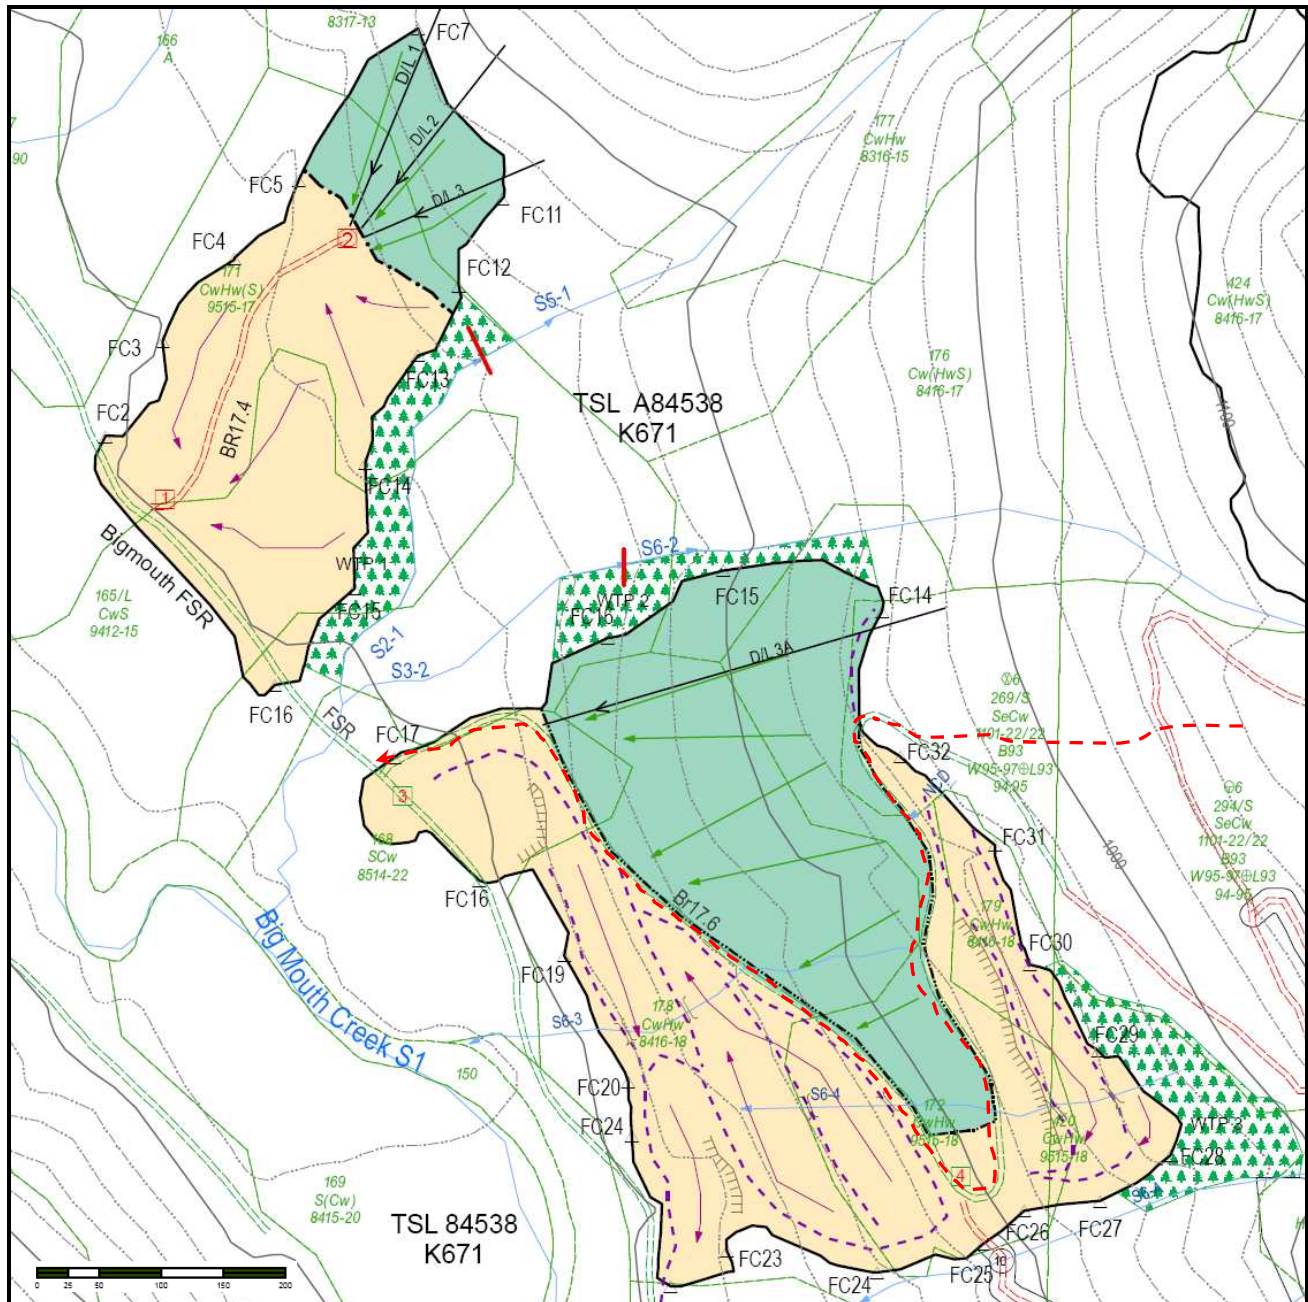
**Figure 5** A copy of the Harvest Plan map for the proposed cutblock K671. North is to the top of the page and the original map scale was 1:5000. The traverse route is depicted by the red dashed line.
