CK-2368  
CK-2368

KAREN 0.2km

2022 Inspection

Crossing Name Dewdney Creek

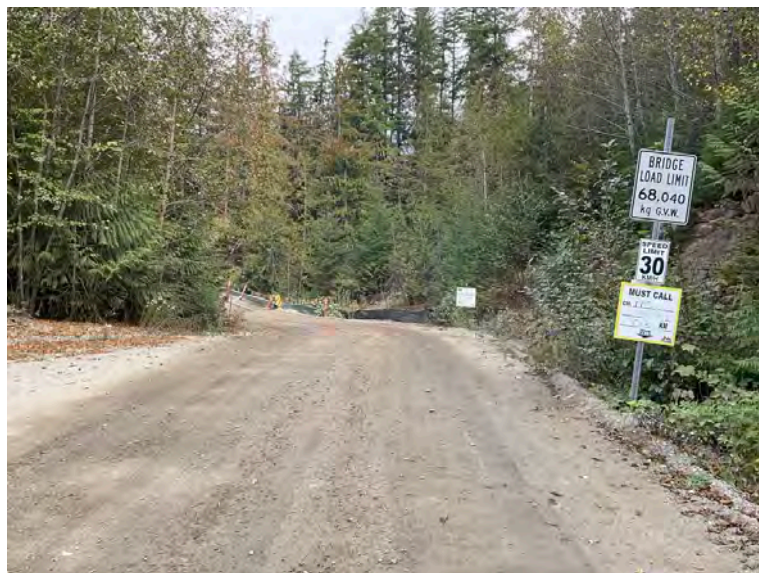
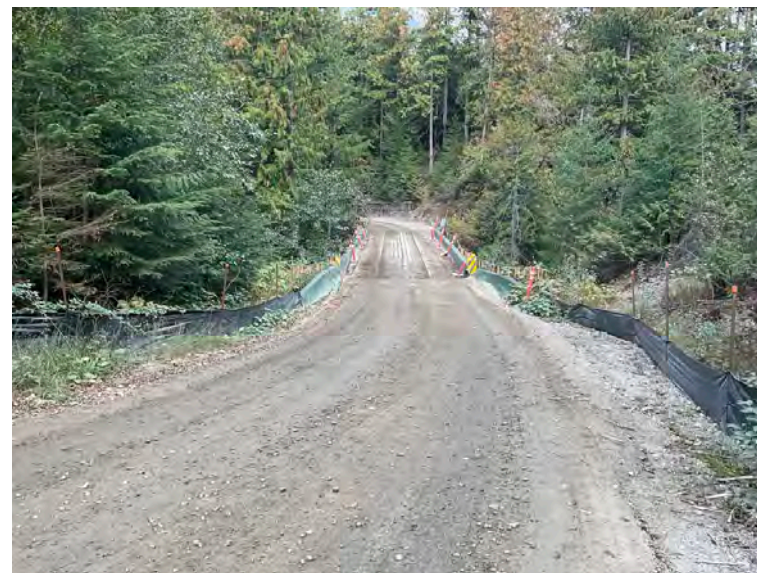
HC and VC left approach, HC right approach

Brushing Required Y

Approach from Left Bank when facing downstream

| Repair Item | Repair Description |
|---|---|
| 2 Approach. Area/sight line brushing. m².<br>Priority:Medium | Brush approaches |

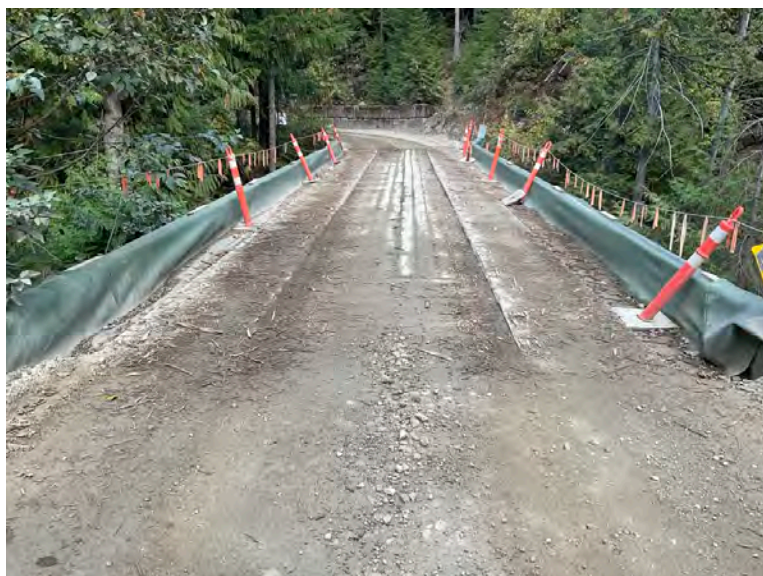
Timber deck appears to be floating on top of composite, installed as a wearing surface for construction equipment to cross

Running Surface      Unrated      Timber wear surface installed directly over top composite deck to allow construction equipment (ie. tracked equipment) to cross; therefore concrete deck surface not visible. No apparent damage noted from below.

Timber deck placed on top of composite deck

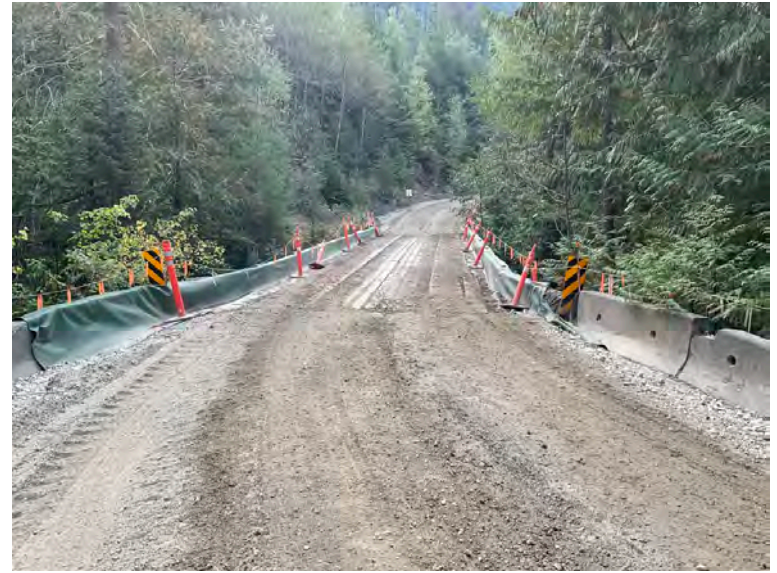
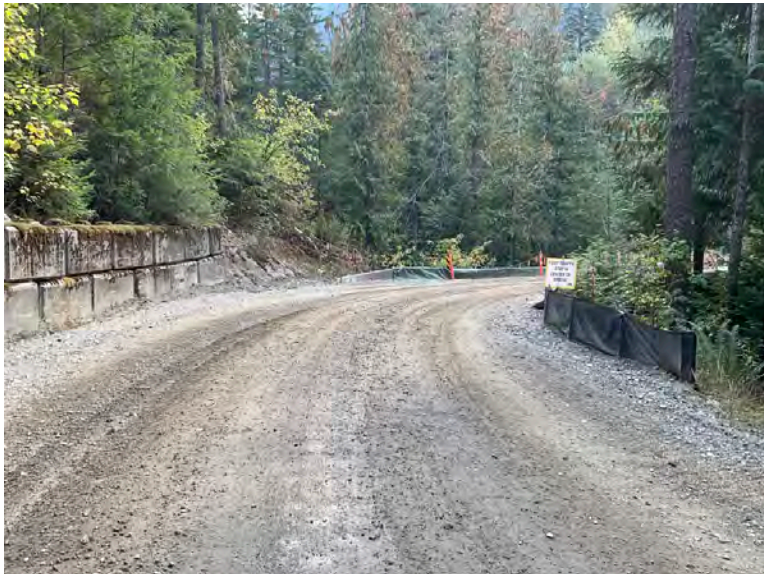
Approach from Right Bank when facing downstream

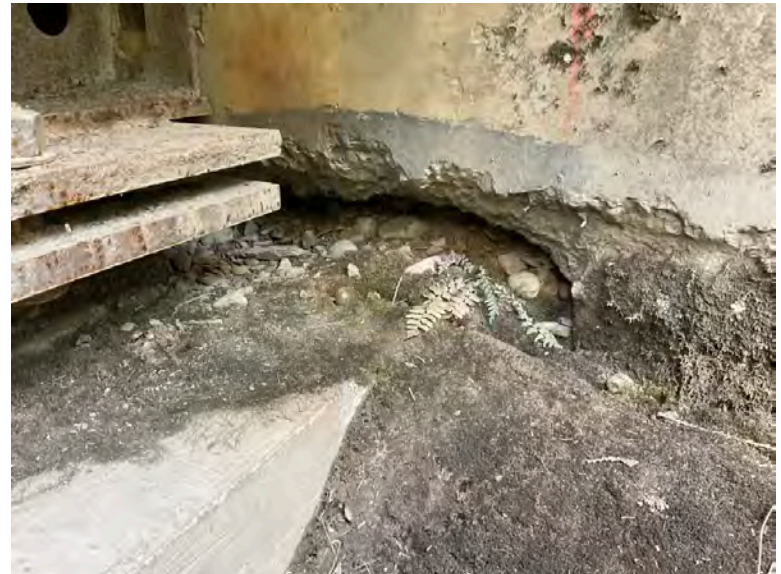
Ballast Wall Fair

Some damage to upstream right bank but likely from installation

Upstream right bank ballast wall condition

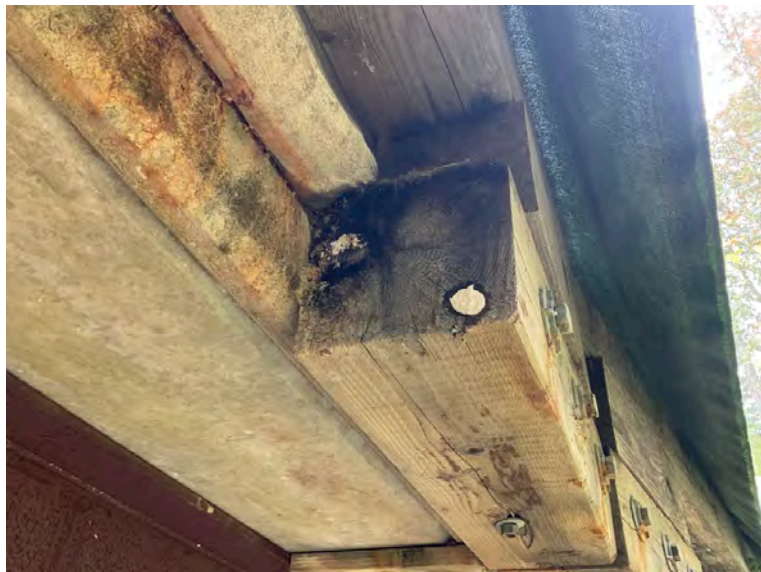
Curb Rail/Blocks/Posts      Poor      Side-blocks visibly rotting, geotextile retaining sediment from falling into stream causing timber components to rot quicker than typical

Guardrail sideblock condition

Replace the guardrail, risers and blocks. Repair the damage noted to the concrete deck. Brush approaches. The current load rating of L75 or 68 tonnes to continue.

| Repair Item | Repair Description |
|---|---|
| 1 Structure. Full Curb Replacement. .<br>Priority:Medium | Replace the guardrail, risers and side blocks. |

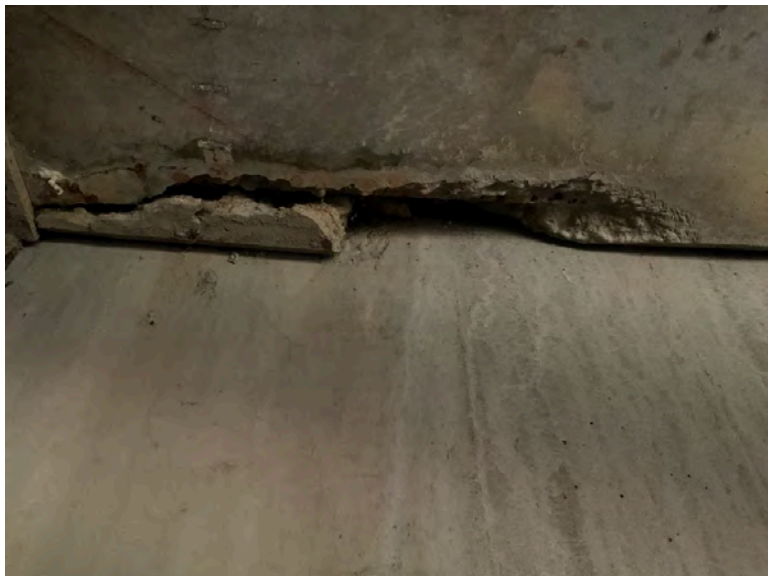
Concrete Deck      Unrated      Not visible from deck surface due to timbers on deck. Appears in good condition from below. Minor damage noted to panel 1 at right bank.

1st panel right bank damage

| Repair Item | Repair Description |
|---|---|
| 3 Structure. Concrete repair.<br>Priority: Medium | Repair damage noted to the concrete deck consistent with the Concrete Repair Guide for Concrete Bridge Components |

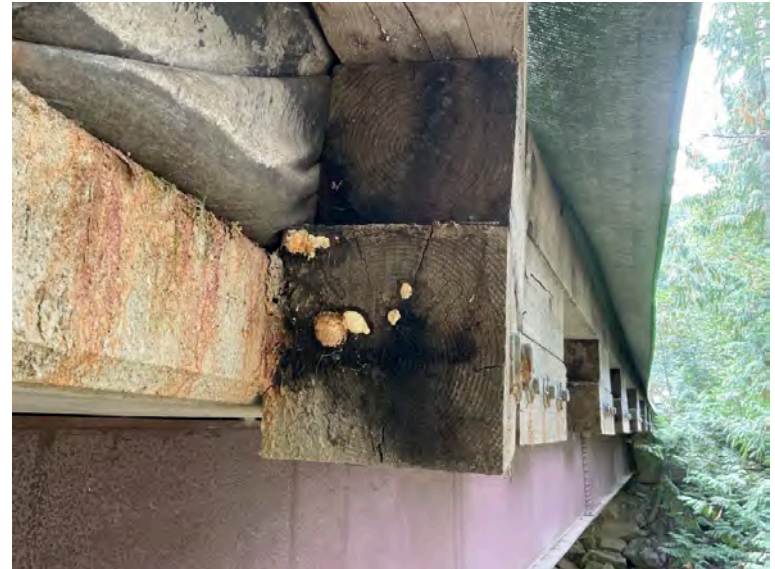
Guardrail sideblock condition

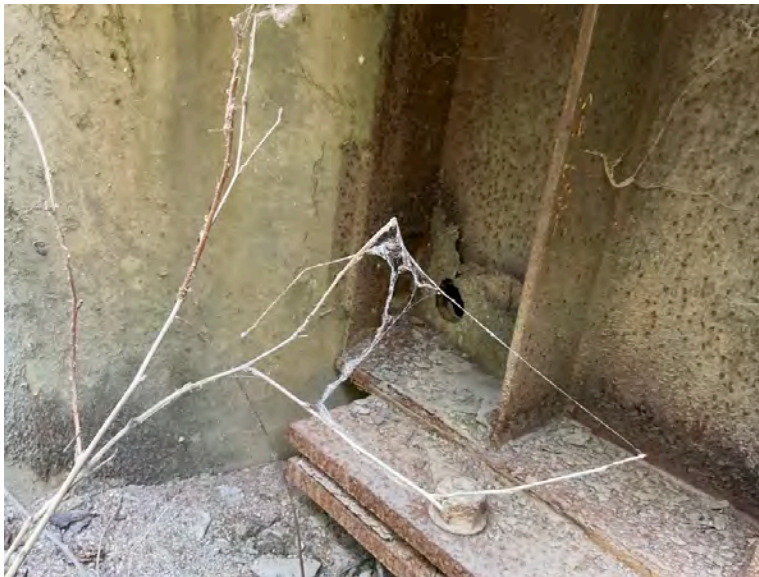
Minor steel delamination

Corrosion Protection Fair

Upstream left bank steel corrosion
