**Deroche Creek Debris Flow and Debris Flood Study**

**EBA ENGINEERING CONSULTANTS LTD.  
Vancouver, B.C.**

**Hay & Company, Vancouver, B.C.**

**Project No. 0806-99-86217**

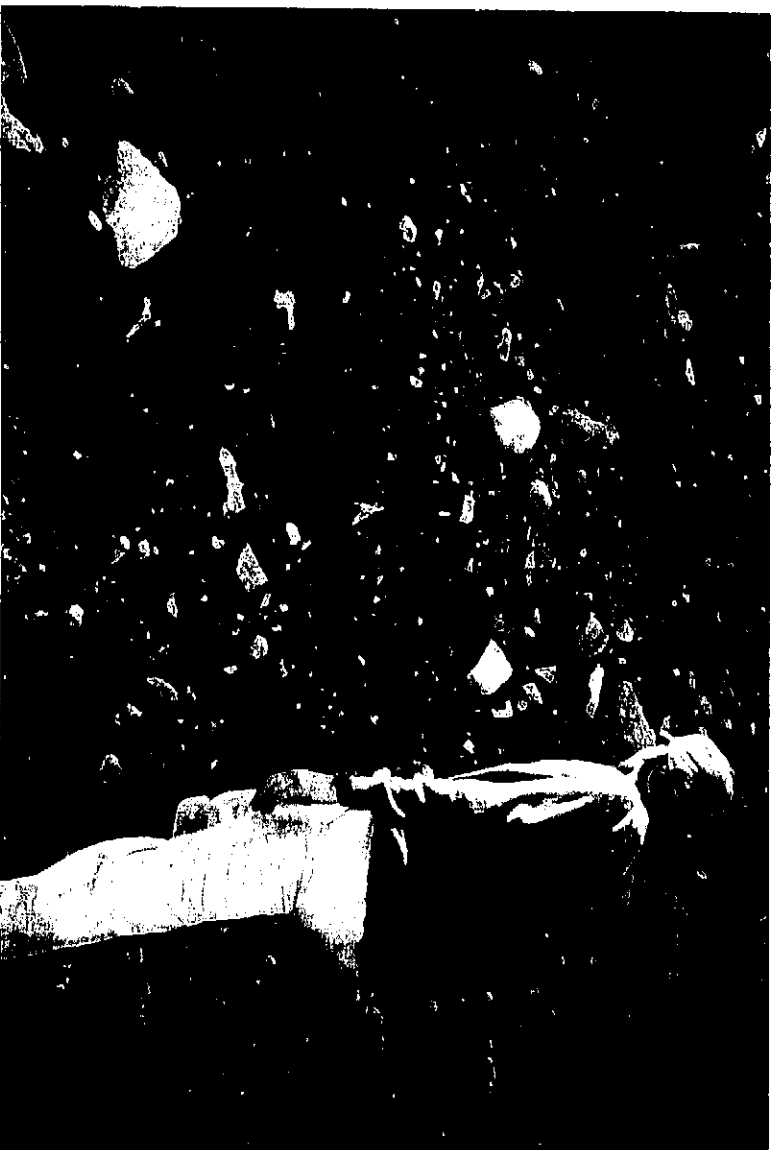
Photo 2. Interface between basal and weathered ablation till in the upper watershed

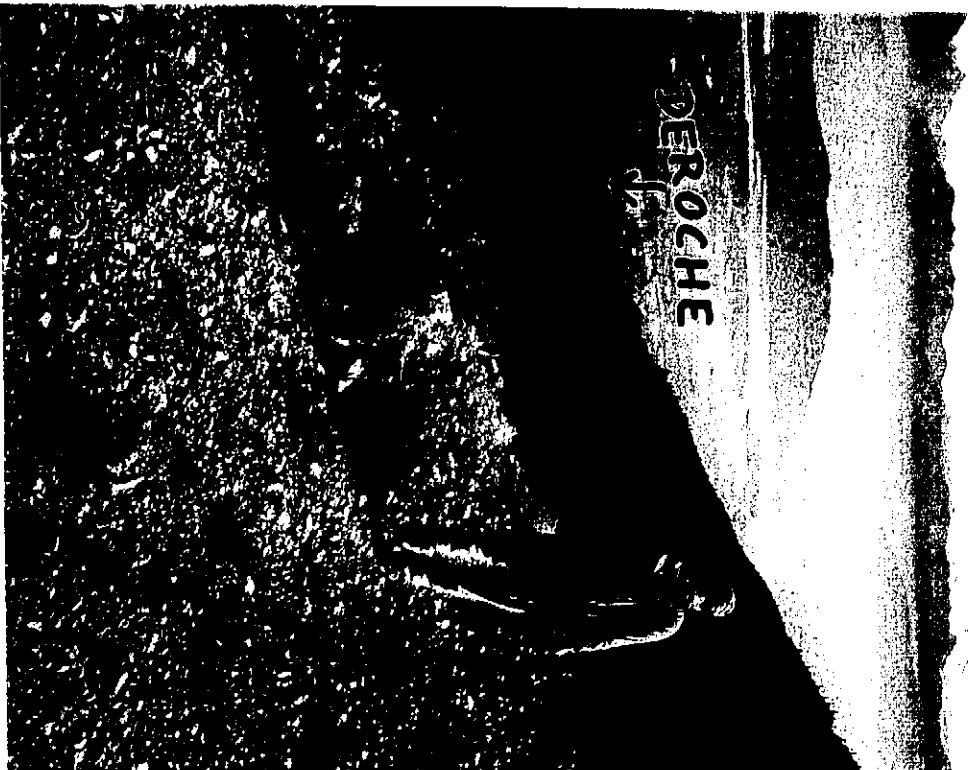
Photo 10.

Tension cracking and small fill slope slump along upper road

- Organic material in fillslopes. It is often observed that organic material (trees, branches, root wads) are part of the fillslope. When these rot, water conducting asperities are created that will concentrate runoff and may lead to failure at the point where water is discharging into the slope. Tension cracks are usually the predecessor to failure of the fillslope section of logging roads as displayed on Photo 9 and 10. In addition, layers of organic material can serve as potential shear planes.
