## FLOOD DAMAGE RECOVERY PLAN LAGACE CREEK, HATZIC VALLEY

JUNE 2005

# **FLOOD DAMAGE RECOVERY PLAN LAGACE CREEK, HATZIC VALLEY *DRAFT REPORT***

nhc 3-4195

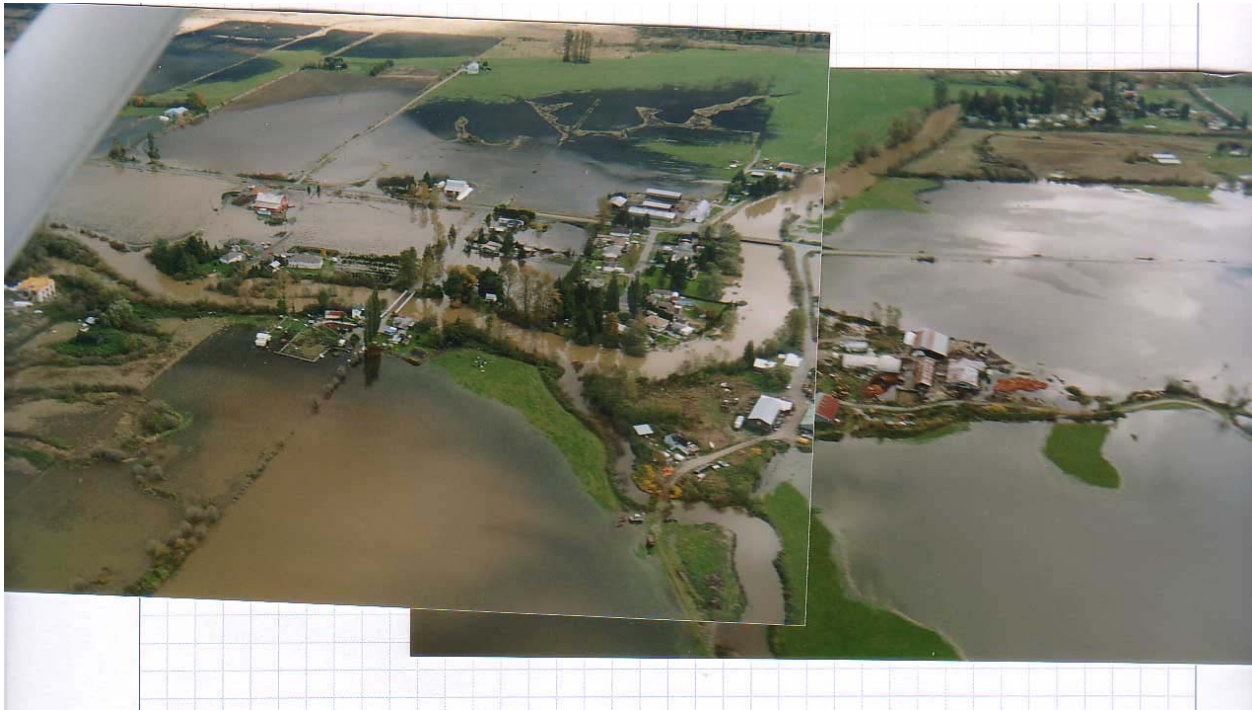
**PHOTO NO. 1**

**Lagace Creek**

**The sediment-laden Lagace Creek  
is in the middle of the photo and  
the South Farms Road Bridge is  
down from the bend.**

**Flow is left to right**

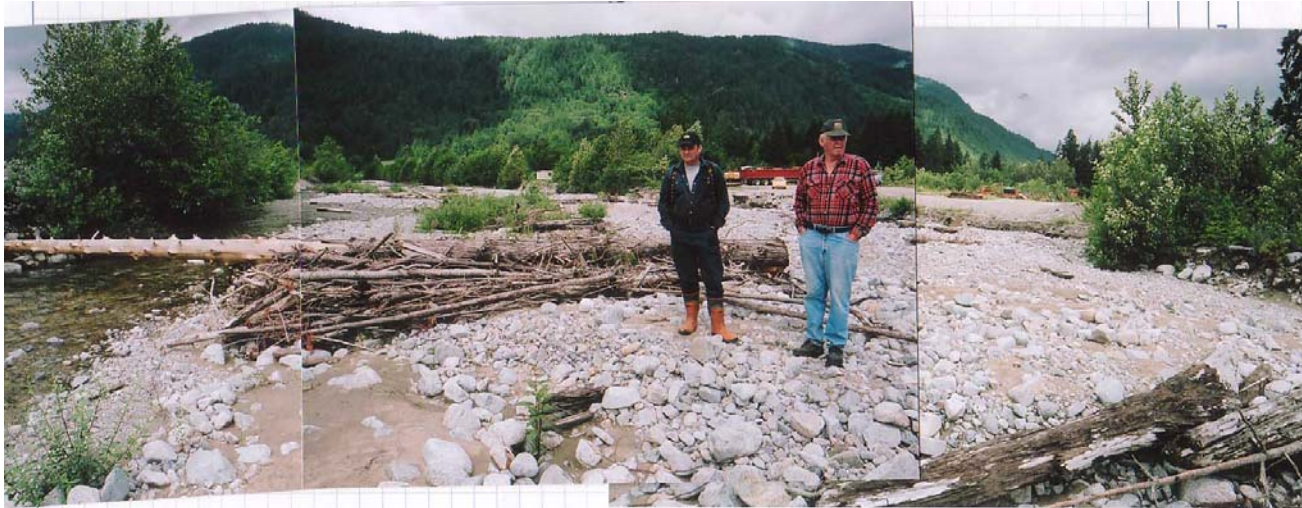
**PHOTO NO. 2**

**Downstream view to Reach #3 (Anderson's Gravel Trap)  
which is almost completely filled with gravel. The creek  
bank on the right is the same elevation as the bed  
in the middle of the creek.  
(June, 2005)**
