## **PROVINCIAL EMERGENCY PROGRAM**

# **PRELIMINARY DEBRIS FLOW HAZARD ASSESSMENT OF FIELD, CARRATT, ENG, MCNAB AND DALE CREEKS, HATZIC VALLEY**

## **FINAL REPORT**

PROJECT NO: 0378-001  
DATE: February 16, 2004

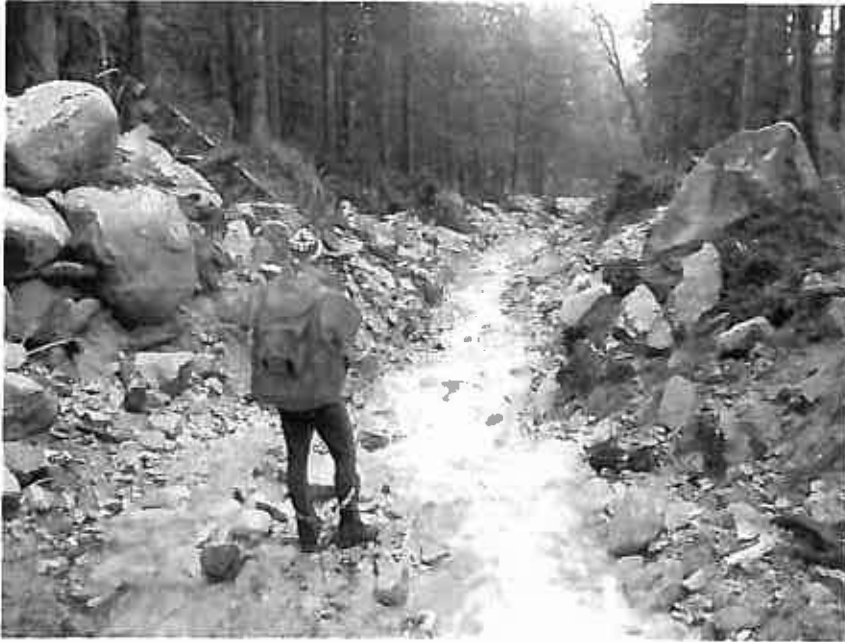
**Photograph 29**

Reaches of McNab Creek downstream of the fan apex. The channel has recently (December) been cleared of debris by an excavator that moved up the centre line of the creek and pushed debris onto both sides. Future debris flow events will likely entrain some of this loose material and redeposit it further downstream.

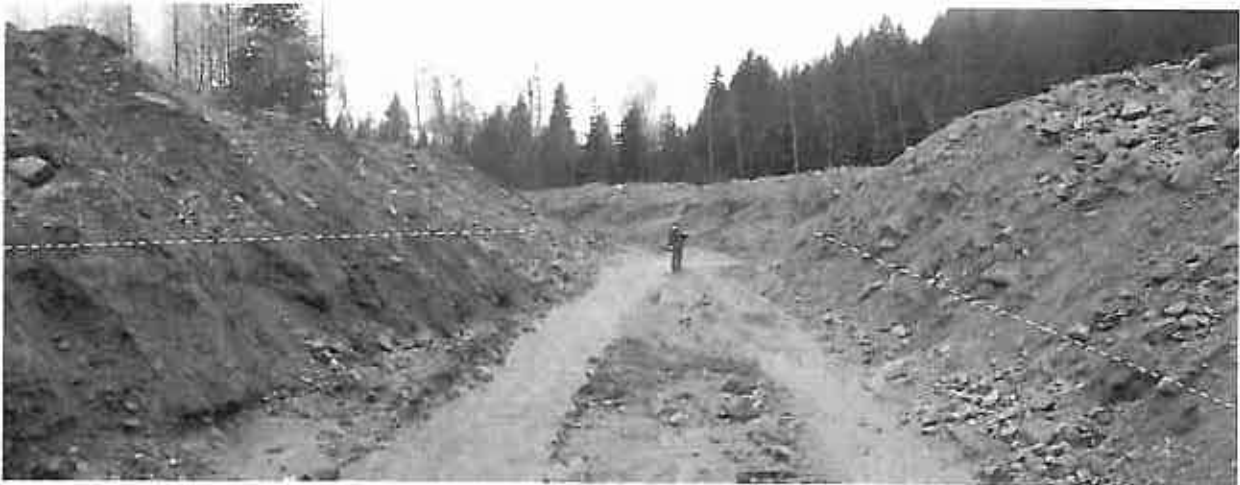
**Photograph 30.** Freshly excavated channel of McNab Creek 200 m upstream of Sylvester Road, December 8, 2003. The yellow lines show aggradation that was observed by BGC on Jan. 20, 2004.

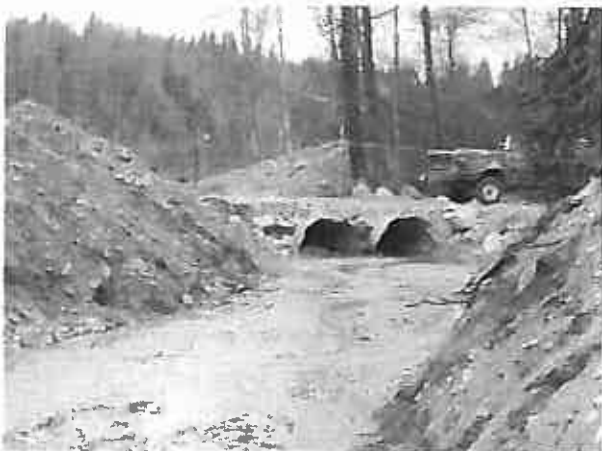
**Photograph 31**

Lowermost 50 m of McNab Creek upstream of Sylvester Road. The channel has been freshly excavated into very loose material. Future streamflow will likely undercut the artificial creek banks and will cause rapid stream channel aggradation. Continued channel maintenance will be required to keep the channel cleared of debris and prevent plugging of the dual culverts.

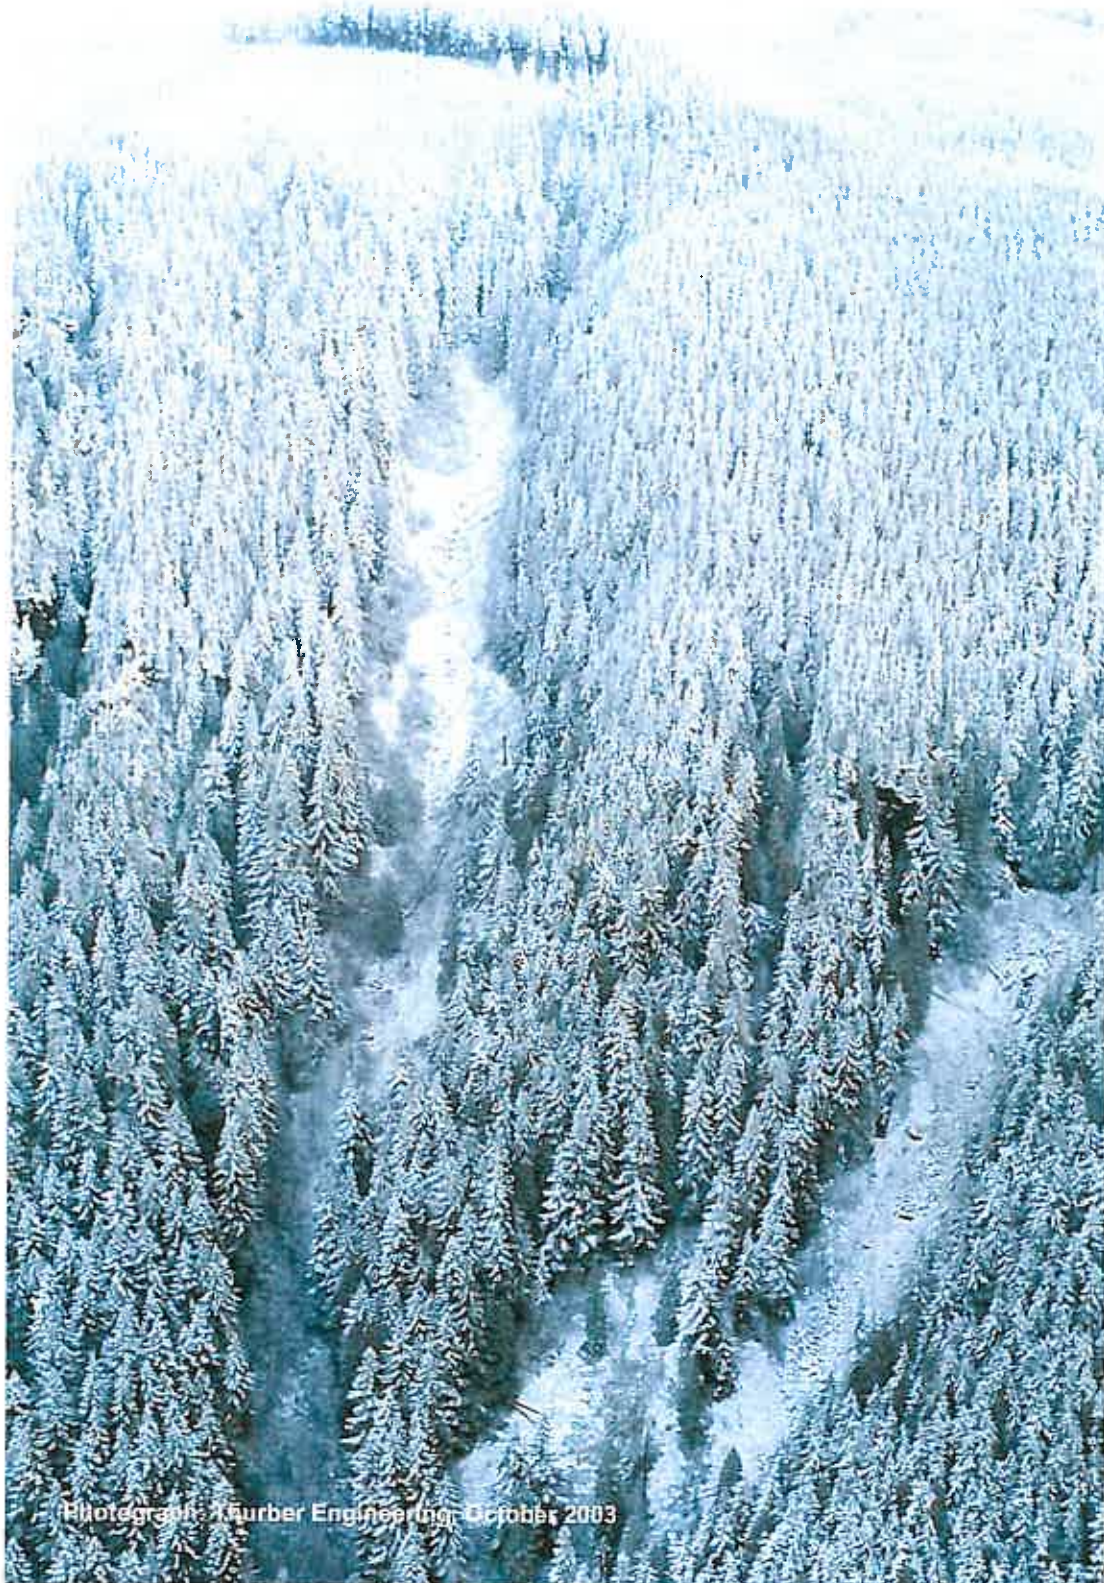
**Photograph 32.** Upper Dale Creek watershed. Note the extensive talus. High hydrologic conductivity will likely prevent frequent debris flows in this environment. Large, rare events, however, are conceivable.

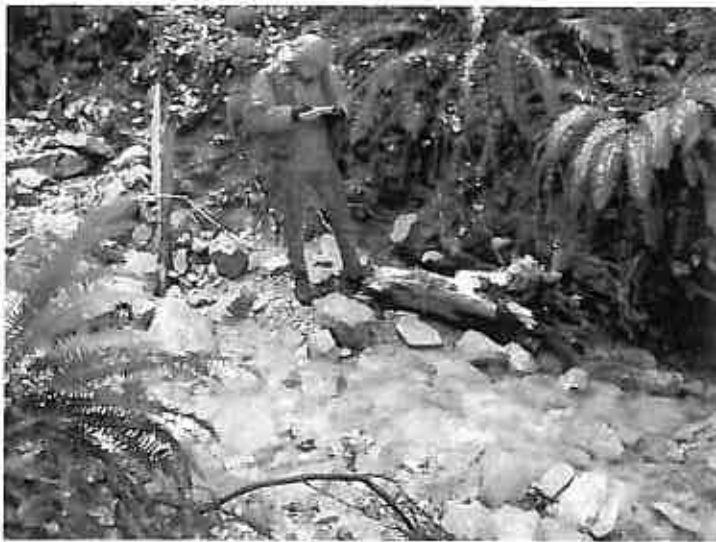
**Photograph 33**

Stream channel section on the Dale Creek fan, approximately 100 m downstream of the fan apex. This type of steep fan has the capability of rapid incision and entrainment of substantial amounts of fan material as has happened on Hope Creek in November of 1995. There has not been such an event recorded in recent history at Dale Creek.

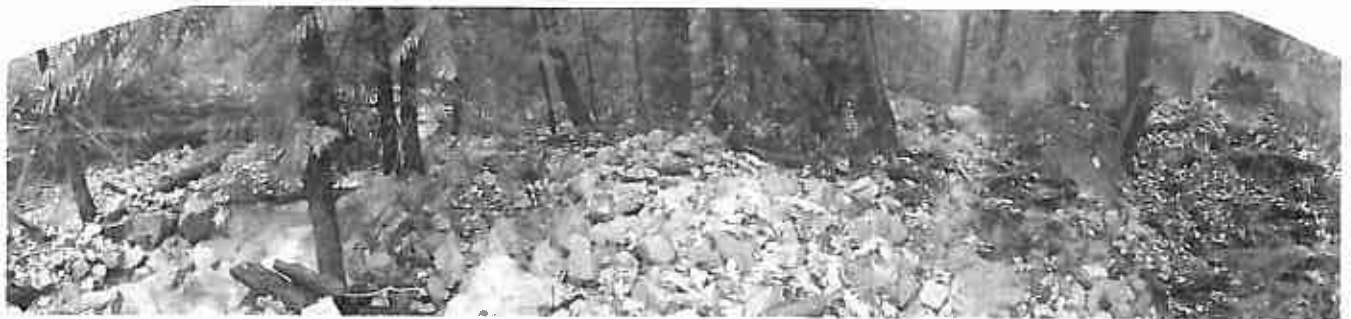
**Photograph 34.** Panorama view from the fan apex of Dale Creek looking downstream. The fresh boulders in the foreground were deposited by high flood flow during the mid October 2003 storm.

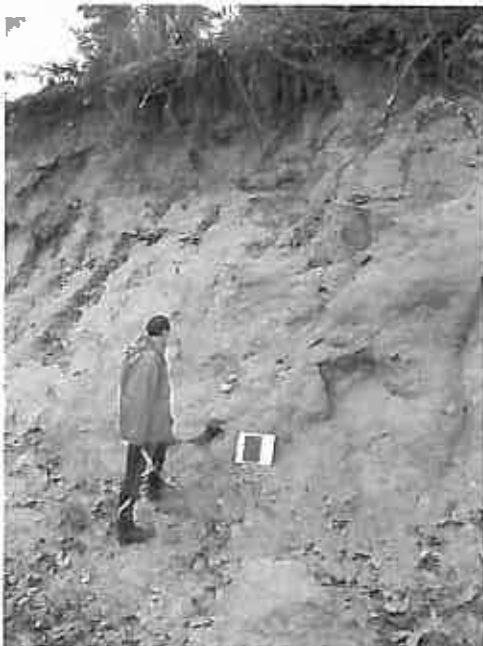
**Photograph 35**

Glacial deposits upstream of Sylvester Road near the intersection with Dale Road. This photograph demonstrates that much of the Dale Creek fan is underlain by glacial deposits consisting mostly of basal till which is over-consolidated.

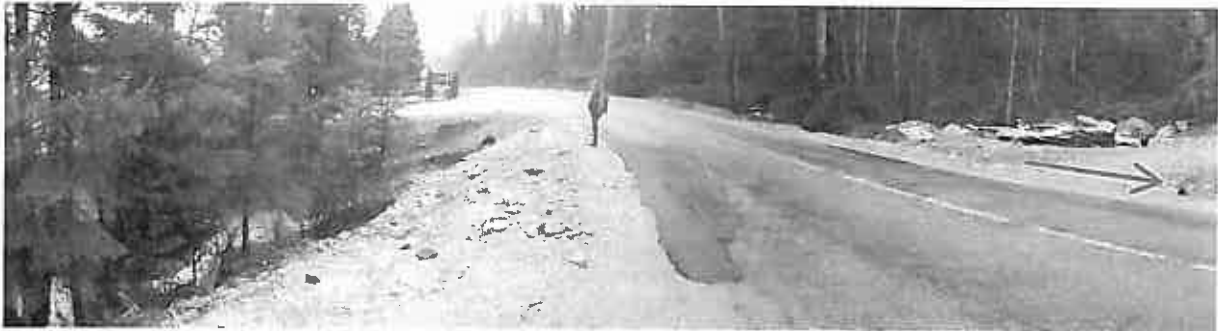
**Photograph 36.** Road fill repair at Dale Creek, where a malfunctioning culvert (the right) caused drainage avulsion across the road.

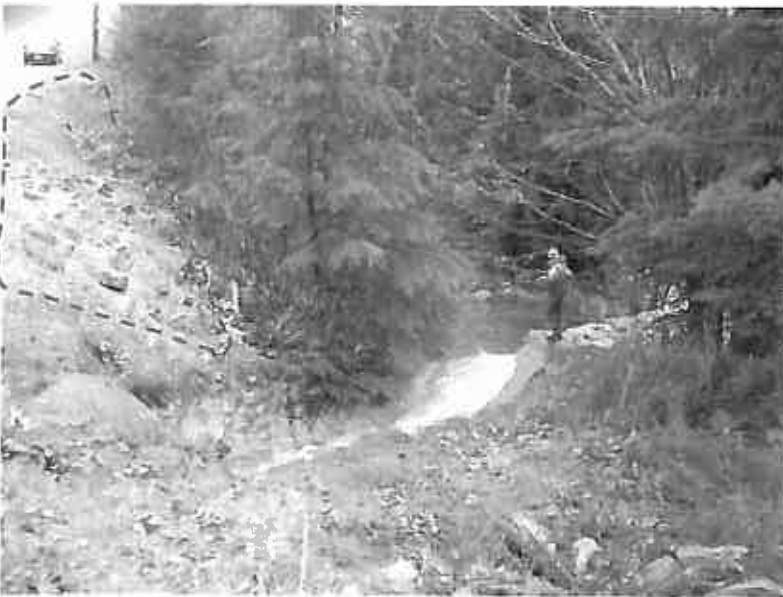
**Photograph 37.** Dale Creek downstream of the concrete culvert, which directs the creek below Sylvester Road. The cross-section at the point where the person is standing most likely will not contain the 200-year return period flood flow. The red dashed line delineates the area of the road fill that failed on October 17, 2003 due to culvert overtopping on the east side of Sylvester Road (shown by a red arrow on Photograph 36).

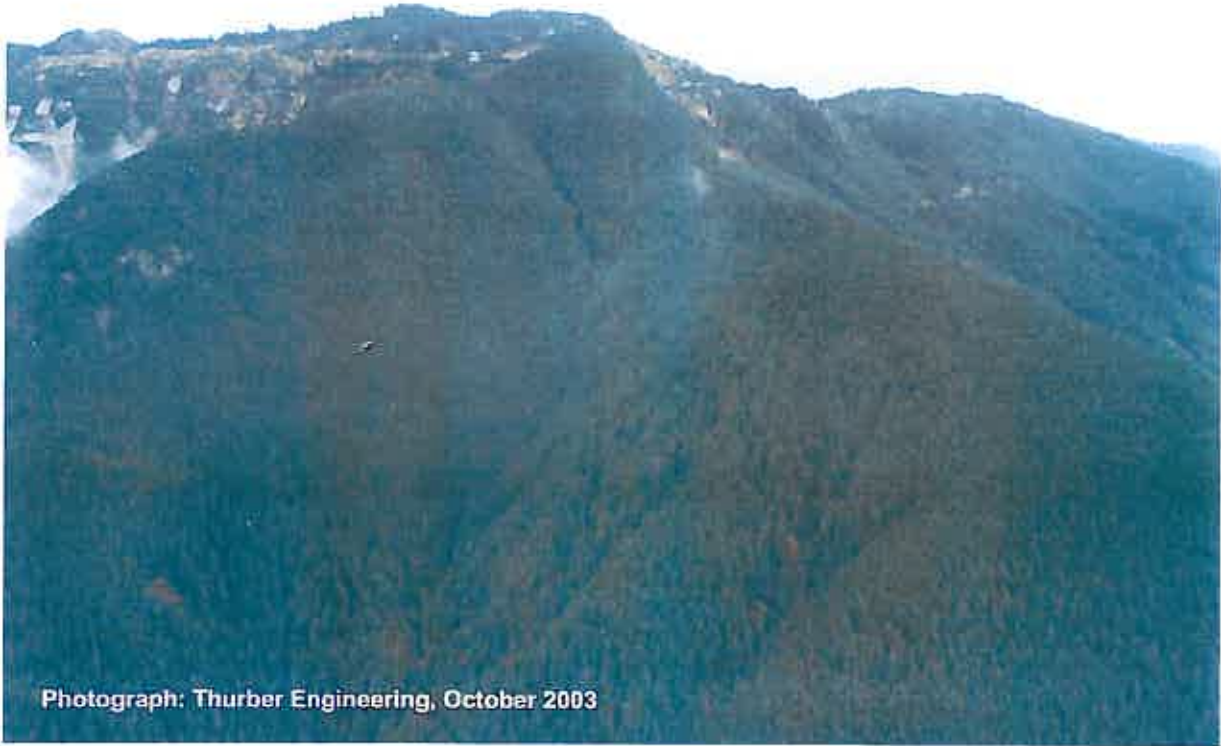
**Photograph 40.** Aerial photograph of Pattison Creek taken in 1993. Note the large debris flows (marked with red arrows) in the northern part of the watershed that were likely caused by logging road fill failures or drainage redirection. Also note the large deep-seated landslide delineated in red. The yellow lines approximate the watershed boundary. Source: Ministry of Sustainable Resource Management, 1993.

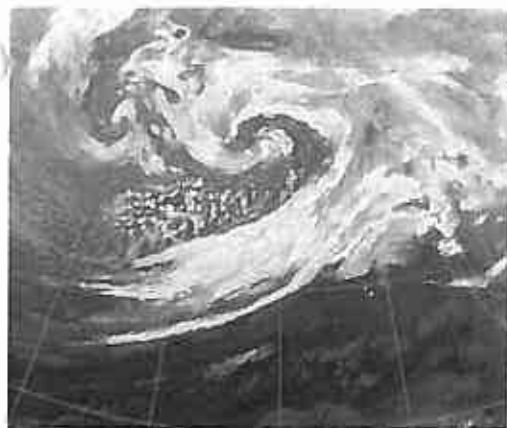
**Figure 1a.**

Infrared satellite image taken at 10 PM Pacific Standard Time (PST) on October 15, 2003. The front makes a landfall.

On the evening of October 15<sup>th</sup>, 2003, a westerly flow aloft drove a major Pacific frontal system onto the BC Coast (Fig. 1a). While an associated low-pressure system in the Gulf of Alaska deepened, the flow towards BC became increasingly southwesterly. This increased the supply of sub-tropical moisture as a "Pineapple Express" circulation became well established. A series of moist impulses surged along the frontal stream as it remained stalled across southwestern BC for the next several days. This sequence of events can be seen on the GOES Infrared Satellite imagery in Figures 1a,b, c and d.

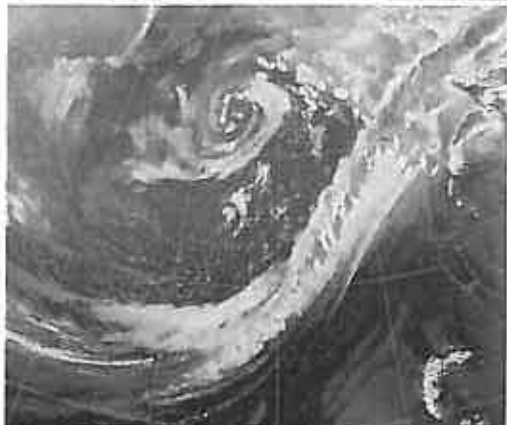
**Figure 1b.**

Infrared satellite image taken 10 PM PST Oct 16, 2003 at the height of the storm at Victoria Airport where 51 mm fell in 6 hours and 136 mm fell in 24 hours far exceeding previous records.

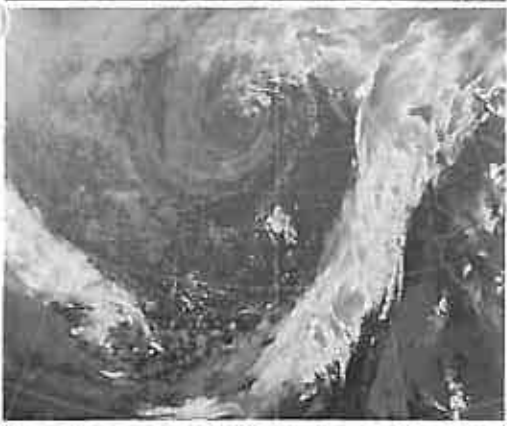
**Figure 1c.**

Infrared Satellite image taken 10 PM PST Oct 17, 2003. Flow more southerly, Olympic rain shadow strengthening Vancouver Airport received 141 mm in previous 48 hours exceeded previous record by 38 mm.

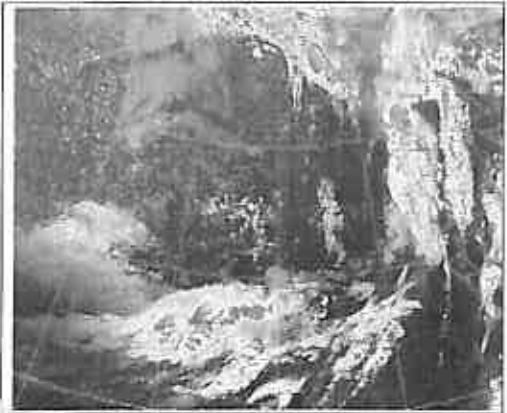
**Figure 1d.**

Infrared Satellite image taken 10 PM PST Oct 18, 2003. Southerly flow directs moisture into Howe Sound.

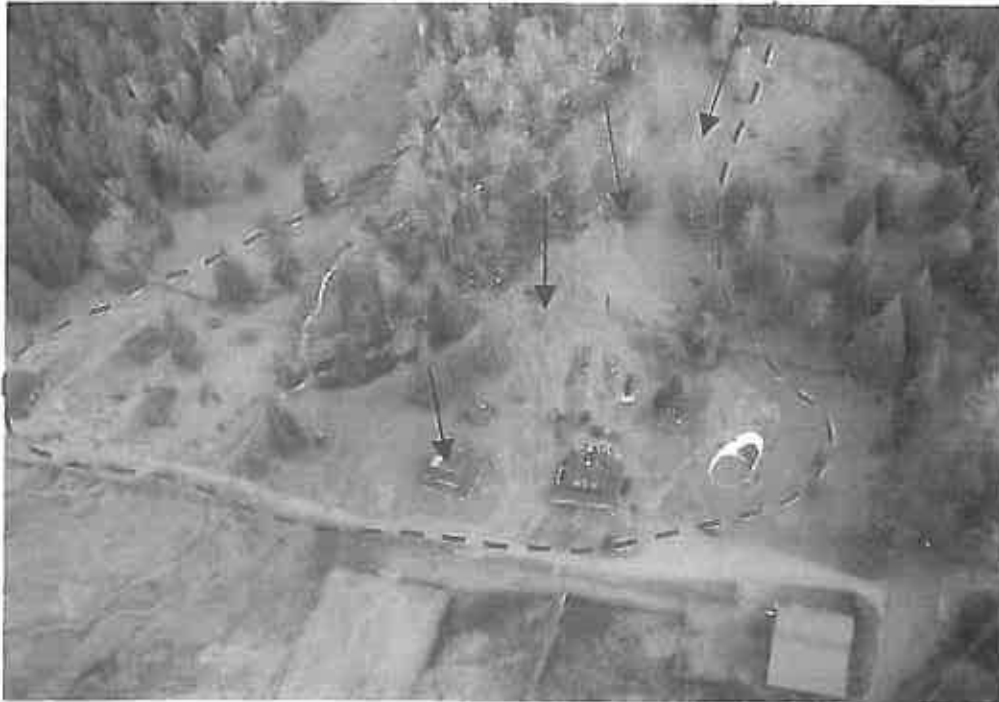
**Photograph 1.** Field Creek debris flow. The red line approximates the outline of the modern debris flow fan.

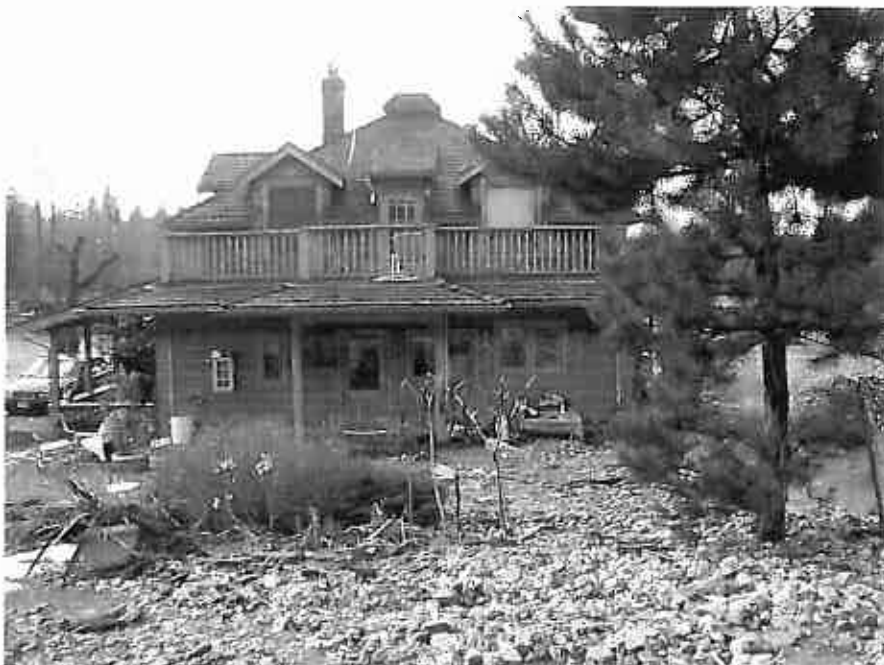
**Photograph 2.** The Virtue residence with a fresh boulder lobe banking against the east side of the house.

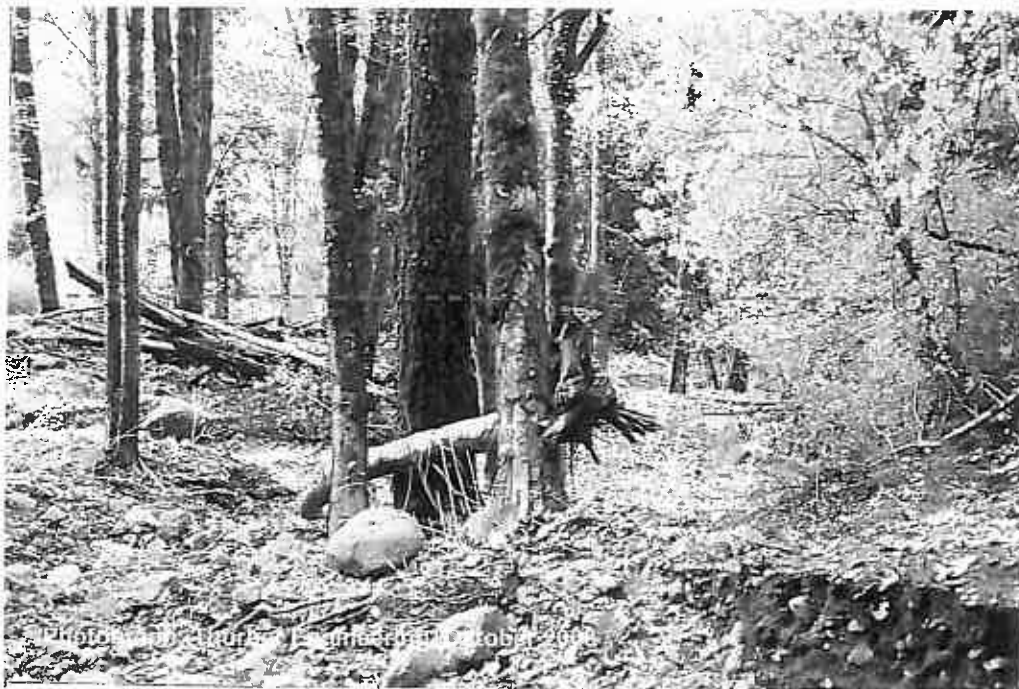
**Photograph 3.** Channel section near the apex of Field Creek debris flow fan. The red line indicates

the approximate height of the flow as evidenced by bark and cambium scour of tree trunks. At this location the flow began losing confinement and began to spread.

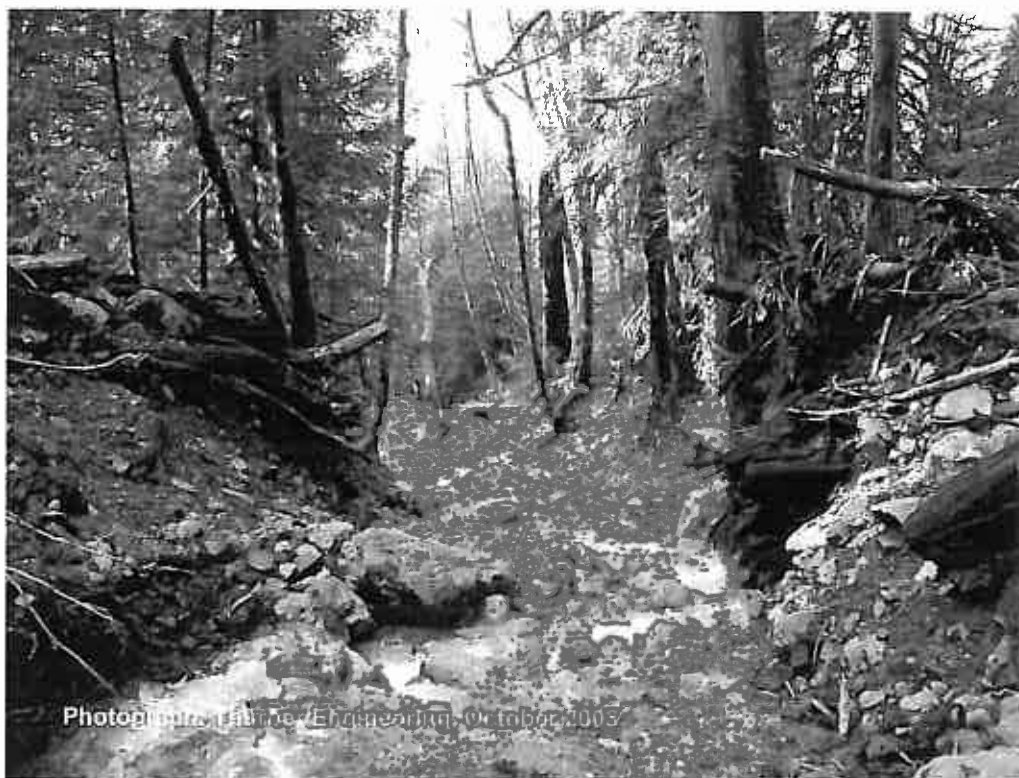
**Photograph 4.** Channel section approximately 150 m upstream of the fan apex of Field Creek. The peak discharge back-calculated at this section was approximately  $200 \text{ m}^3/\text{s}$ .

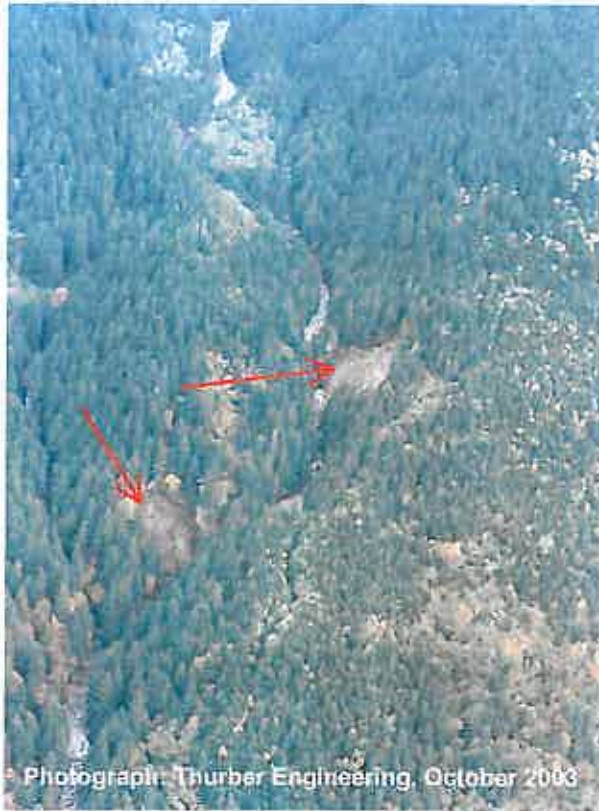
#### **Photograph 5**

Upper Carratt Creek at an elevation of approximately 500 m. Two small debris slides in unlogged terrain likely contributed to the volume of the debris flow. It is possible that these debris slides were triggered by the main debris flow undercutting the slope, thus destabilizing the slide mass above.

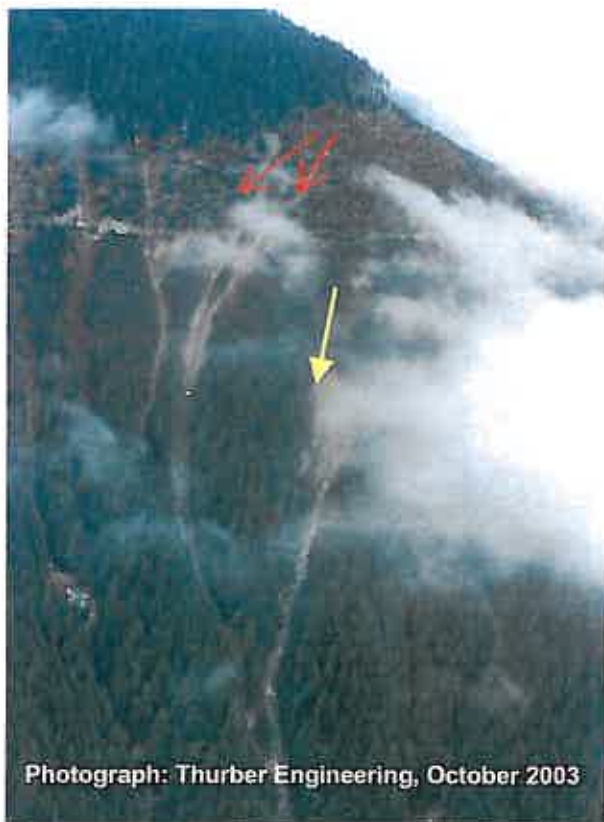
#### **Photograph 6**

Several small debris slides that quickly transformed into debris flows. The two red arrows point towards debris slides in poorly regenerated clearcuts, and which were likely caused by progressive loss of root strength.

The yellow arrow points towards a debris avalanche that was triggered at the boundary between clearcut terrain and old-growth forest.

In summary, it can be stated that landslide activity is still elevated in the upper watersheds of the study area due to incomplete recovery from root strength loss (Photograph 6 at Carratt Creek and Photograph 26 at McNab Creek) and progressive weakening of road fill (Photograph 7 and 8 at Carratt Creek). The present landslide scars will supply sediments to the stream channels by ravelling and minor sliding for some years to come. This process will accelerate channel recharge and add to the volume of future debris flows.

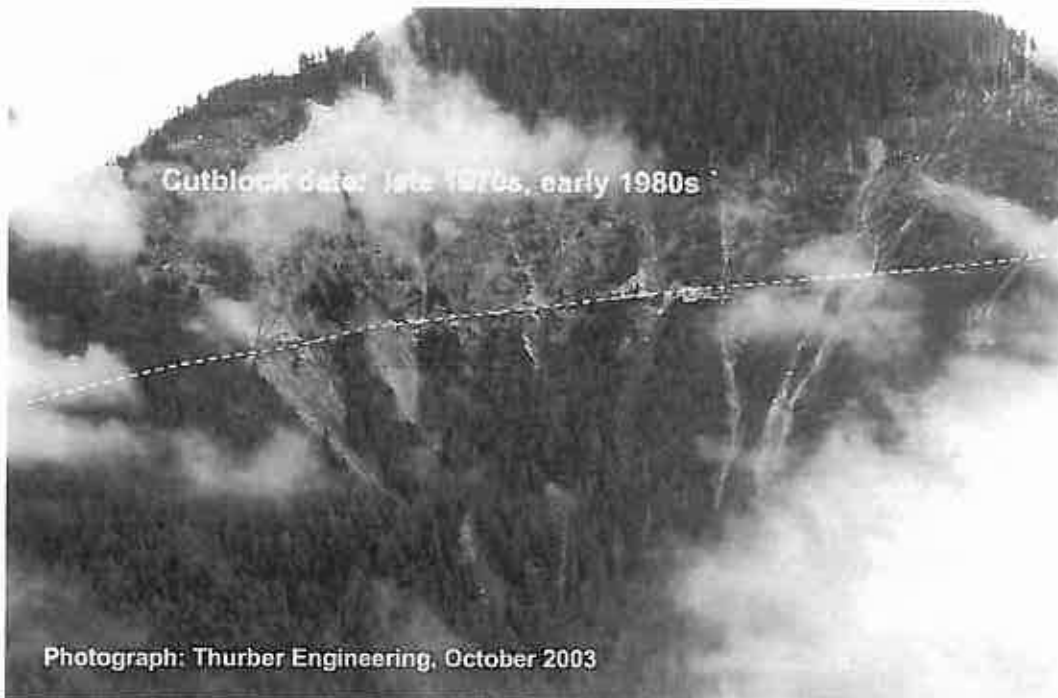
**Photograph 7.** Debris avalanches and debris flows in the upper watershed of Carratt Creek. Red arrows points towards the failures also shown on Photograph 6, blue arrows shown as vertical images on Photograph 8. The yellow dashed line indicates the location of the forest road.

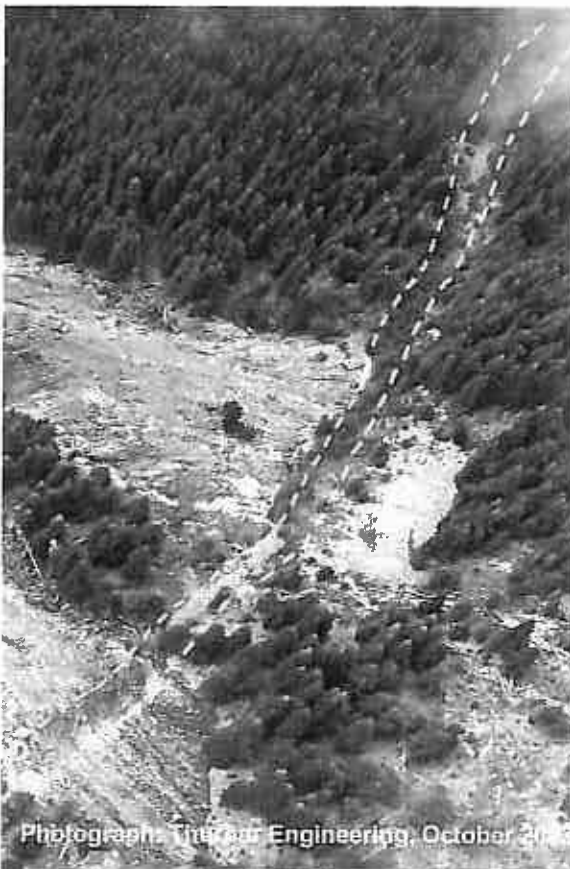
**Photograph 8**

Two large debris avalanches (volume approx. 3000 m<sup>3</sup> each) in the upper Carratt Creek watershed. The upper failure (far left on Photograph 7) initiated as a road-fill failure, while the lower debris avalanche initiated in a cutblock and then overran the logging road indicated by a double dashed yellow line. These failure scarps will provide fine materials into the channel systems below for some time to come before vegetation can be re-established. Further debris avalanches from this cutblock can be expected in the future.

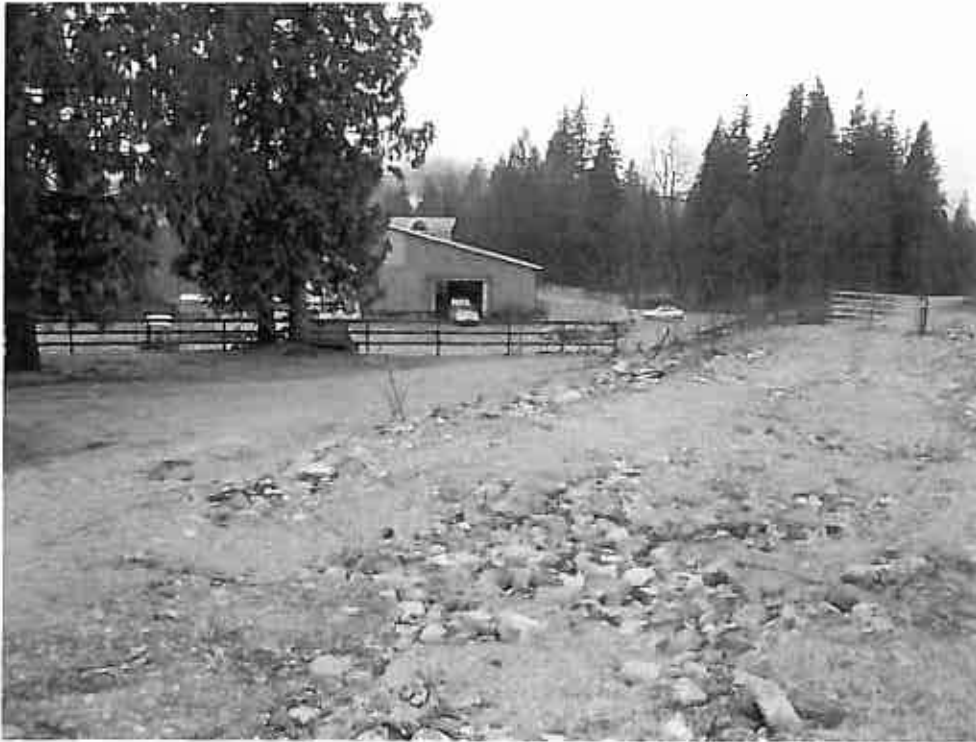
**Photograph 9.** The riding and film studio south of Carratt Creek. The building is roughly at the same elevation as the creek bed at the present time (December 2003).

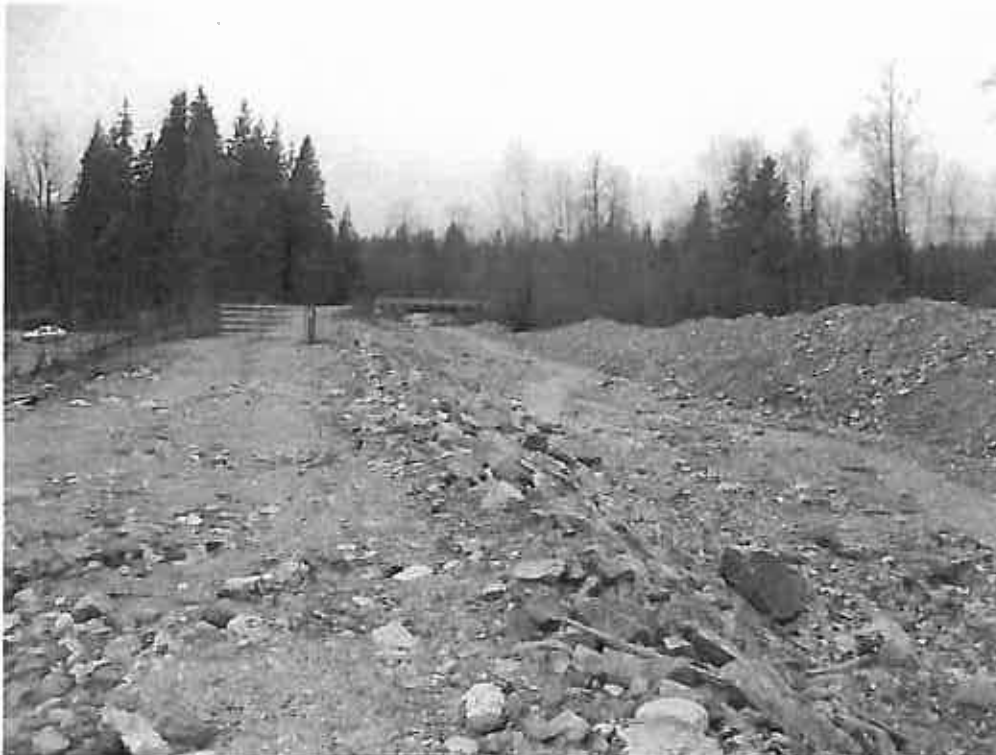
**Photograph 10.** Carratt Creek north of the horseback riding and stables facility. Freshly deposited debris has been pushed towards the north of the creek and is now being undercut by streamflow.

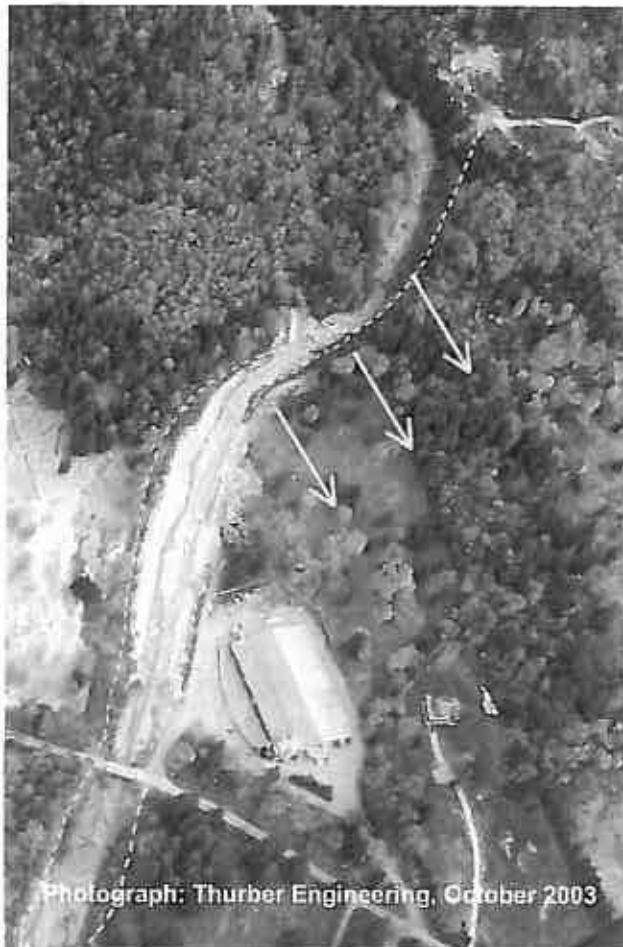
#### Photograph 11

Lower Carratt Creek with the horseback riding facility in the lower photograph. The red arrow indicates recent debris avulsion that caused bypassing of the right (northern) berm of Carratt Creek and flooding and sediment deposition on the Virtue residence. It is possible, that had this avulsion not occurred channel aggradation further downstream could have forced the flow into the southern sections of the fan as indicated by the yellow arrows. The yellow dashed line indicates the approximate location of berms paralleling Carratt Creek.

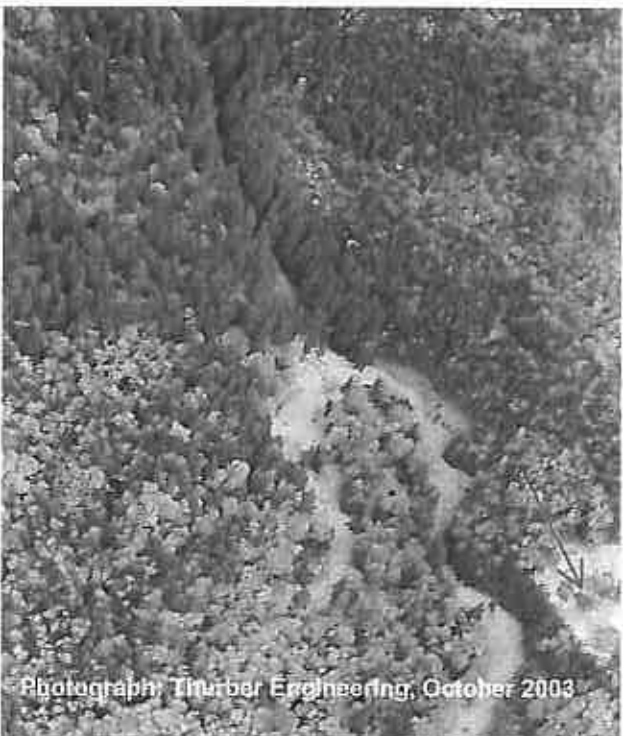
#### Photograph 12

Fan apex of Carratt Creek. Here the flow avulsed to the left (north), which caused flooding, and sediment deposition at the Virtue property. A gravel pit, which could be used as a debris basin is visible on the right, marked by a red arrow.

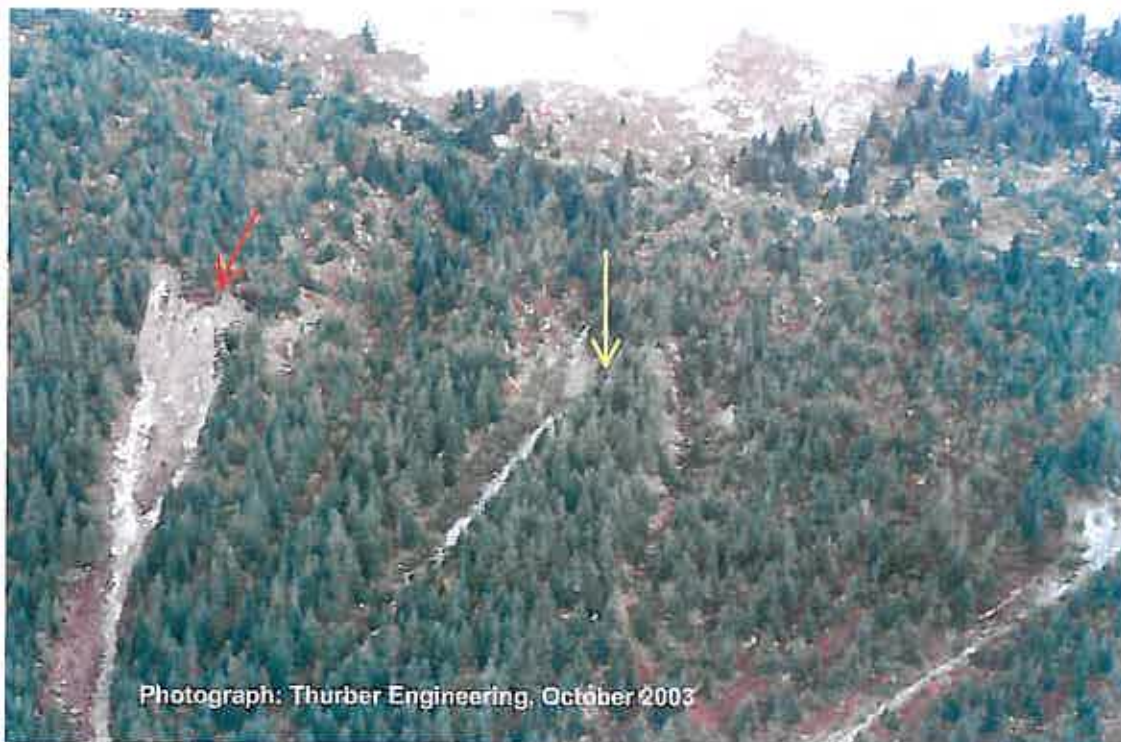
**Photograph 13.** Upper Eng Creek watershed. The fresh failure to the left indicated by a red arrow initiated approximately 50 m downstream of an old logging road and may have been associated with drainage redirection. An older failure (yellow arrow) can be seen to the right.

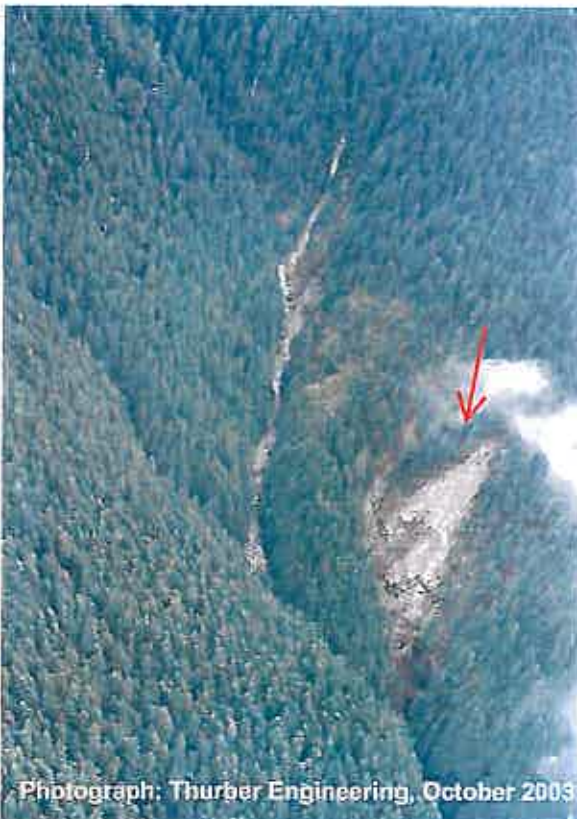
**Photograph 14**

A debris avalanche over bedrock in the lower section of Eng Creek. This event, which is not related to logging activities, likely added significant amounts of material to the debris flow. The sequence of events (i.e. if the debris flow from the upper watershed came first or the landslide shown on this photograph was initiated first) is unclear and can only be answered through detailed field studies.

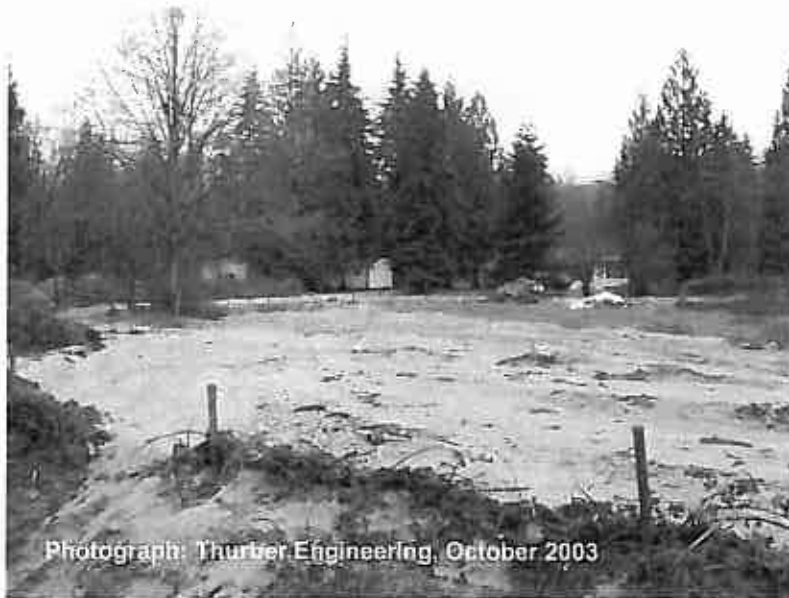
**Photograph 15**

Fine-grained (mostly sand) runout of the debris flow on Eng Creek with Sylvester Road in the background. This type of inundation is classified as nuisance flooding.

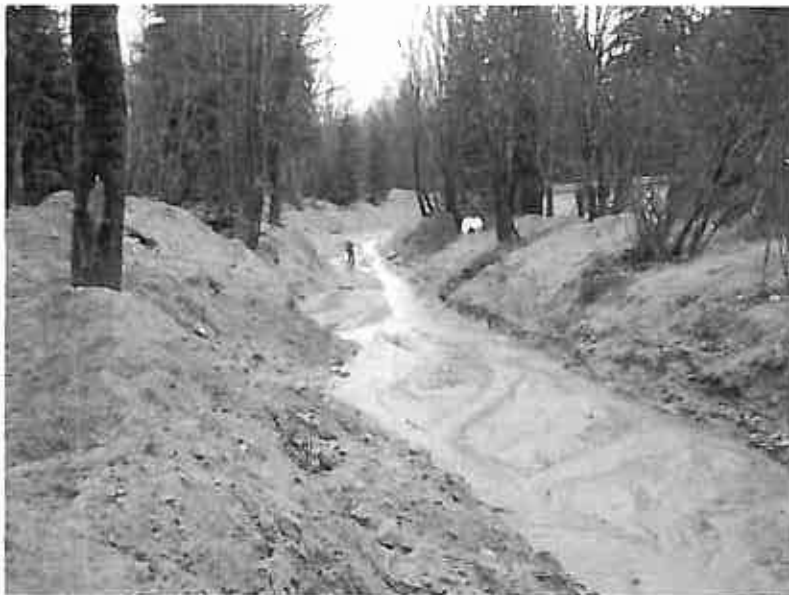
**Photograph 16**

Fresh channel works at Eng Creek. Excavators went up the centre of the creek and pushed the sandy gravel to both sides creating a trapezoidal channel. It is expected that this channel will rapidly fill in with sediment during the winter months. December 2003

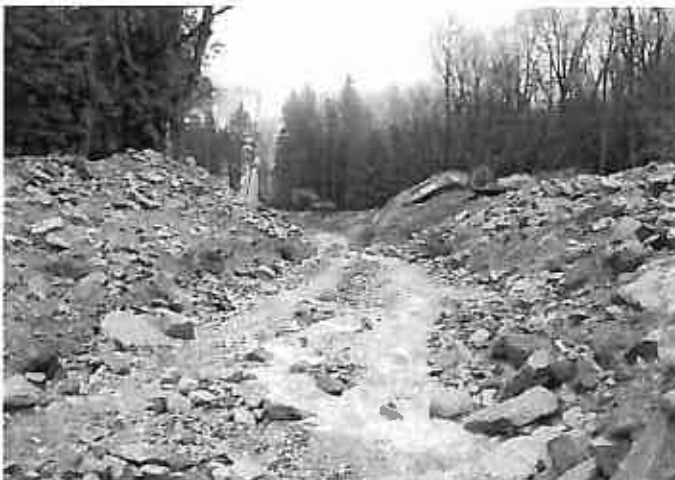
**Photograph 17**

Excavators working in the upper fan area of Eng Creek, attempting to return the channel to approximately pre-event topography. December 2003.

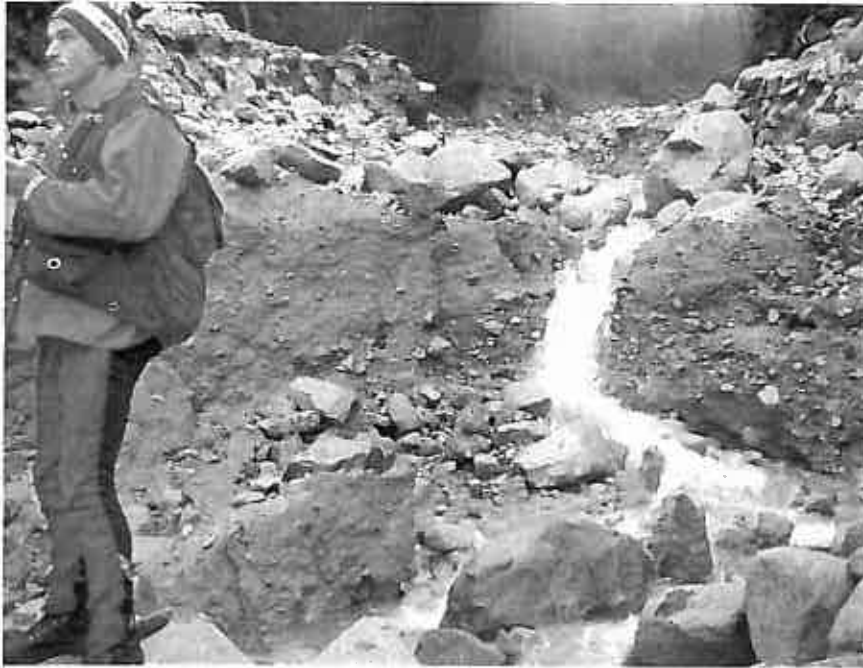
**Photograph 18**

Fan head entrenchment on Eng Creek near the fan apex. In this reach, the debris flow was able to scour through consolidated fluvio-glacial materials and glacial till thus adding to the material from the upper watershed. Explosive were used near this location in 1984 to clean out the channel. Disturbance by blasting could have created conditions favourable to deep scour.

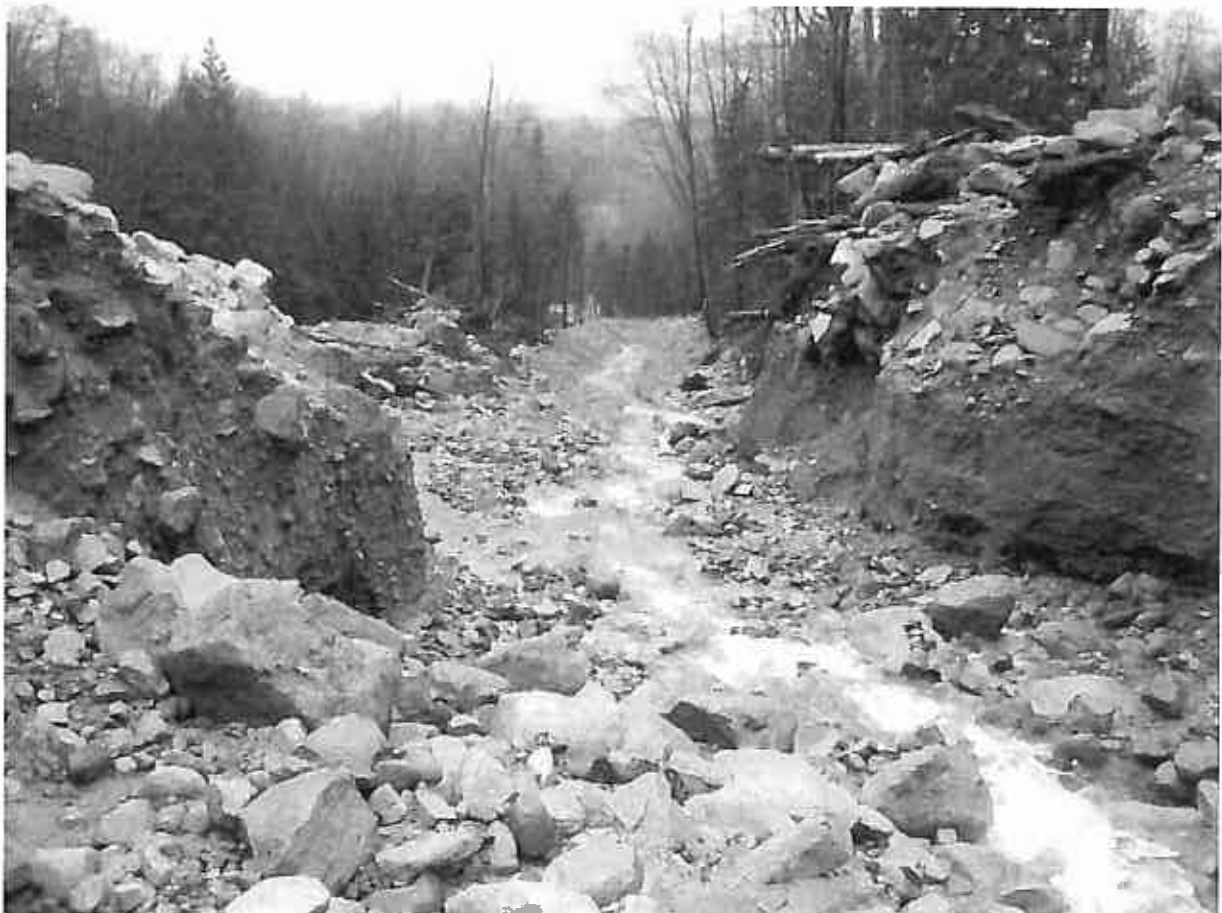
**Photograph 19.** Scoured upper fan reaches of Eng Creek illustrating the possibility of additional channel scour in an area usually defined as the deposition area.
