## **PROVINCIAL EMERGENCY PROGRAM**

# **PRELIMINARY DEBRIS FLOW HAZARD ASSESSMENT OF FIELD, CARRATT, ENG, MCNAB AND DALE CREEKS, HATZIC VALLEY**

## **FINAL REPORT**

PROJECT NO: 0378-001  
DATE: February 16, 2004

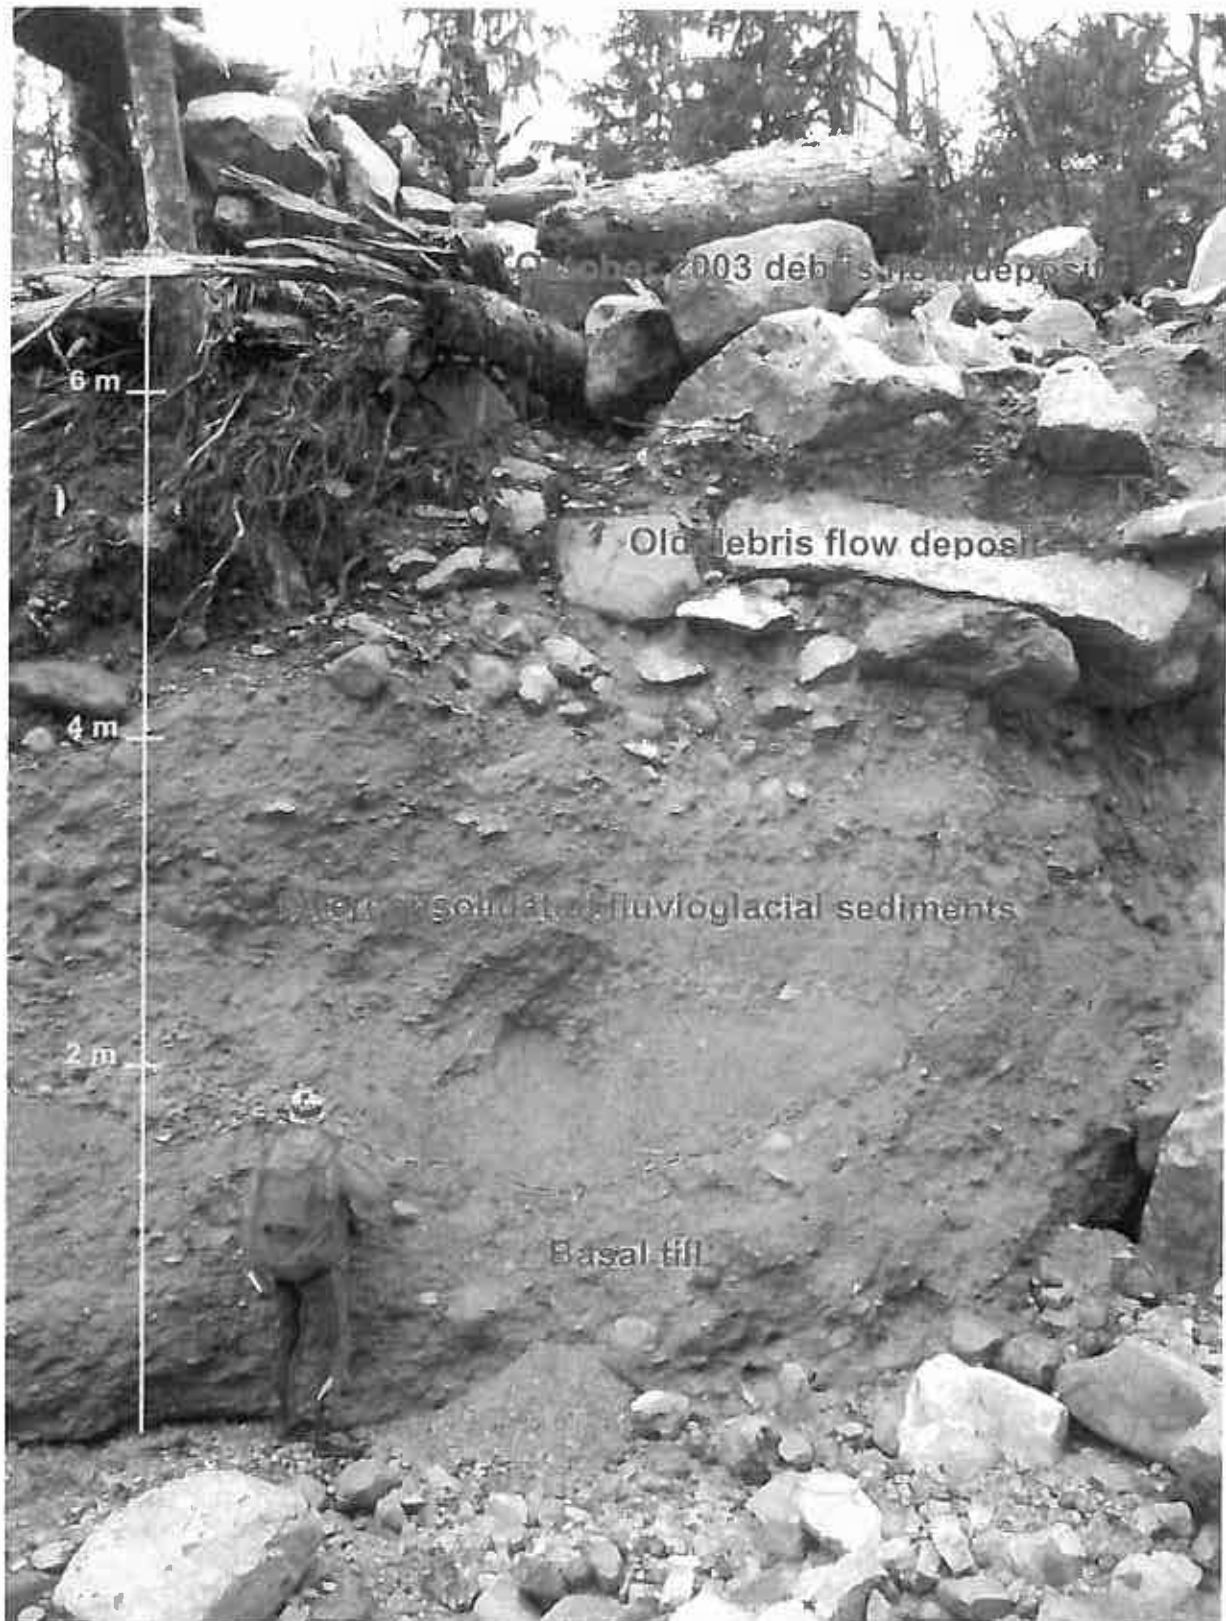
**Photograph 21.** Upper fan stratigraphy at Eng Creek with old debris flow deposits overlying fluvioglacial and glacial sediments.

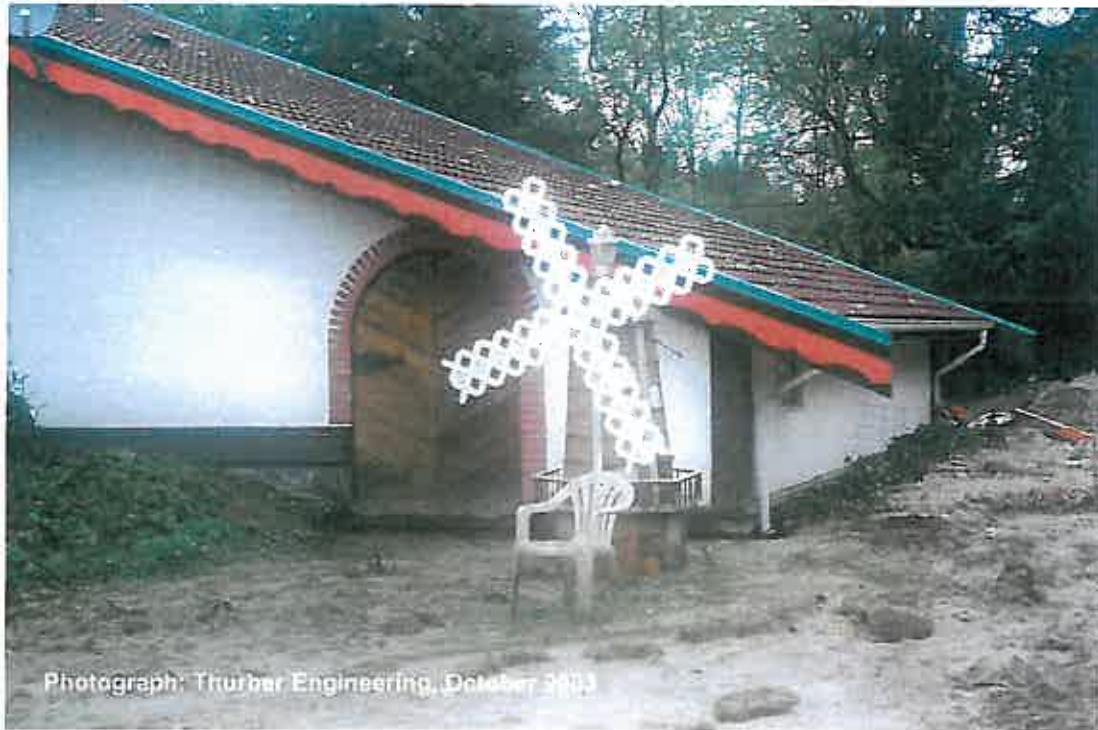
**Photograph 22.** The Ramasteder residence. According to eyewitness accounts by Ms. Ramasteder, sandy debris piled up to 50 cm around the house.

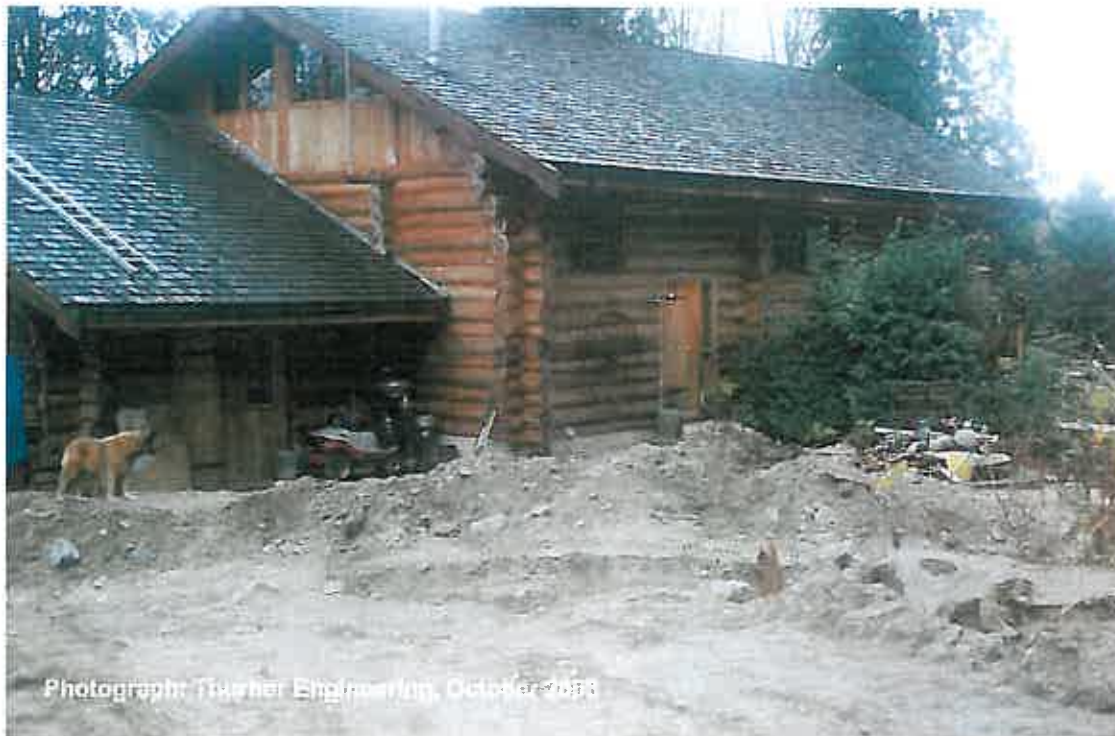
**Photograph 23.** The Lund Residence where boulders up to 40 cm in size impacted the log home but did not cause structural damage. Much damage was likely avoided by the owners using a front-end loader to create a temporary berm, which directed water and debris away from the home.

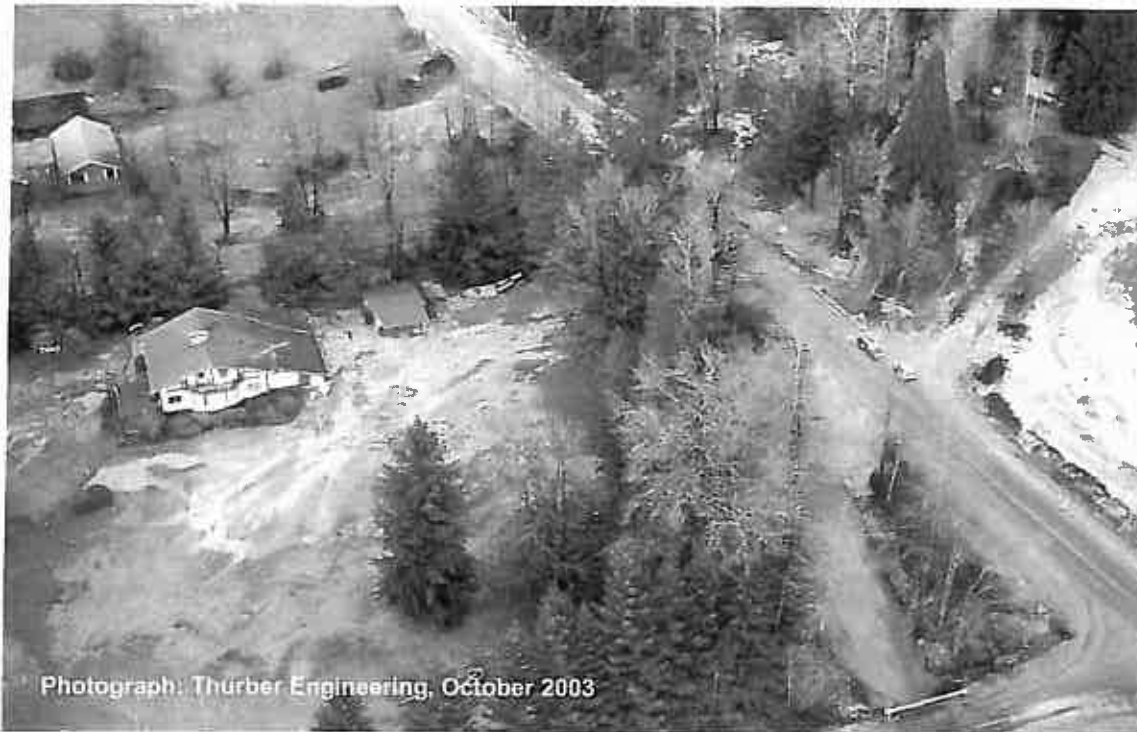
**Photograph 24.** Lower reaches of Eng Creek before reaching Allen Lake. The Remester residence is the one with the red roof on the left side of the photograph.

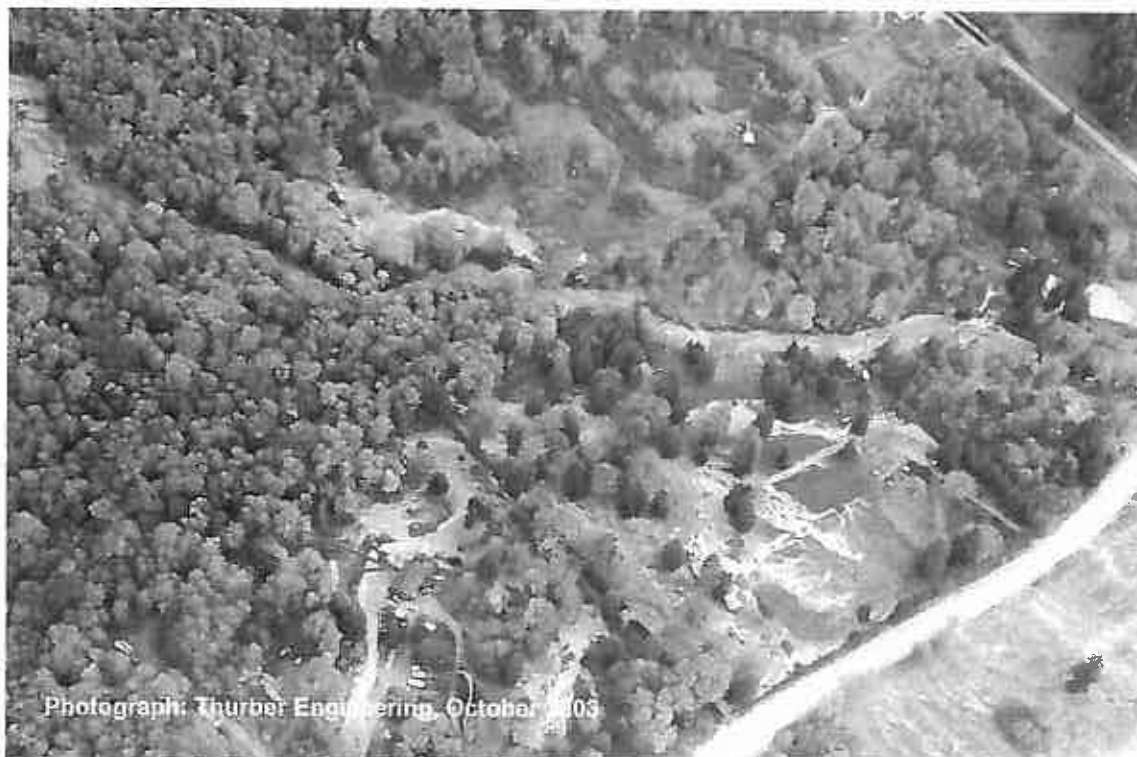
**Photograph 25.** This image shows the lower fan of Eng Creek. The red arrow points towards the Lund residence, which is also shown in Photograph 23.

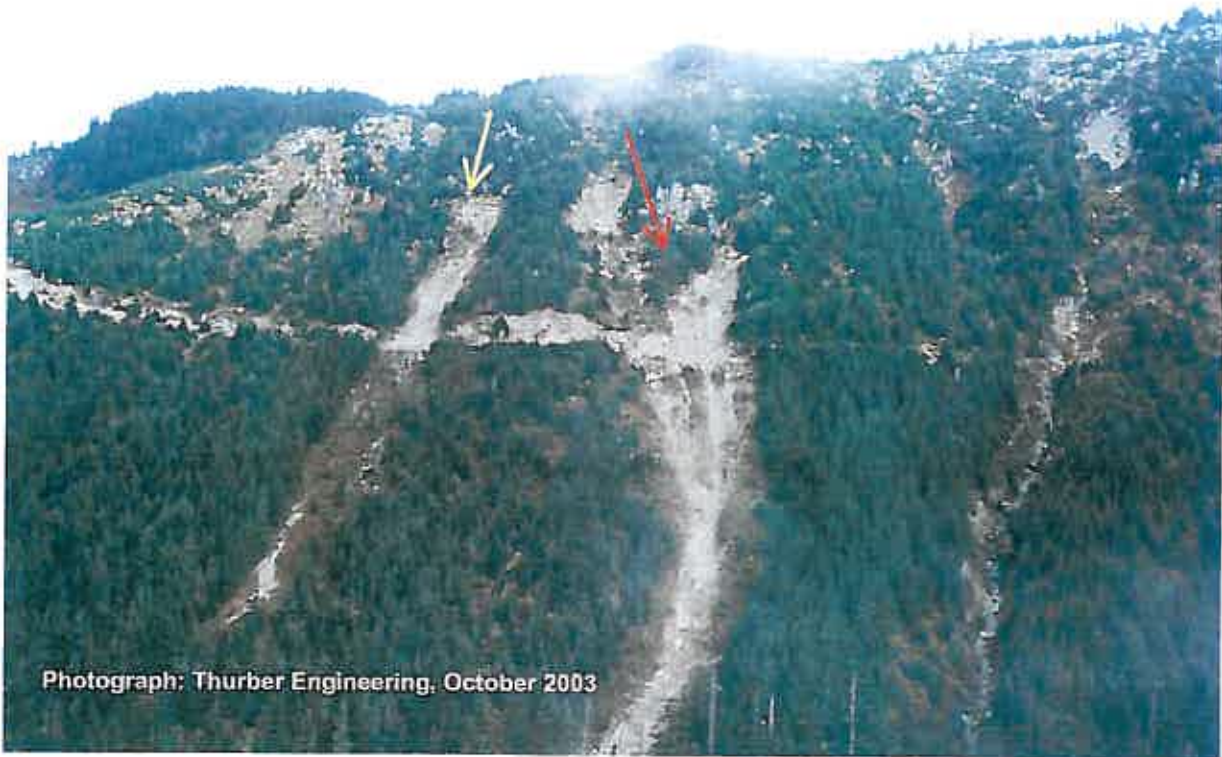
**Photograph 26.** The upper McNab Creek watershed. The photograph shows an older failure (yellow arrow) and a new debris avalanche (red arrow) that crossed a forest road and transformed into a debris flow.

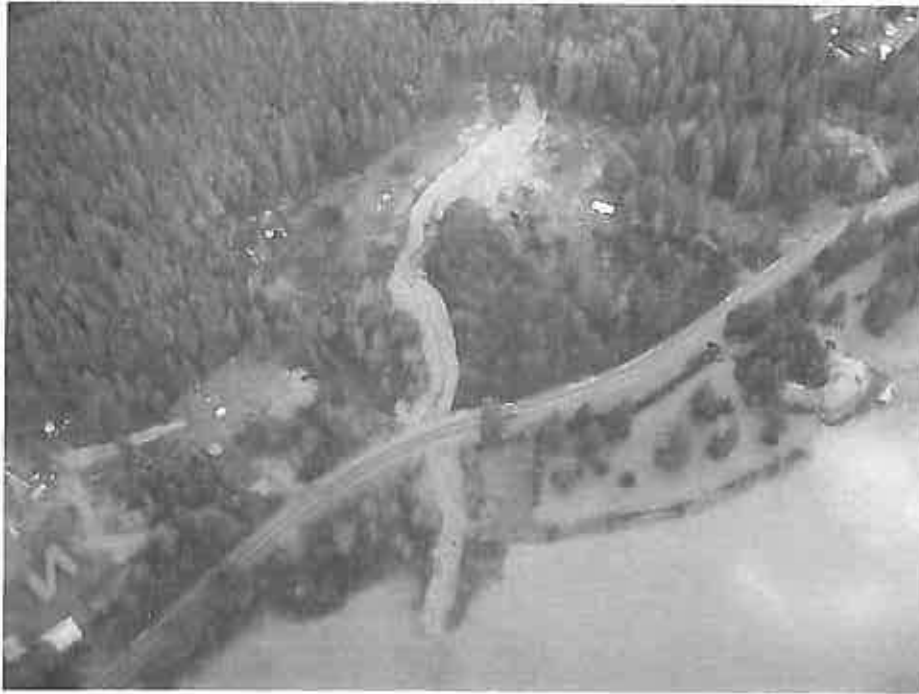
**Photograph 27**

The lower reaches of McNab Creek including Allan Lake. The reaches shown are at a gradient between 1 and 4 degrees and, therefore constitute an area of debris deposition. This area could be acquired and, in conjunction with a deflection berm be used to mitigate debris flow hazards on the McNab Creek fan.

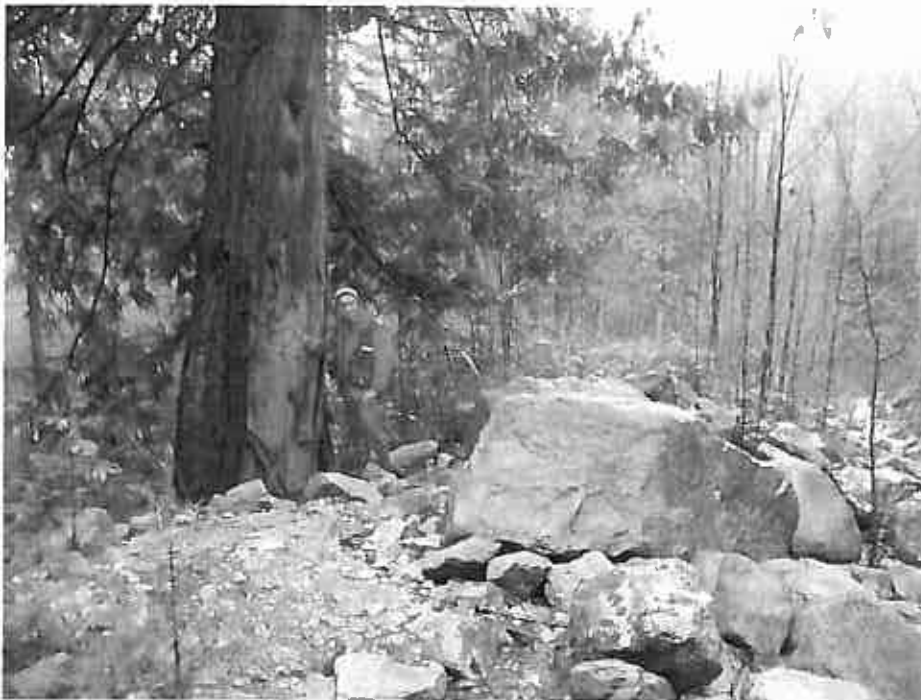
**Photograph 28**

This photo was taken at the fan apex of McNab Creek where a large cedar has been impacted by previous debris flows. This tree would be well suited for dendrochronologic analysis. Also clearly visible are the large boulder levees to the right of the person. Some work has been done in the past at this location to prevent debris flows from avulsing on the southern fan margins.
