**HATZIC PRAIRIE RIPARIAN  
PLANTING AND SEDIMENT CONTROL  
PROJECT**

**SECOND PHASE – SEDIMENT REMOVAL  
ALONG SAND REACH FROM  
DALE ROAD TO HATZIC LAKE**

**Fraser Valley Regional District**  
8430 Cessna Way  
Chilliwack, B.C.  
V2P 7K4

**Northwest Hydraulic Consultants**  
30 Gostick Place  
North Vancouver, B.C.  
V7M 3G2  
Phone: (604) 980-6011  
Fax: (604) 980-9264

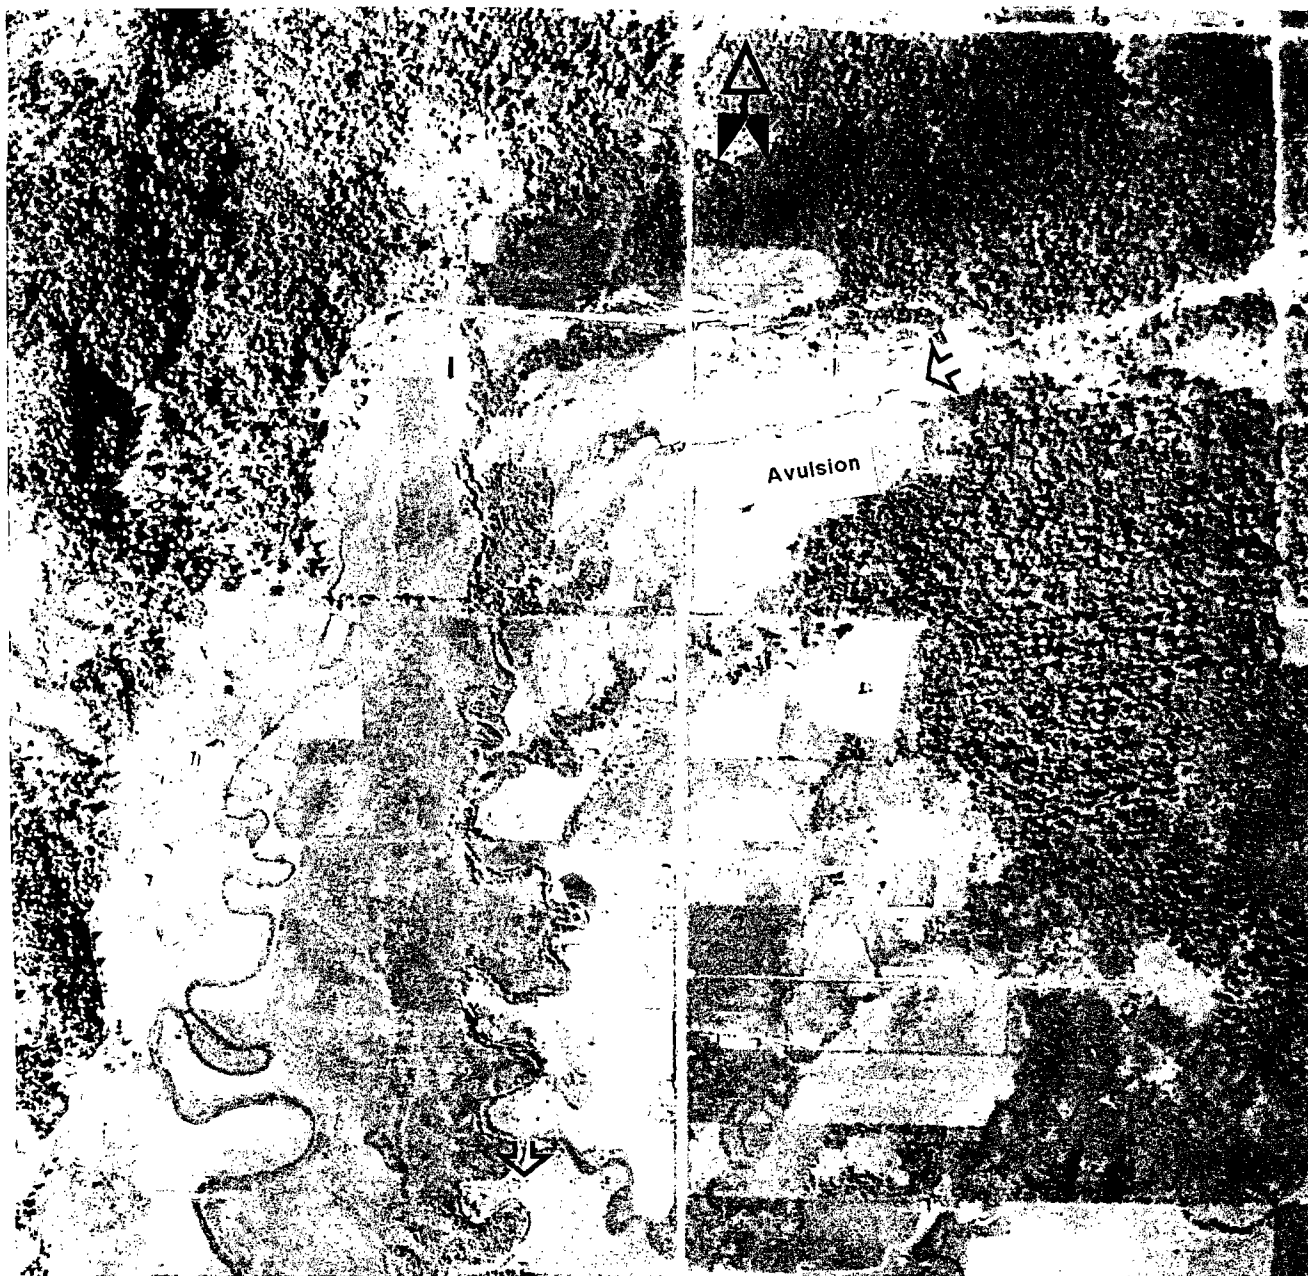
Lagace Creek in 1940 - AVULSION

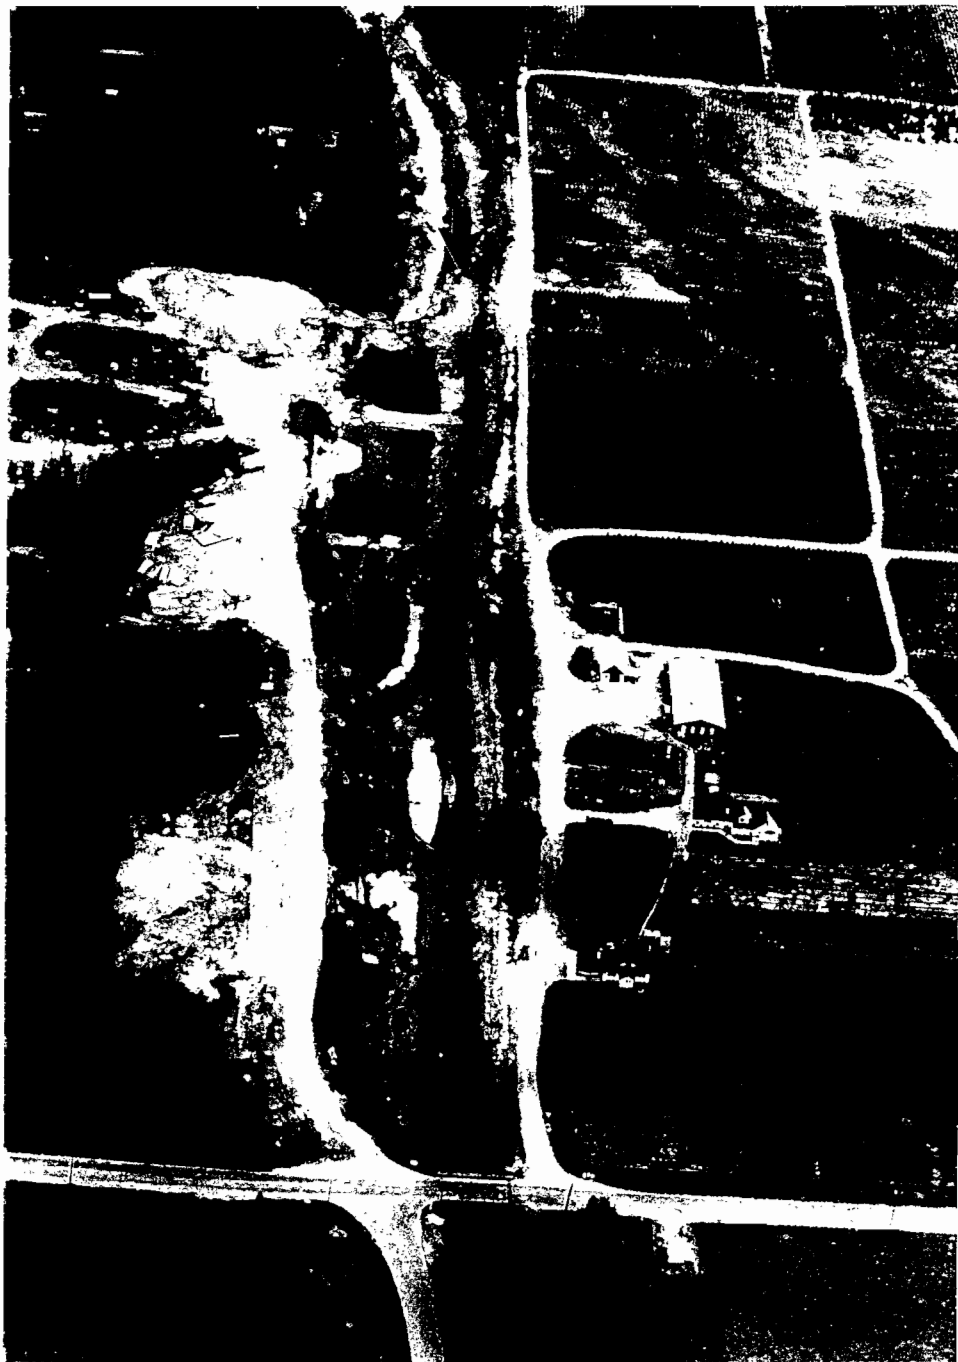
PHOTO NO. 1.1

Upstream view of three-basin  
gravel trap excavated just  
above the Farms Road Bridge.

In a previous brief report by Northwest Hydraulic Consultants (nhc 2001) several alternative sites were recommended for sediment removal in order to lower flood levels along the Pattison/Lagace Creek systems (see Figure 1.1 for location). The main site selected for a gravel trap was upstream of the Farms Road Bridge and this site was excavated during the month of September, 2001. The excavation involved the creation of three separate basins as shown in Figure 1.2 and Photo 1.1. This gravel trap, however, is only one component of a wider-scope flood and bed lowering plan.

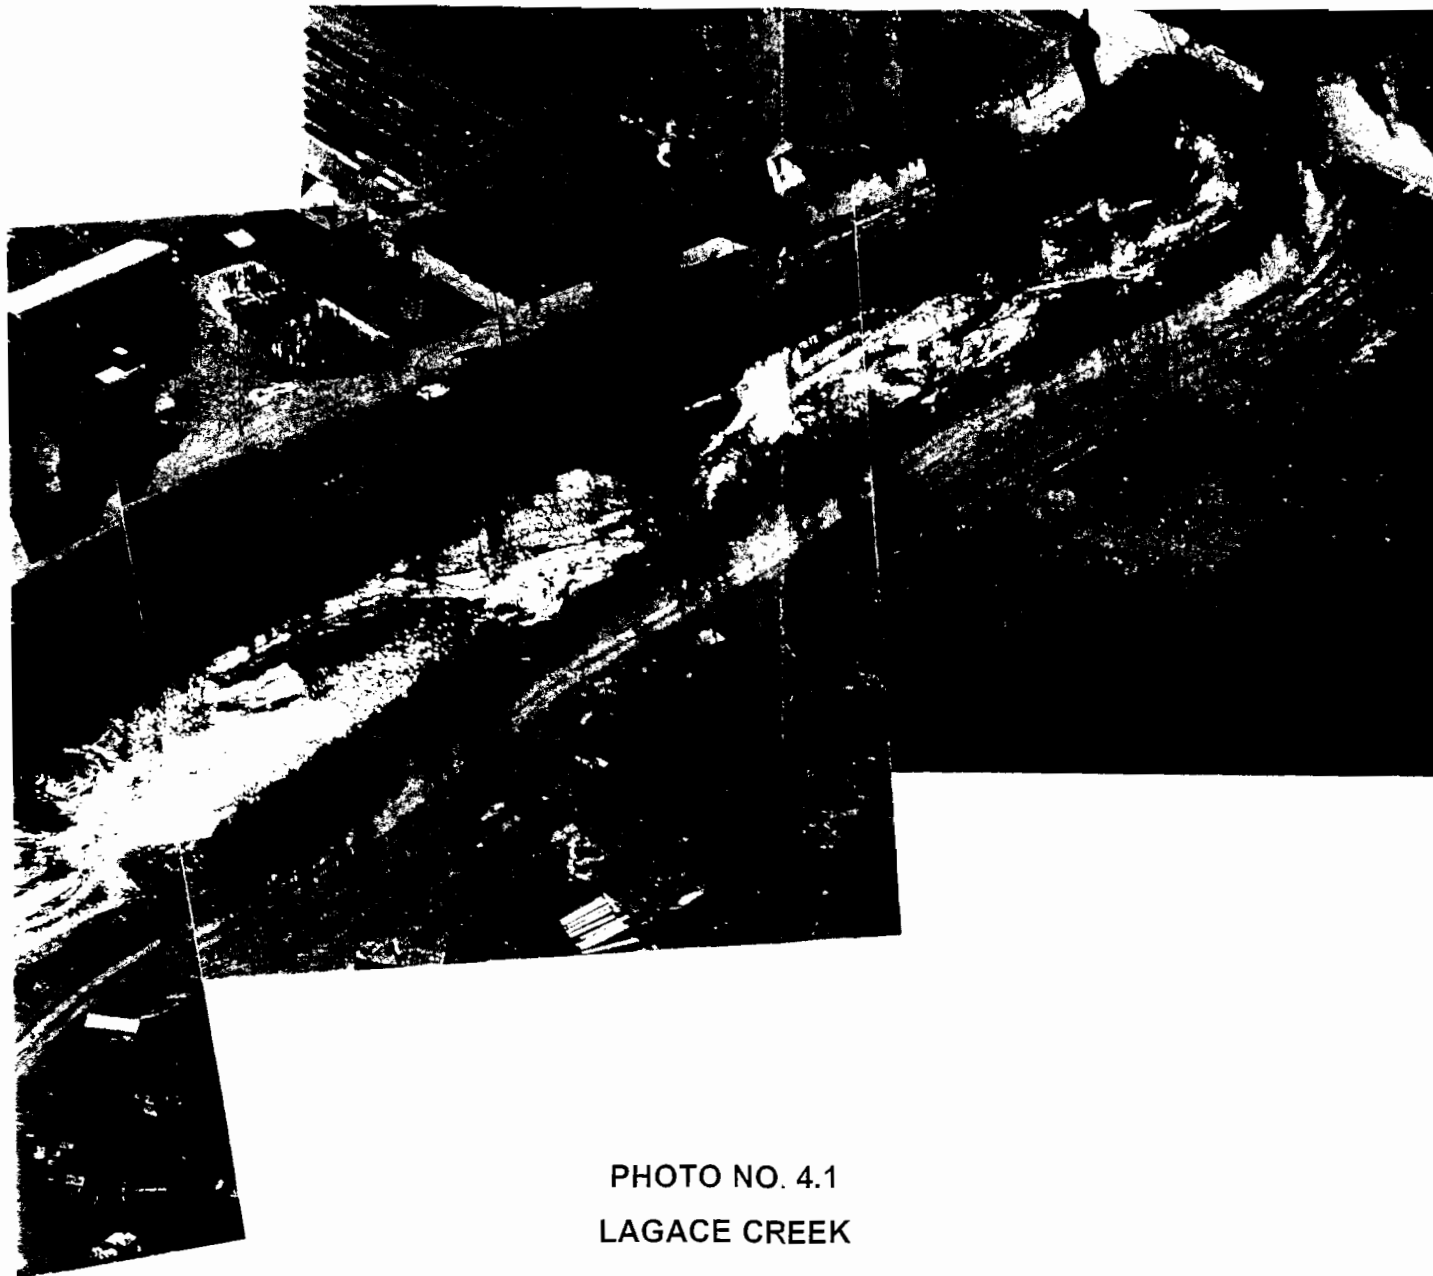
PHOTO NO. 4.1  
LAGACE CREEK

Condition of Farms Road Gravel  
Trap after several high flows.  
Pits #1 and #2 have partially  
refilled with sand and gravel.  
Flow is left to right.

The recently excavated Farms Road pit should be re-assessed for the existing condition of fish habitat and for possible enhancement. Recent overflights, see Photo 4.1 on November 7, 2001, show that the upstream two pits have partially filled with sand and gravel and several cross-berms have been eroded. Also, consideration should be given to establishing permanent cross-sections for monitoring of filling rates and co-operation from the landowner will need to be arranged. The Cascade Creek flood plan has already established cross-sections for monitoring and a maintenance manual has also been prepared for this creek.
