**Re: Post Construction Report - Lagace Creek Sediment Basins and Stream Complexing**

**Attachment 4. Photographs of the Legace Creek sediment basins and in-stream complexing.**

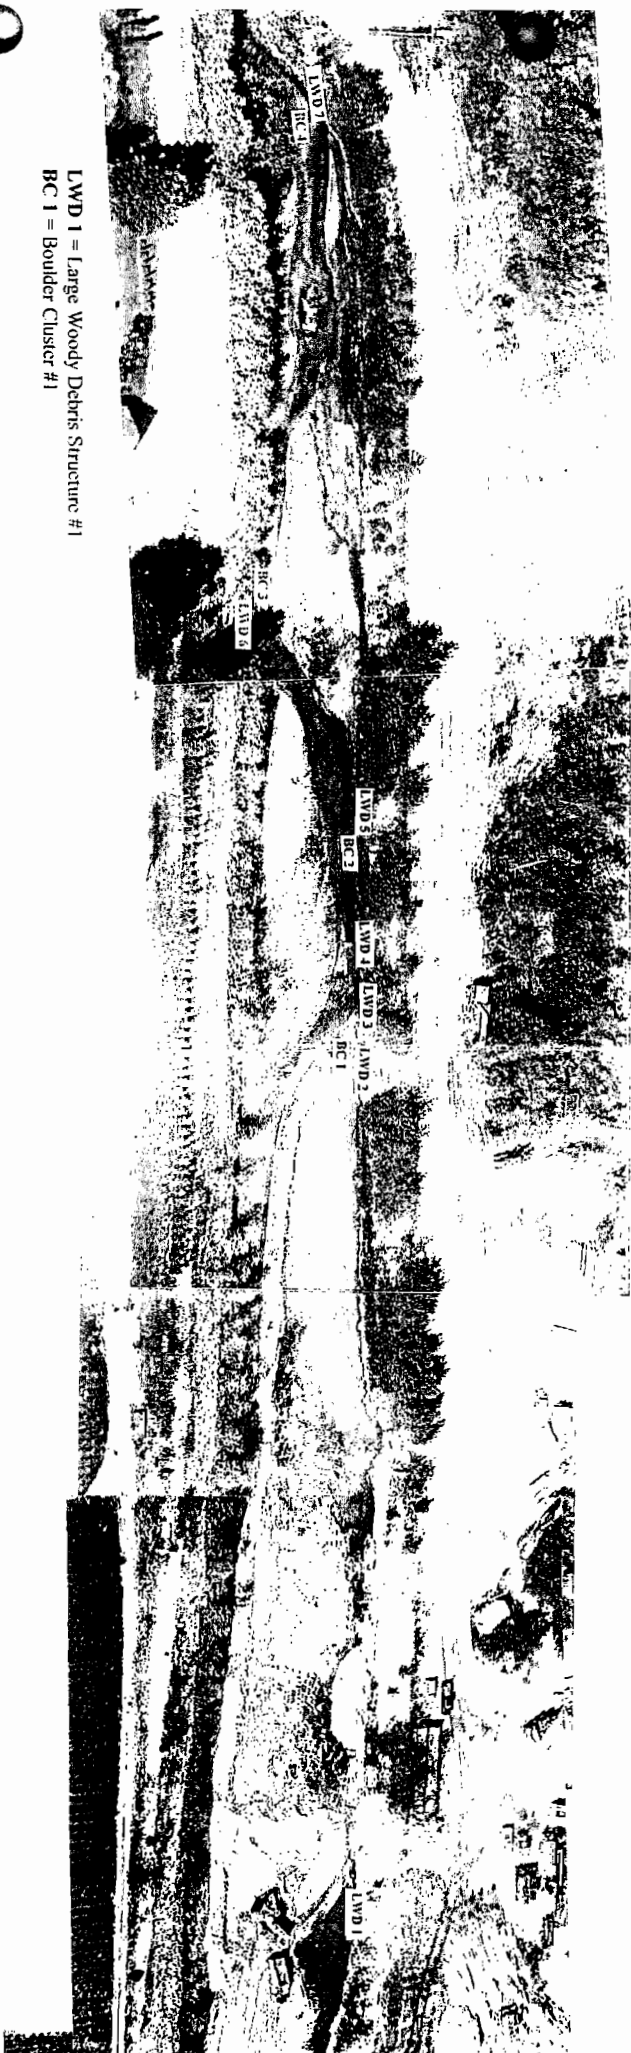
Attachment 5. Aerial photograph showing LWD and boulder cluster locations.

LWD 1 = Large Woody Debris Structure #1  
BC 1 = Boulder Cluster #1

All structures, except LWD Structure 1, were cabled and secured to lock blocks keyed into the bank. Lock blocks were buried for aesthetic purposes. See Attachment 5, for an aerial photo of LWD structure locations.

During the on site meeting on September 26, FOC requested boulder clusters in a variety of locations downstream of the sediment basins. Boulder clusters were placed in four agreed upon locations (Attachment 5). Following is a list of boulder clusters:
