# **Geologic Hazards and Risk Assessment, Yale, BC**

For  
Rick McDermid  
Manager of Development Approvals  
Fraser Valley Regional District  
tel 604-702-5000

By  
Pierre Friele  
Cordilleran Geoscience  
PO Box 612  
1021 Raven drive  
Squamish, BC  
V8B 0A5

March 9, 2010

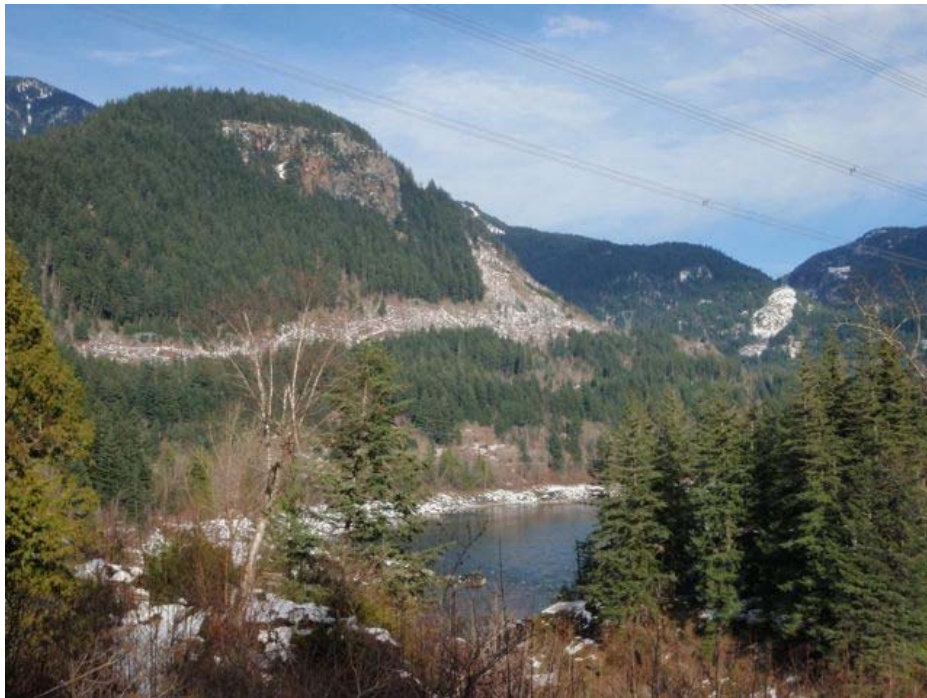
A significant feature on the slope is a 300 m wide, 150 m tall bedrock bluff lying between 350-500 m elevation. This feature is referred to as Spirit Caves bluff. The steep slopes below the wall are mantled with rockfall colluvium; with rubble-sized material higher up the slope and boulder sized material near the toe. At the foot of the slope is the outwash terrace described below. Thurber (1987) and Golder (2008) have mapped rockfall hazard on the Spirit Caves steeplands. Golder (2008) indicates a moderate rockfall potential.

Neither Thurber (1987) nor Golder (2008) mapped a potential rock avalanche hazard for the 300-m wide by 150-m tall Spirit Cave cliff (Photo 2). Airphotos BC79140:94, 95 (~scale 1/10,000) depict the cliff area in detail. On the airphotos there is no evidence of bedrock lineaments at or above the headscarp that would suggest tension cracking and the potential for a larger instability.

**Photo 2.** View towards Yale from south of town on the Trans Canada Highway showing the Spirit Caves cliffs that loom above the town. These present a rockfall hazard.

- 3) On the basis of apparent lack of postglacial catastrophic landslide activity from Spirit Caves cliffs, the areas downslope (Polygons 9-15) are considered to be potentially affected by very low ( $<1/10,000$  per annum) catastrophic landslide hazard. However, this hazard estimate is uncertain. Since much of the Yale OCP is in the shadow of this potential catastrophic landslide, any future development proposals that involve changes in zoning or require subdivision, thereby allowing an increase in population density, must be required to conduct a detailed assessment of this hazard and the potential risks.

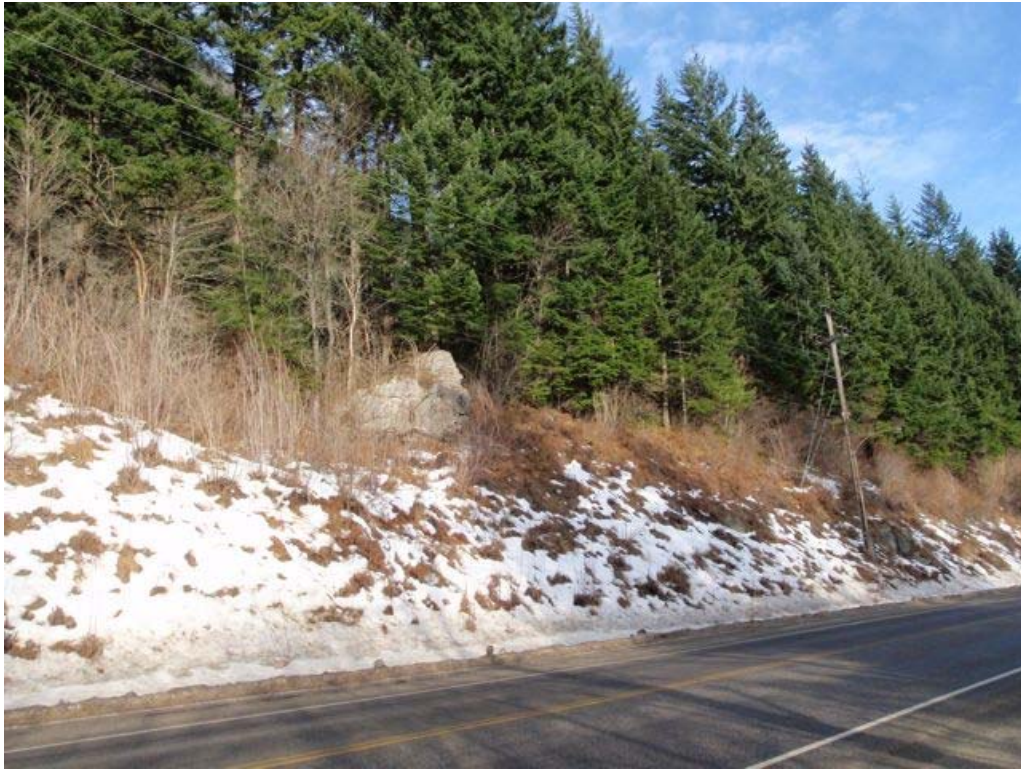
**Photo 3.** Cutbank on Trans Canada Highway showing 3-5 m diameter gneiss boulders within gravel matrix.

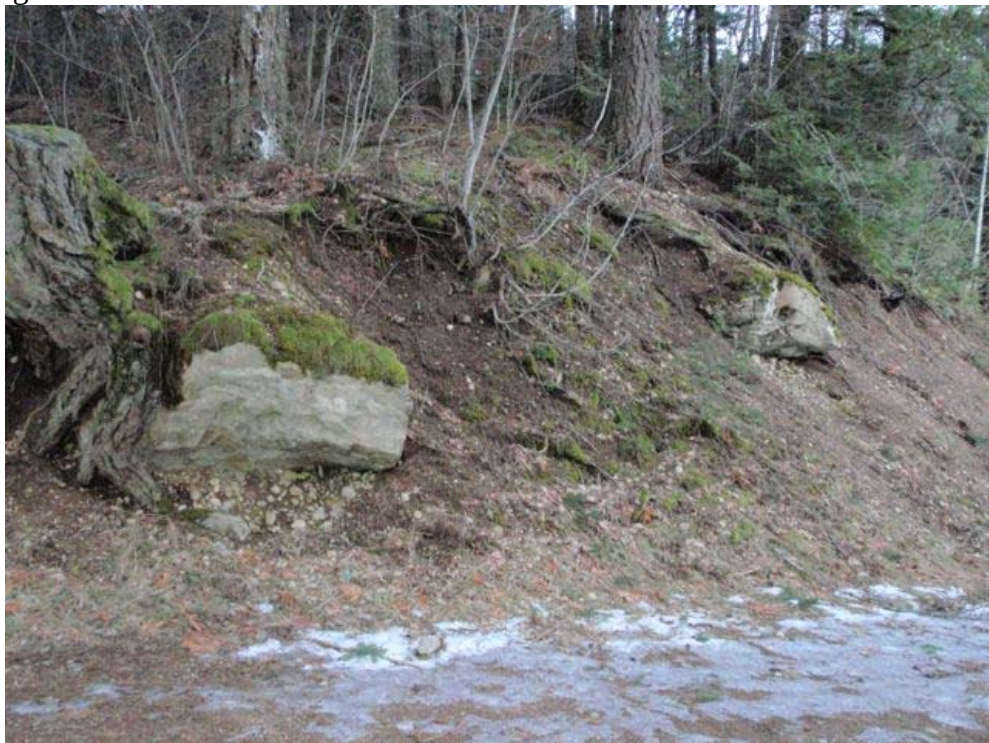
**Photo 4.** Cutbank in outwash terrace showing 1-2 m diameter gneiss blocks within gravel matrix.

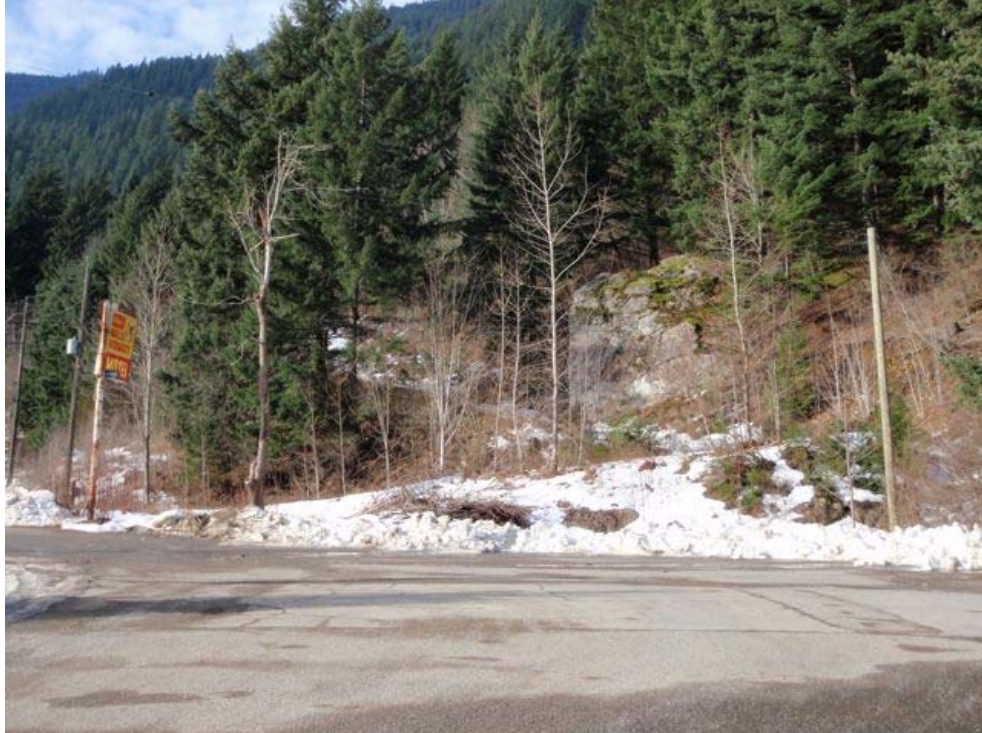
**Photo 5.** Toe of outwash terrace escarpment showing 10-m diameter block partially imbedded in gravel matrix.

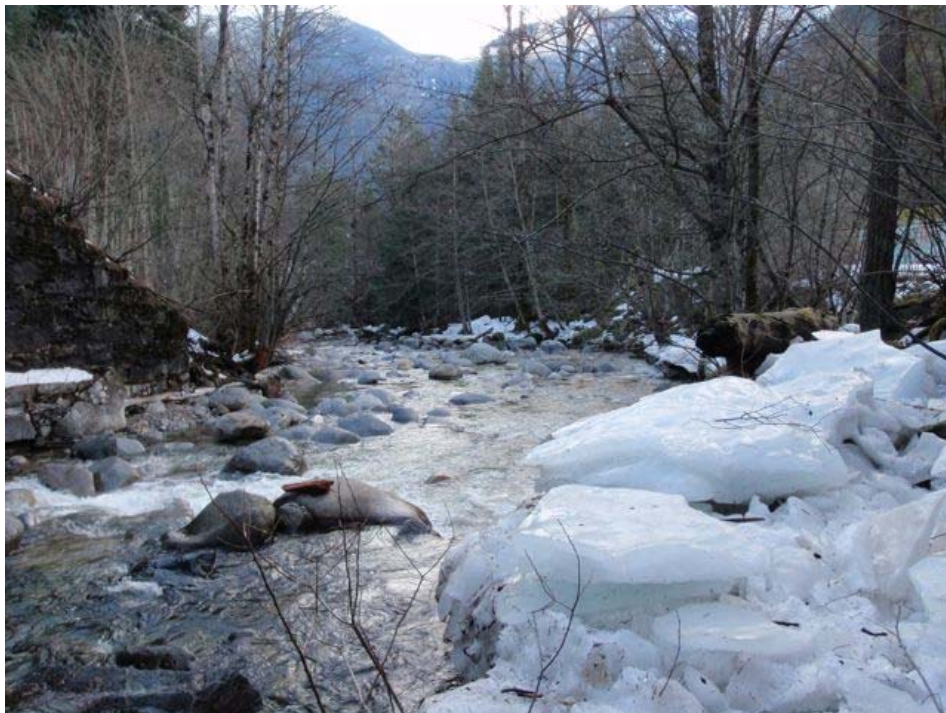
An additional hazard is ice jam flooding caused by rapid thaw and heavy rain following a prolonged period of cold. This type of weather occurred once in the 20<sup>th</sup> century, in 1935 (Table 3). This winter, the recent flood cycle (Jan '09) that followed a prolonged cold mobilized large ice blocks on Yale Creek (Photo 6), although no associated flooding occurred.

**Photo 6.** View from CPR bridge down Yale Creek. Note ice blocks on right bank. This indicates a potential ice-jam hazard. The Church Road area of Yale Town IR 1 is considered vulnerable to ice jam flooding.

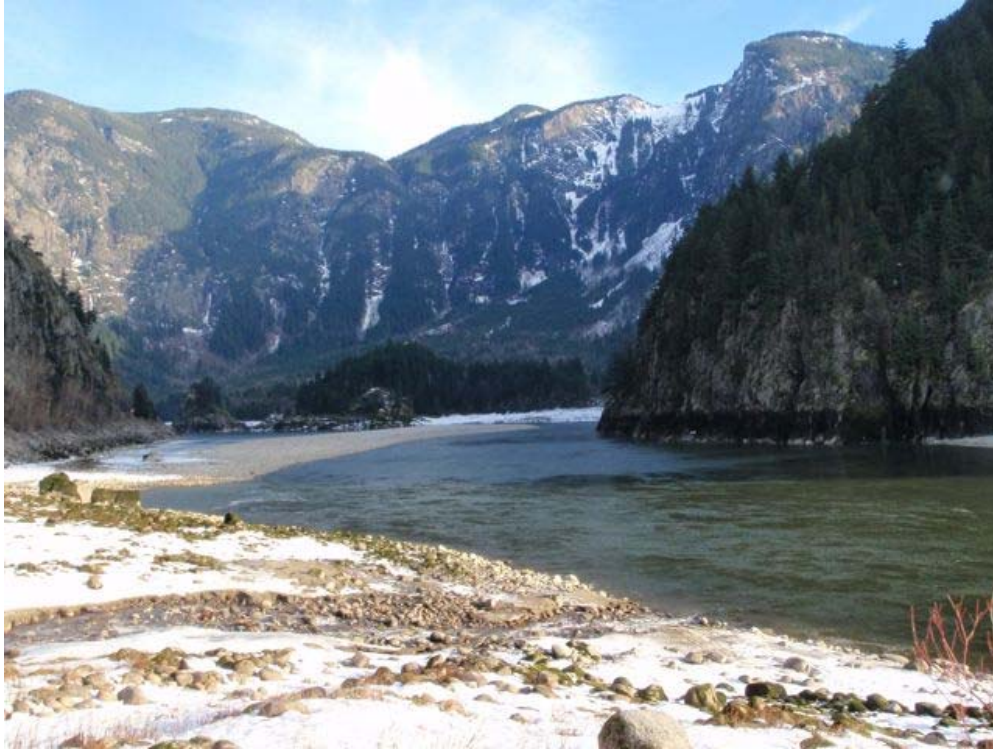
The Kuthlalth landslide headscarp (Photo 7) is likely the product of an extended landslide history spanning the Pliocene/Pleistocene. There is an angular, fresh appearing scarp on the southwest side of the headscarp, but there are no known remnant rock avalanche deposits at the foot of slope that may have been derived from a singularly large event. The origin of the South Yale blockfield remains enigmatic. Although fragmental rockfall occurs at the headscarp, which may trigger debris flows that affect CNR. There is no unequivocal evidence for large post glacial rock avalanches that have caused major interruption of the Fraser River with severe downstream affects. The potential for this hazard is considered uncertain.

**Photo 7.** View up Fraser River from Yale Creek, looking into the Kuthlalth headscarp.
