# WATERSHED REVIEW

## TACHEK CREEK WATERSHED

### Draft March 13, 2012

Ministry Contract No: CS12NRH-012

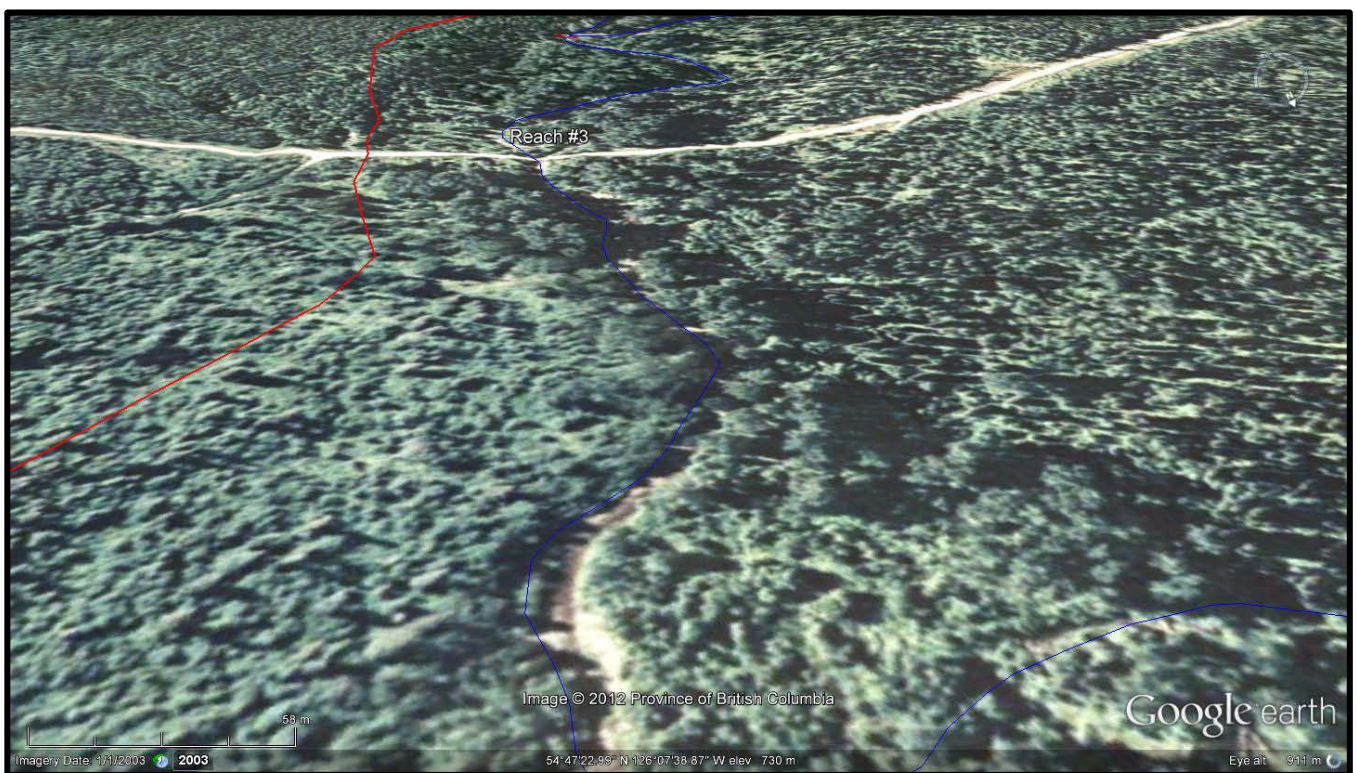
Figure 6. Google Earth image looking upstream along Reach #3 of Tachek Creek.

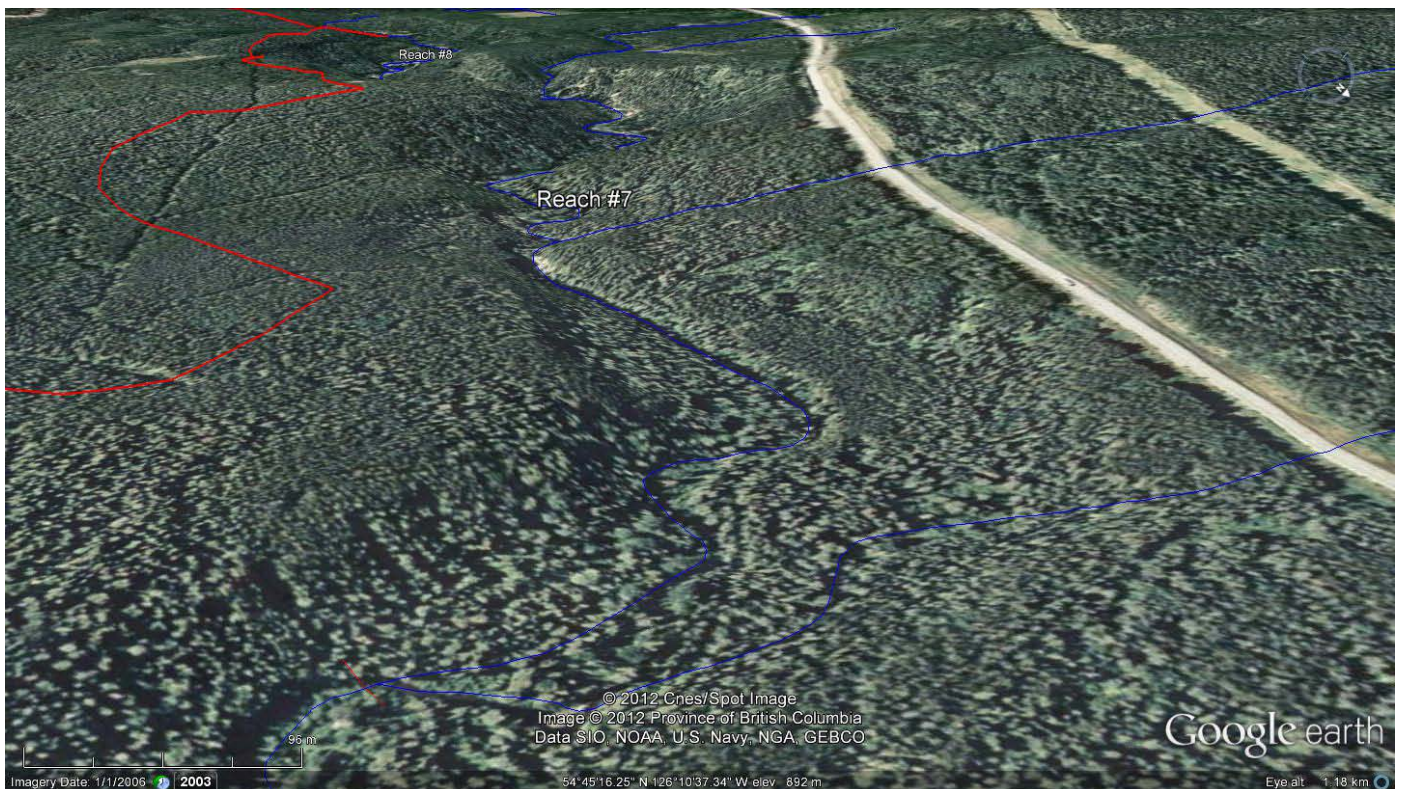
Figure 10. Google Earth image looking upstream along Reach #7 of Tachek Creek.

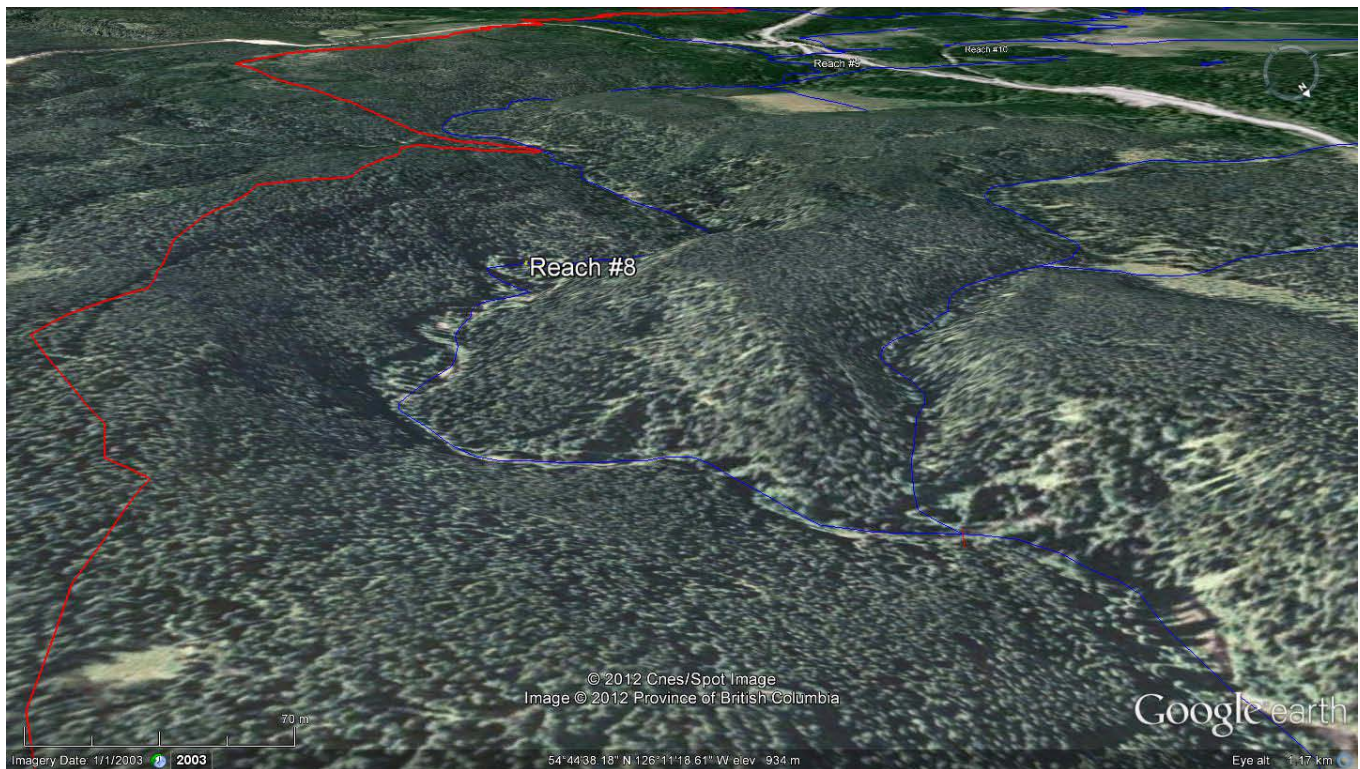
Figure 11. Google Earth image looking upstream along Reach #8 of Tachek Creek.

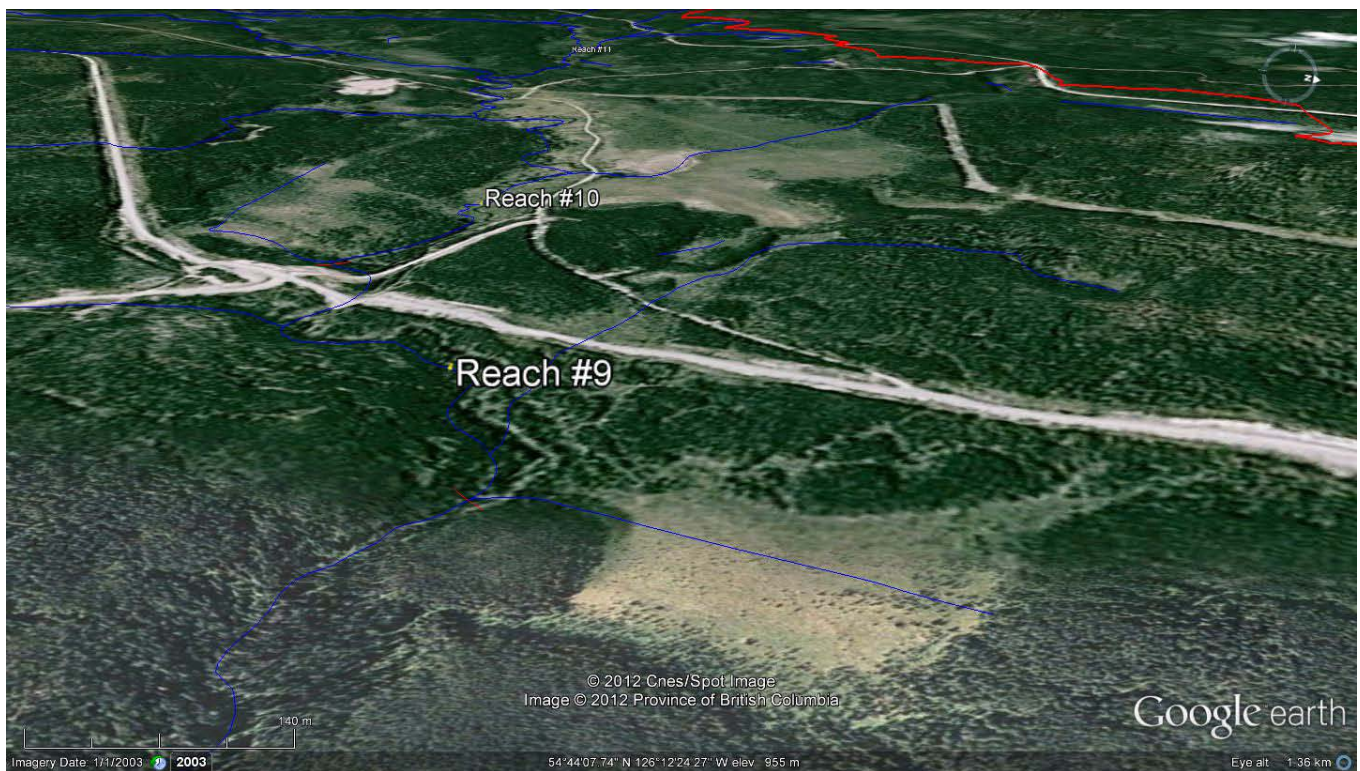
Figure 12. Google Earth image looking upstream along Reach #9 and 10 of Tachek Creek.
