# WATERSHED REVIEW

## UPPER NADINA RIVER WATERSHED

### Draft March 16, 2012

Ministry Contract No: CS12NRH-012

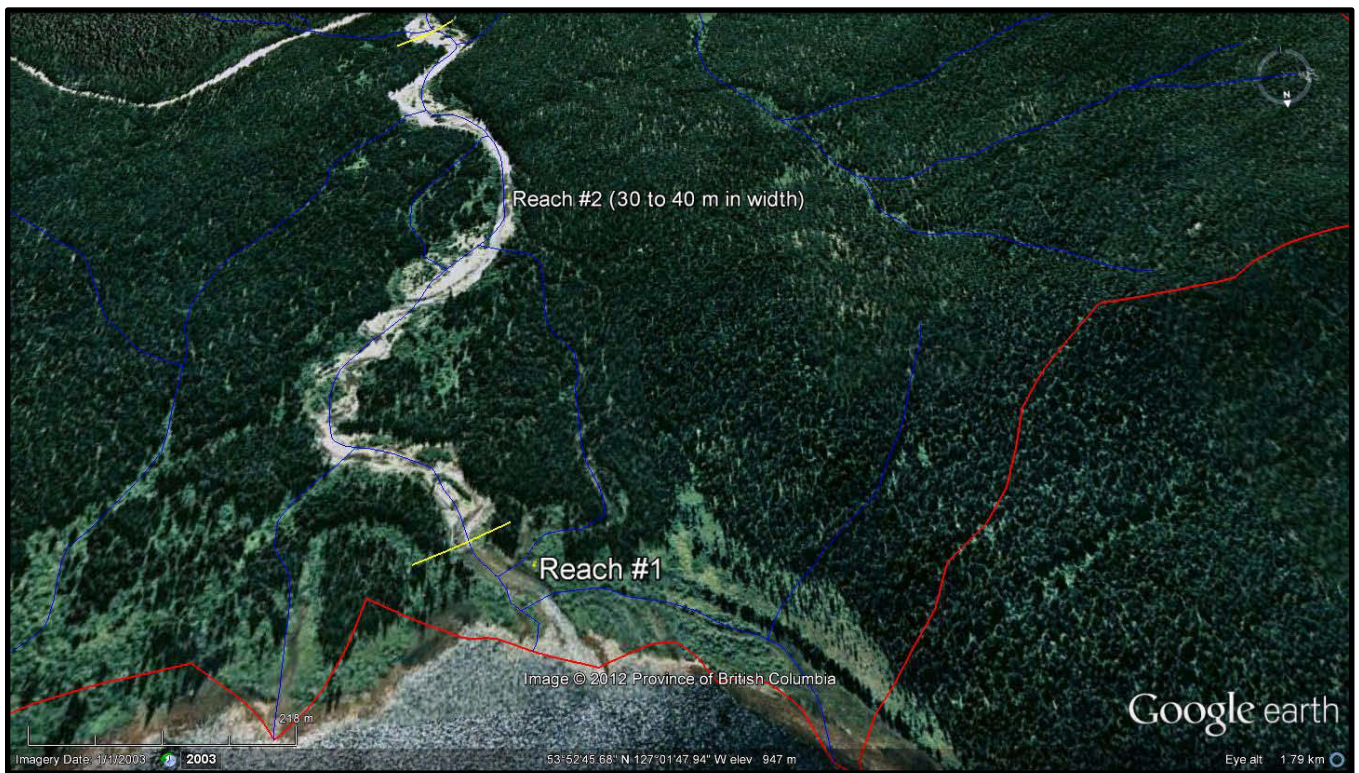
| Reach Number | Rosgen Stream Type | Reach Length (m) | % riparian logged (as interpreted from air photos) | Apparent stability and other comments (as viewed from air photos) |
|---|---|---|---|---|
| 1 | D3-Stable | 144 | 0.0 | Stable |
| 2 | D3-Stable | 1275 | 0.0 | Stable |

Figure 5. Google Earth image looking upstream along Reach #1 and 2 of Upper Nadina River.

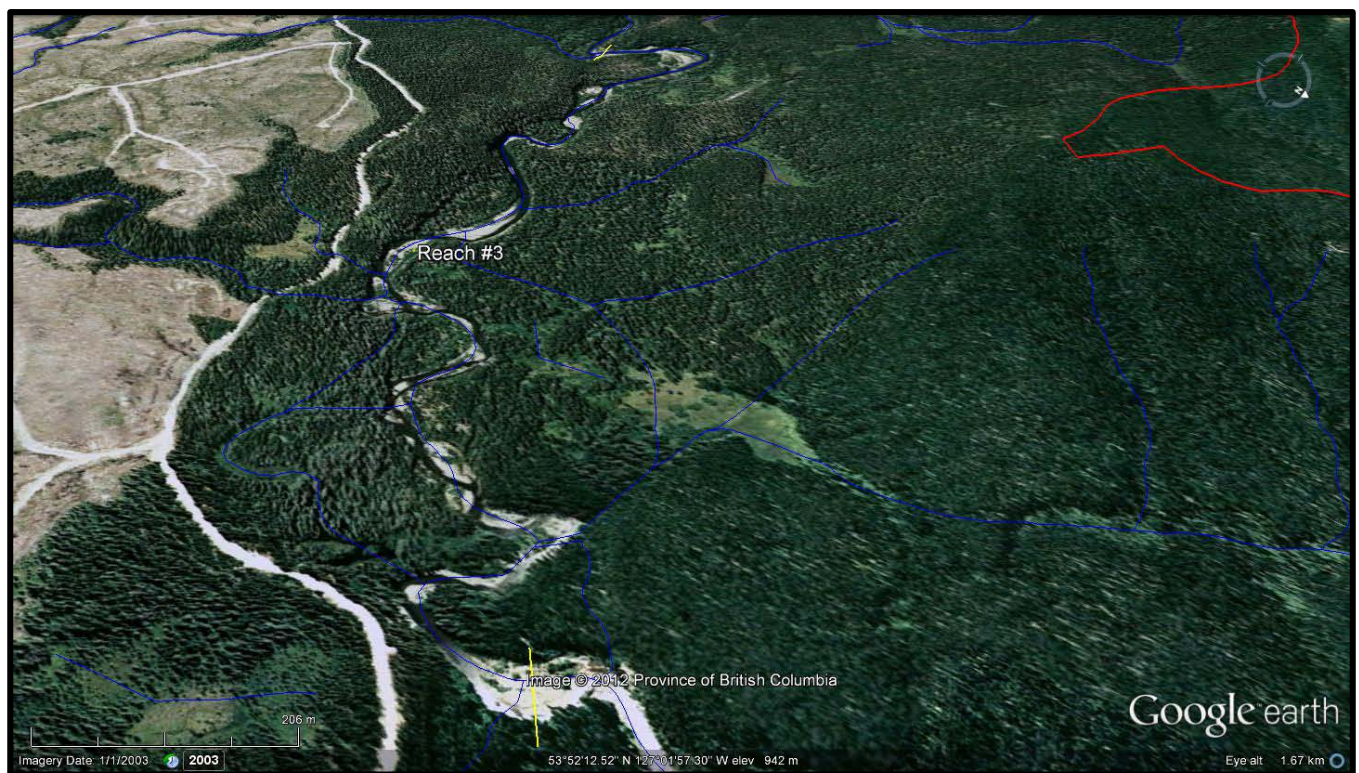
| Reach Number | Rosgen Stream Type | Reach Length (m) | % riparian logged (as interpreted from air photos) | Apparent stability and other comments (as viewed from air photos) |
|---|---|---|---|---|
| 3 | D3-Stable | 2100 | 0.0 | Stable |

Figure 6. Google Earth image looking upstream along Reach #3 of Upper Nadina River.

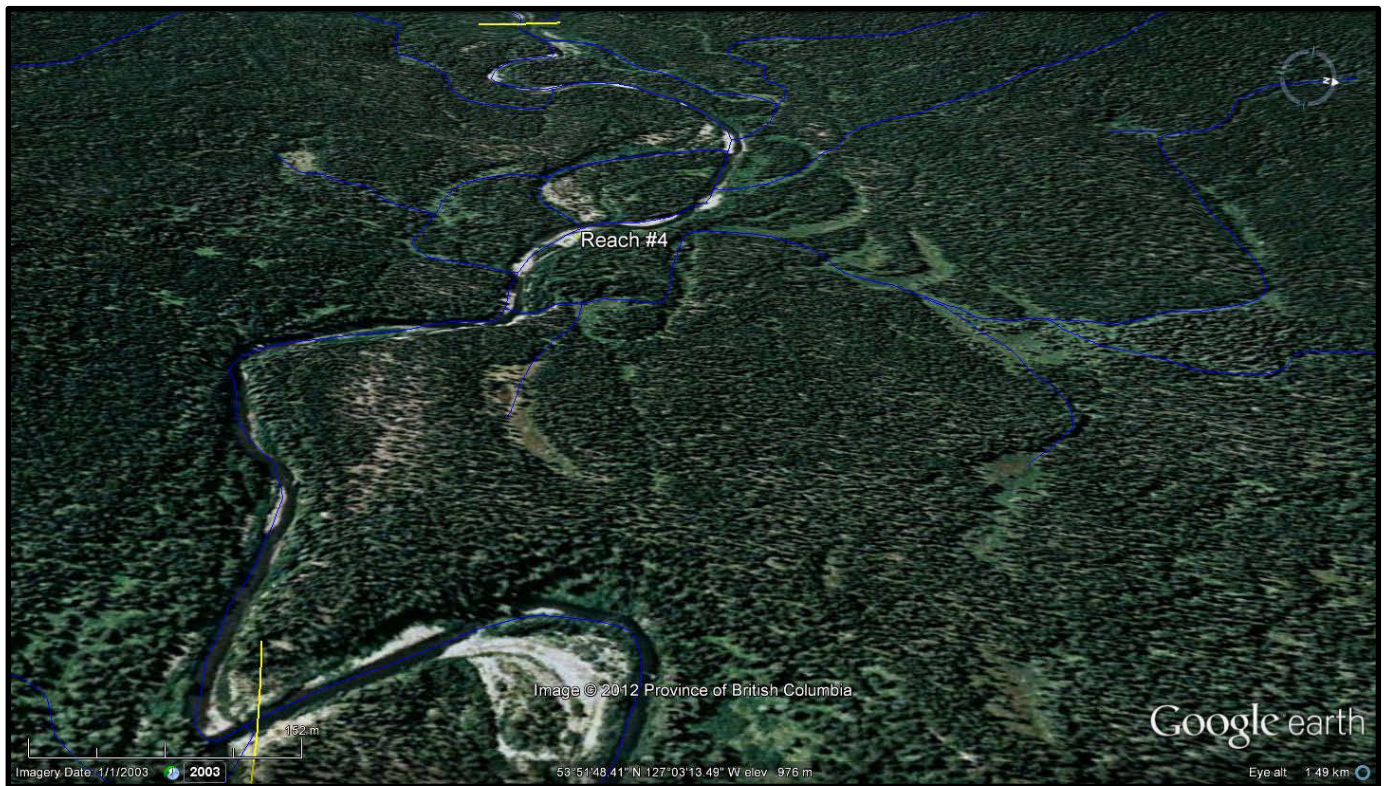
| Reach Number | Rosgen Stream Type | Reach Length (m) | % riparian logged (as interpreted from air photos) | Apparent stability and other comments (as viewed from air photos) |
|---|---|---|---|---|
| 4 | C4- Stable | 1969 | 0.0 | Stable |

Figure 7. Google Earth image looking upstream along Reach #4 of Upper Nadina River.

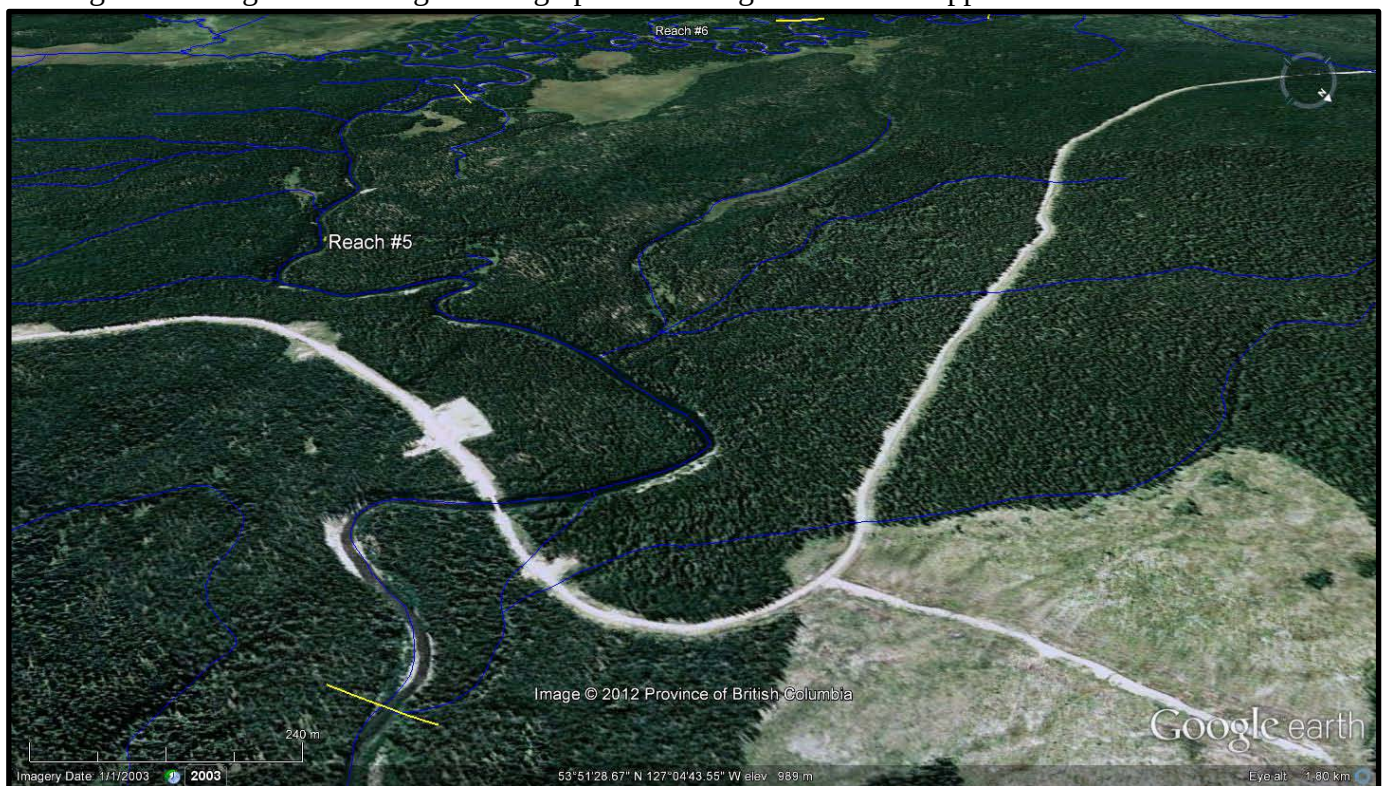
| Reach Number | Rosgen Stream Type | Reach Length (m) | % riparian logged (as interpreted from air photos) | Apparent stability and other comments (as viewed from air photos) |
|---|---|---|---|---|
| 5 | C4- Stable | 2955 | 0.0 | Very Stable |

Figure 8. Google Earth image looking upstream along Reach #5 of Upper Nadina River.

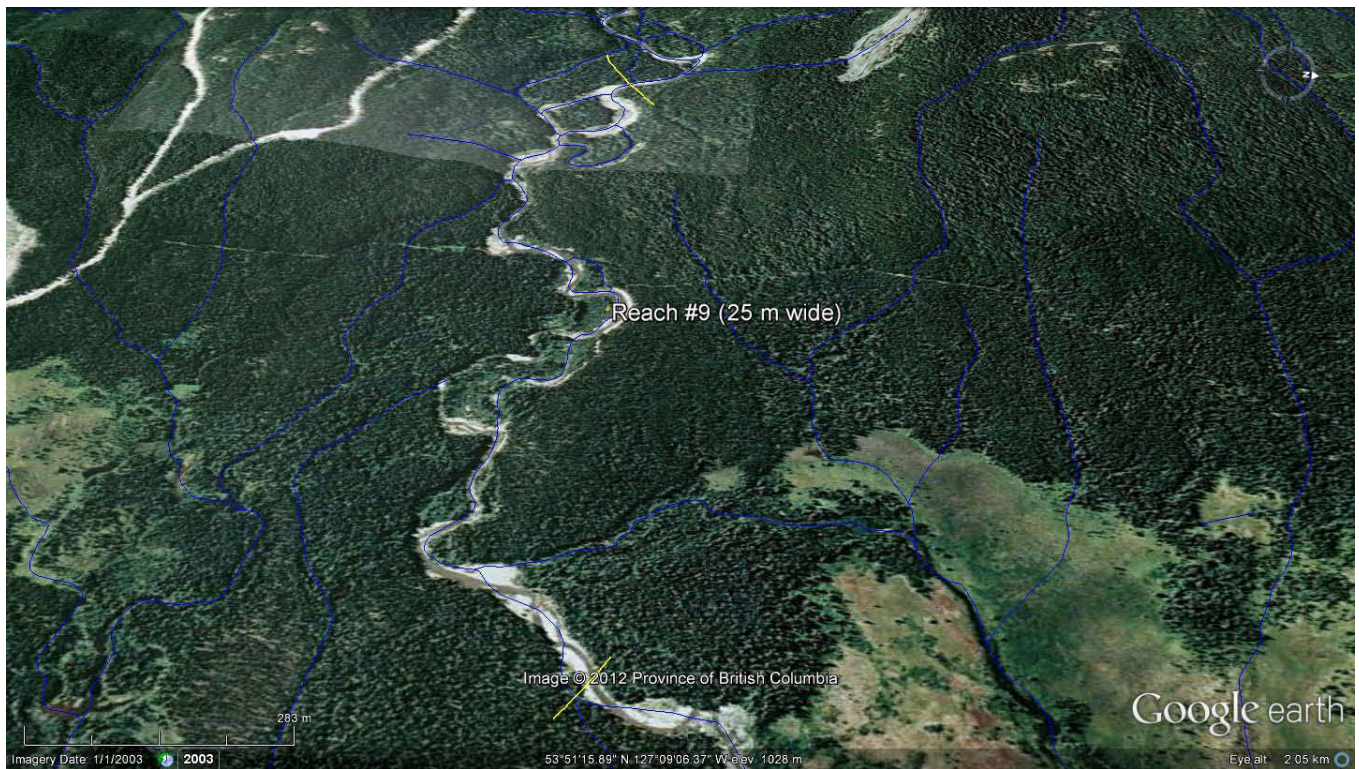
| Reach Number | Rosgen Stream Type | Reach Length (m) | % riparian logged (as interpreted from air photos) | Apparent stability and other comments (as viewed from air photos) |
|---|---|---|---|---|
| 9 | C3/D3- Mod unstable/disturbed | 1979 | 0.0 | Moderately De-stabilized |

Figure 11. Google Earth image looking upstream along Reach #9 of the Upper Nadina River.

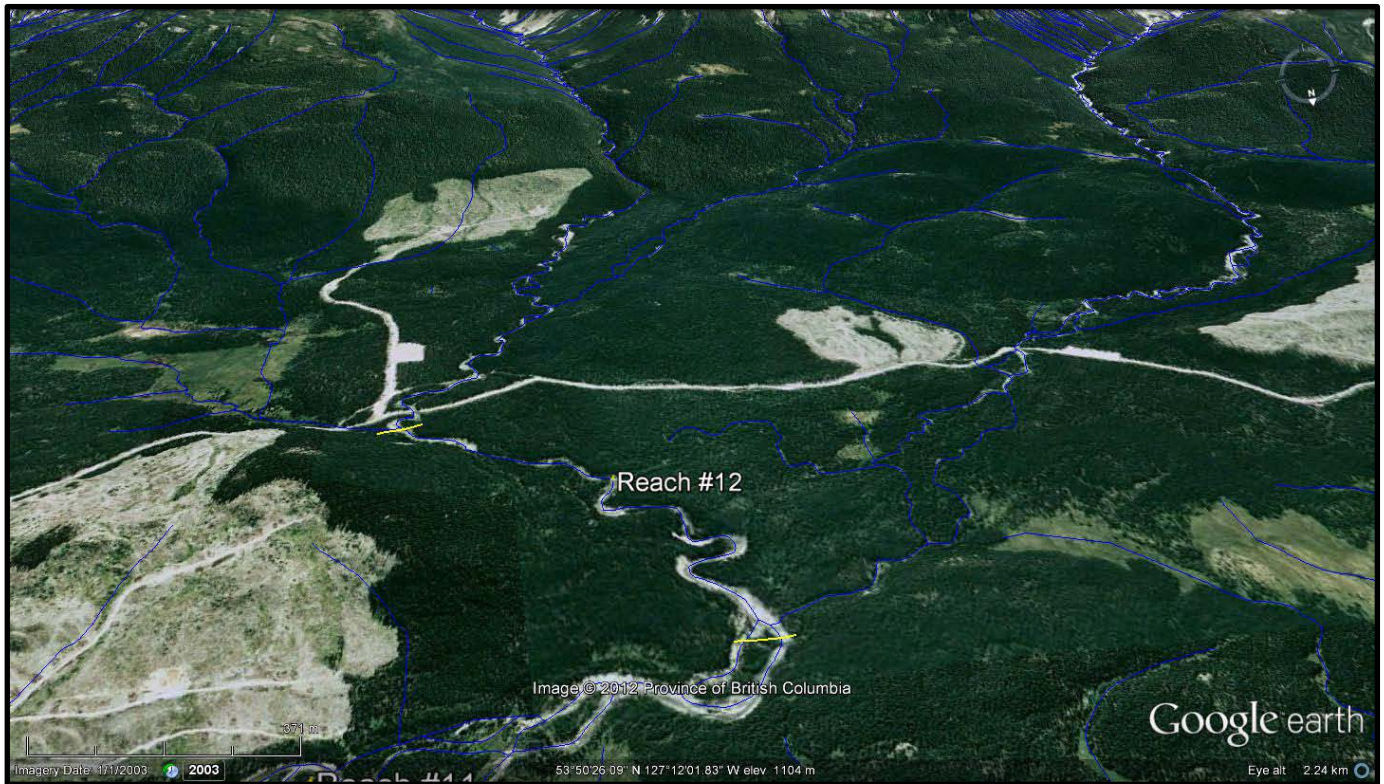
| Reach Number | Rosgen Stream Type | Reach Length (m) | % riparian logged (as interpreted from air photos) | Apparent stability and other comments (as viewed from air photos) |
|---|---|---|---|---|
| 12 | C3/D3- Mod unstable/disturbed | 1280 | 0.0 | Moderately De-stabilized |

The headwaters of the stream network begin in the alpine areas of the watershed in the Sibola Mountains. There are numerous small, steep channels that flow down v-shaped valleys and gullies to the flatter plateau area and then join together around Reach 12 (Figure 4). These steeper channel sections appear to transport large volumes of fine and coarse sediments to the

lower elevation reaches (Figure 13). Reaches 9, 10, 11 and 12 are active, braided channels that have been classified as a mix of Rosgen C3 and C4 channel types and also appear to transport large volumes of sediments. Reaches 8, 7 and 6 are low gradient meandering E4 type channels that flow through a network of wetlands and organic soils. This area appears to be a sink for much of the coarse sediments transported from the higher elevations (Figures 9 and 10). Reaches 5, 4 and 3 are a bit steeper C4/B4 channel types and appear to be quite stable. Reach 2 is a wide, braided channel that is very active and appears to be somewhat unstable. Reach 1 is the lowest reach and is short and flows directly into Nadina Lake. The lower five reaches are quite sensitive to increases in peak flows.

Figure 13. Google Earth image looking upstream along Reach #12 of the Upper Nadina River.
