QC-7911

BEACH/RENNELL HILL km

2019 Inspection

Crossing Name Pedestrian Bridge - Spirit Lake

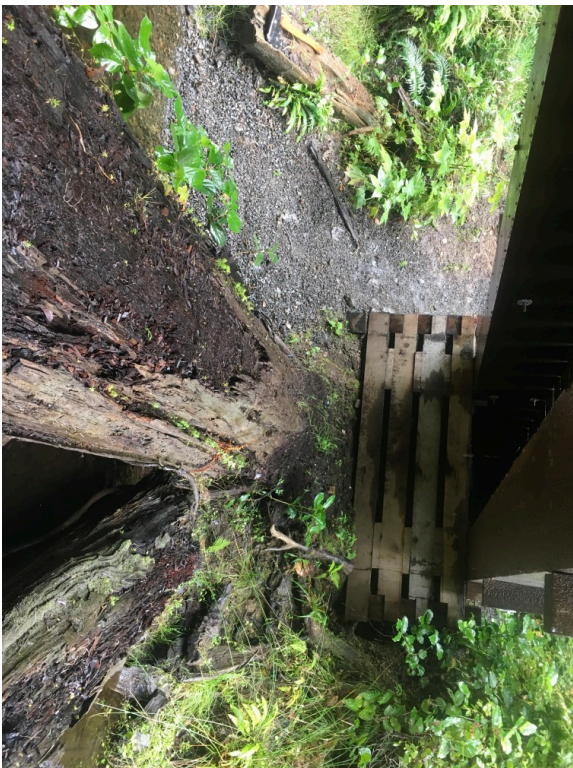
Right Bank Abutment when facing downstream

Log/Timber Cribs Good

Hardware Good 6"x6" timber cribs pinned at corners with rebar

| Item | Monitor Description | Frequency |
|---|---|---|
| 1 | Monitor settlement of cribs over long term. | Routine Inspection |

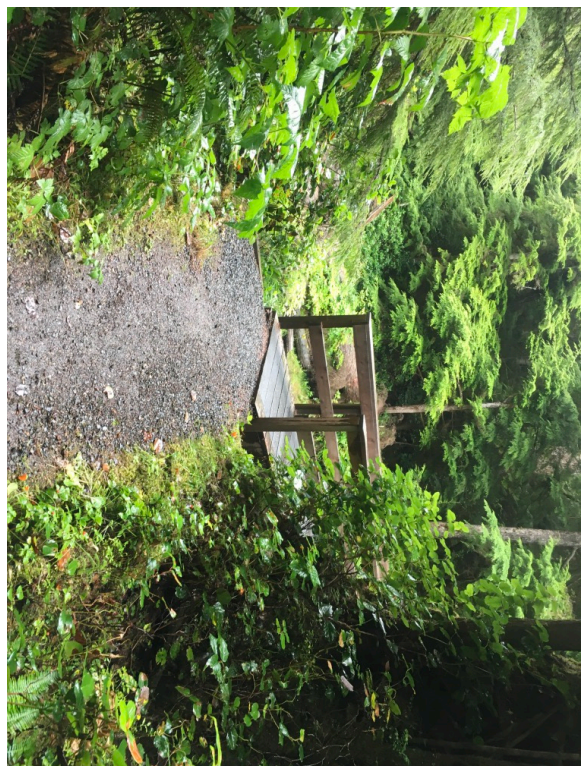
Bearing

Bearings Good
