# **The Meager and Pebble Creek Hotsprings near Pemberton, British Columbia: Guidance towards a Landslide Risk Management Plan**

Cordilleran Geoscience  
Box 612,  
Squamish, BC  
VON 3G0

March 17, 2017

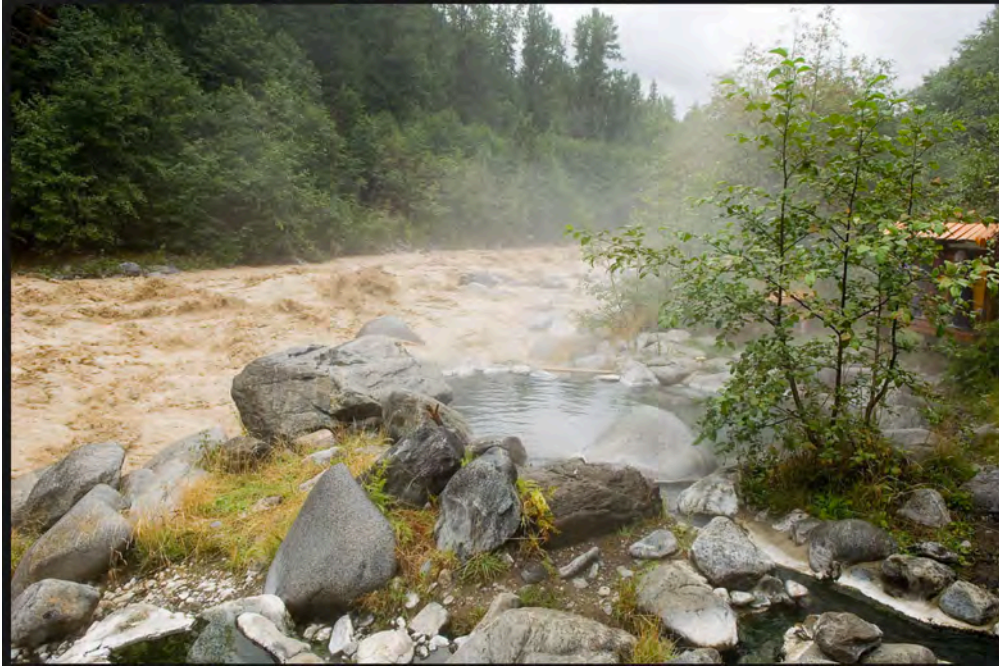
**Photo 1.** Meager Creek Hotsprings pool on the lower terrace is vulnerable to a full suite of hazardous events including floods, outburst floods, debris floods, debris flows and backwater inundation. The site has been destroyed by debris flow in the historic period, and the aggregate hazard is judged to be high to very high.

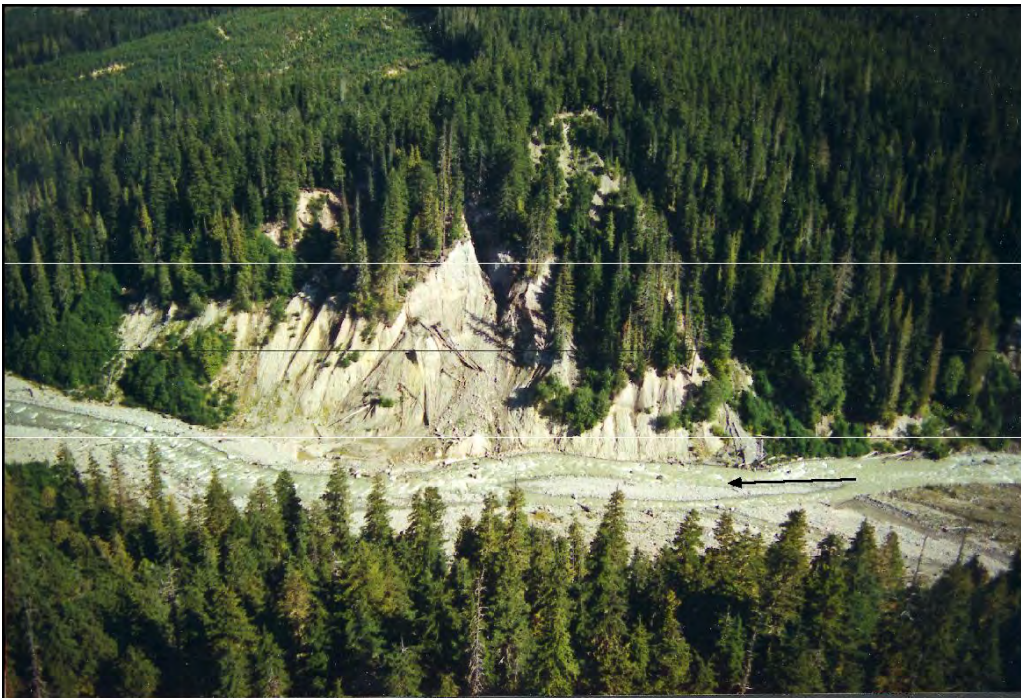
**Photo 2.** Bank failure in edifice collapse debris, 140 m tall and 200 m wide on the south bank of Meager Creek just upstream of Hot Springs Creek fan. Debris at the foot of slope has deflected the channel left, and sediment additions likely affect bed stability downstream.

Upstream of the Hotsprings site, Meager Creek is incised up to 60-140 m in landslide deposits (Photo 2). The steep slopes to the creek are mostly forested, but local slumping is common. Slumps may be tens of metres wide and extend the full height of the scarp, and may introduce abundant coarse woody debris and sediment into the channel. Sediment introduced by bank slumps and from debris flows from tributary basins results in high sediment loads that may lead to cycles of bed aggradation and degradation, which could make the pools more or less vulnerable to flooding.

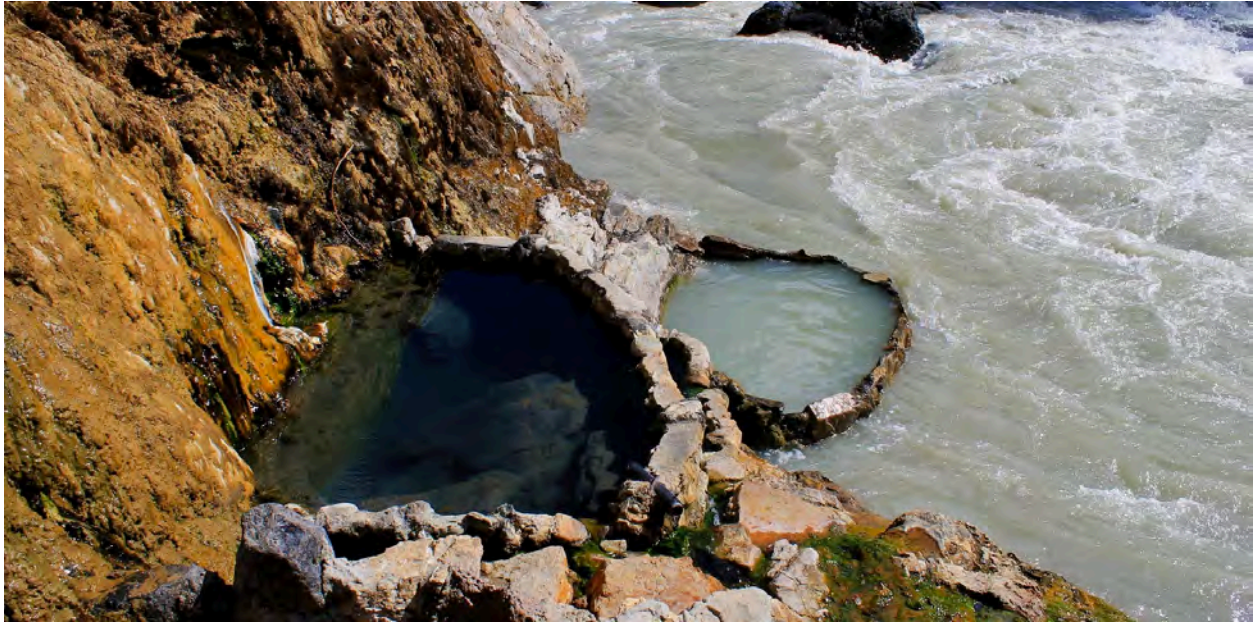
**Photo 3.** Pebble Creek hot springs pools awash by seasonal high water.

The trail into Pebble Creek Hotsprings is in part located on the active floodplain of upper Lillooet River, as are both the shallow pools and the main pools. These areas are affected by hydrologic flooding, with the lowermost of the main pools being flooded out probably yearly (Photo 3). The sections of trail on the active floodplain and the pools are judged to be affected by very high to high flood hazard (Table 1).

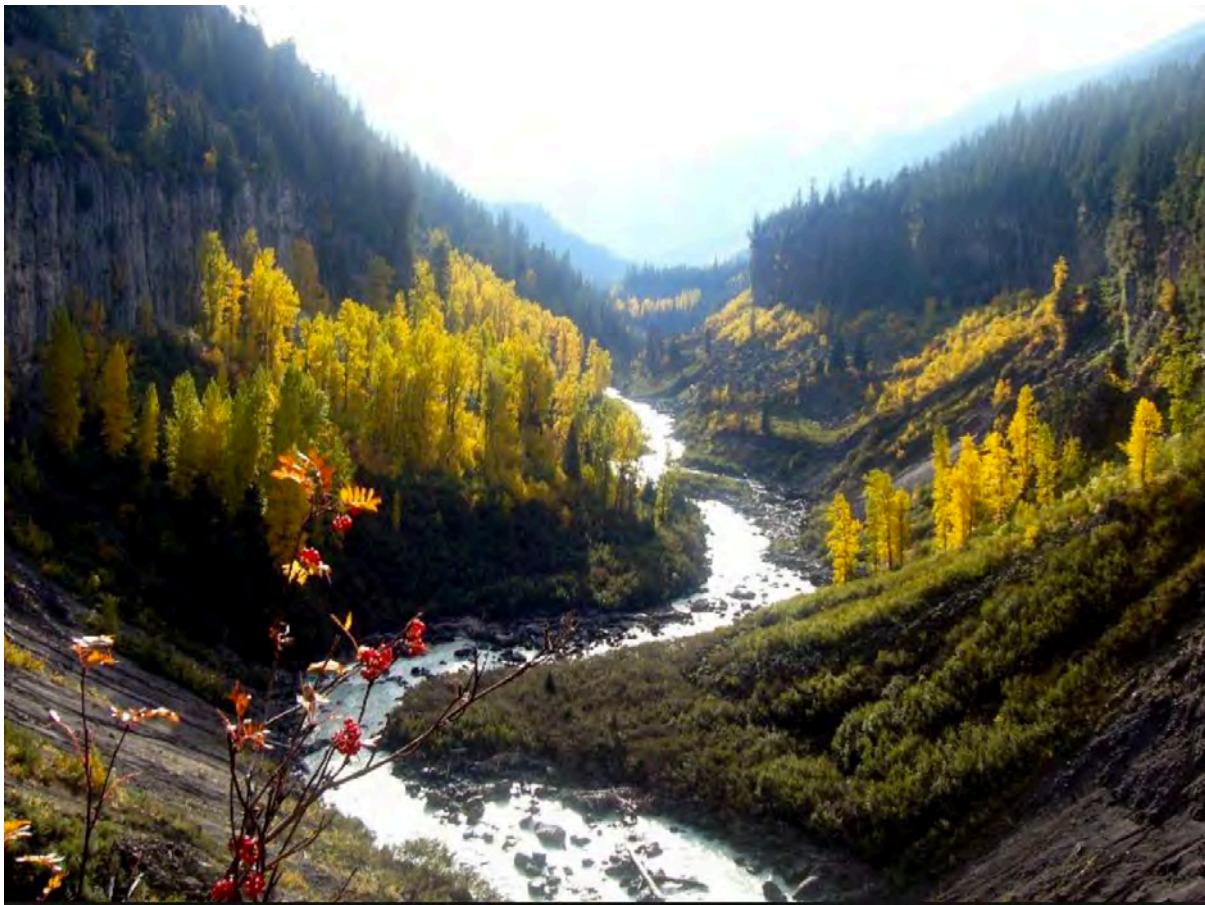
**Photo 4.** View down the upper Lillooet River canyon showing steep slopes directly connected to the river. Note the colluvial cone affected by snow avalanche on the right foreground, undercut toe slopes. A large slide first noted in 1962 affected the river left foreground.

As with Meager Creek, the reach of upper Lillooet River directly upstream of the hotsprings is confined in a bedrock canyon with steep unstable banks up to 260 m tall (Photo 4), with direct connectivity to the river. A large failure encompassing the entire escarpment height was identified on 1962 air photos (Knight Piesold 2010) on the north escarpment wall (Figure 5). Slides from the escarpment slope are judged to have high (Table 1) potential for channel impact and associated effects on channel stability.

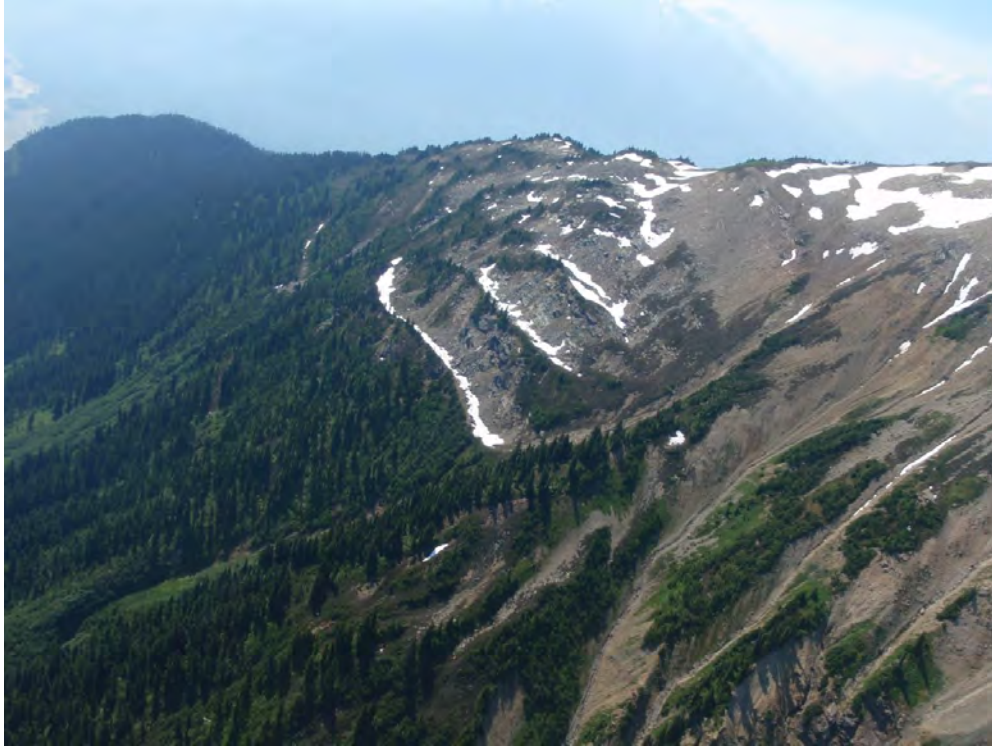
**Photo 5.** View south of the sagging slope SE of the peak of Mount Meager. The stability of these features has not been assessed.

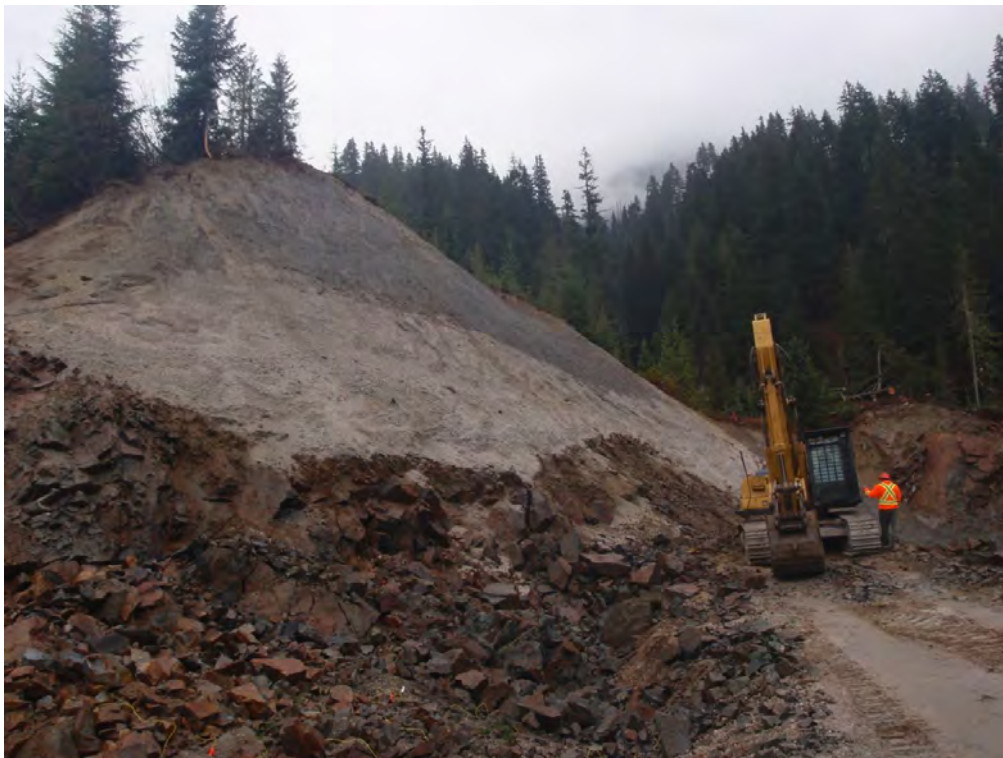
**Photo 6.** 35 m tall exposure of Pebble Creek Formation on the bush side abutment of the Truckwash Creek FSR bridge. Rock avalanche debris (grey) overlying tephra (white).

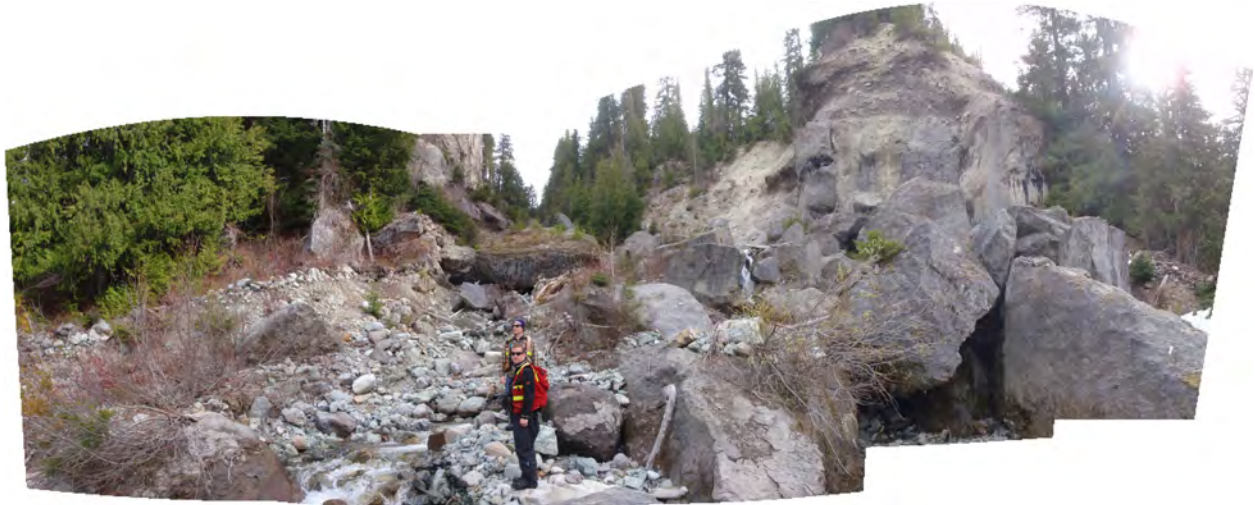
**Photo 7.** Truckwash Creek. View upstream at footbridge crossing area. Truckwash Creek is vulnerable to debris floods, periodic debris flow, and rockfall detached from the canyon walls. Also, Class 1 snow avalanche from ravine sidewalls may affect the crossing.

Truckwash Creek has incised a deep notch in the canyon sidewall formed in the Pebble Creek Formation. On the downstream side there are large (multi-metric) blocks that have fallen from the canyon wall (Photo 7). Trail descriptions available on the internet indicate an active rockfall hazard at this site: “we experienced rockfall when we arrived here; the rocks were fist-sized and were flying across the trail, making the area hazardous” ([www.ashikaparsad.com](http://www.ashikaparsad.com)). Further, debris flow on Truckwash Creek could destroy the footbridge (Photo 8).

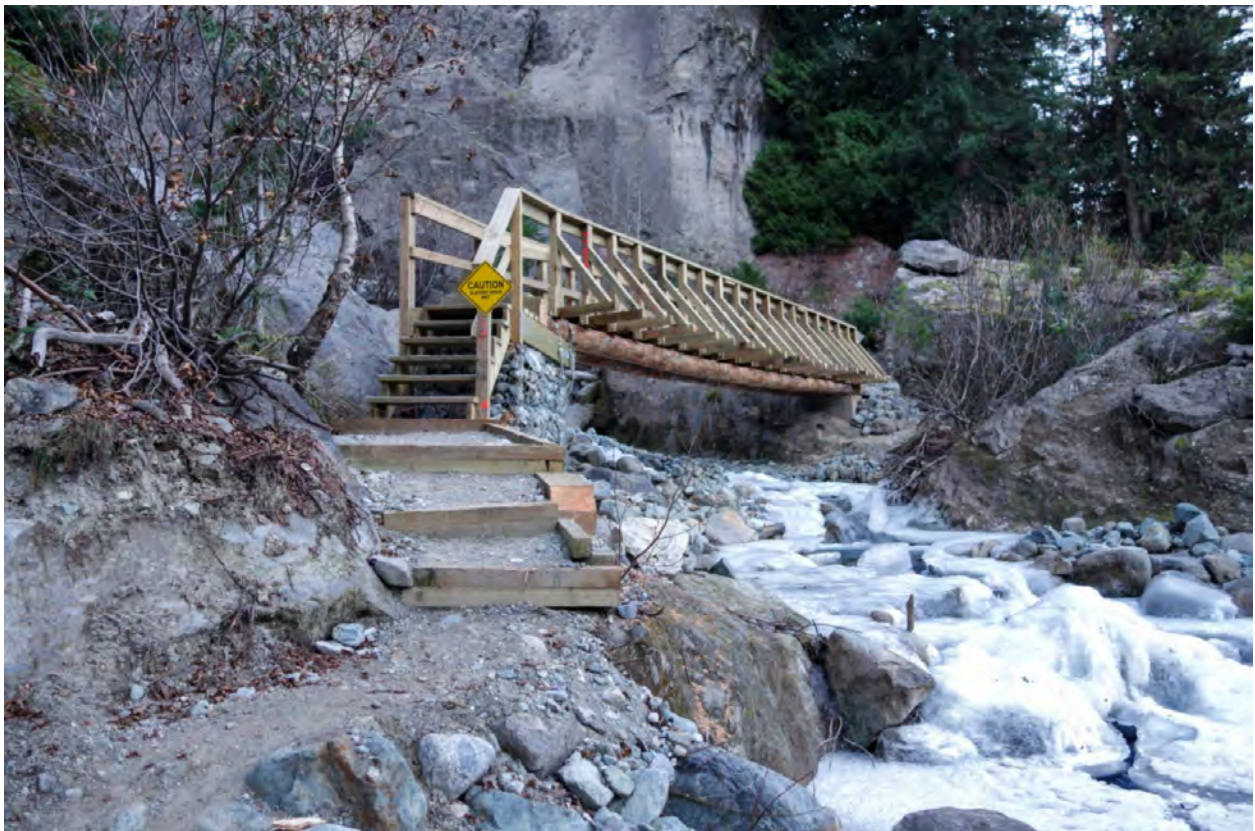
**Photo 8.** The Truckwash Creek footbridge. The bridge may be destroyed by debris flow activity. Further small, Class 1 snow avalanche from the left ravine sidewall may affect the crossing site and damage the bridge.

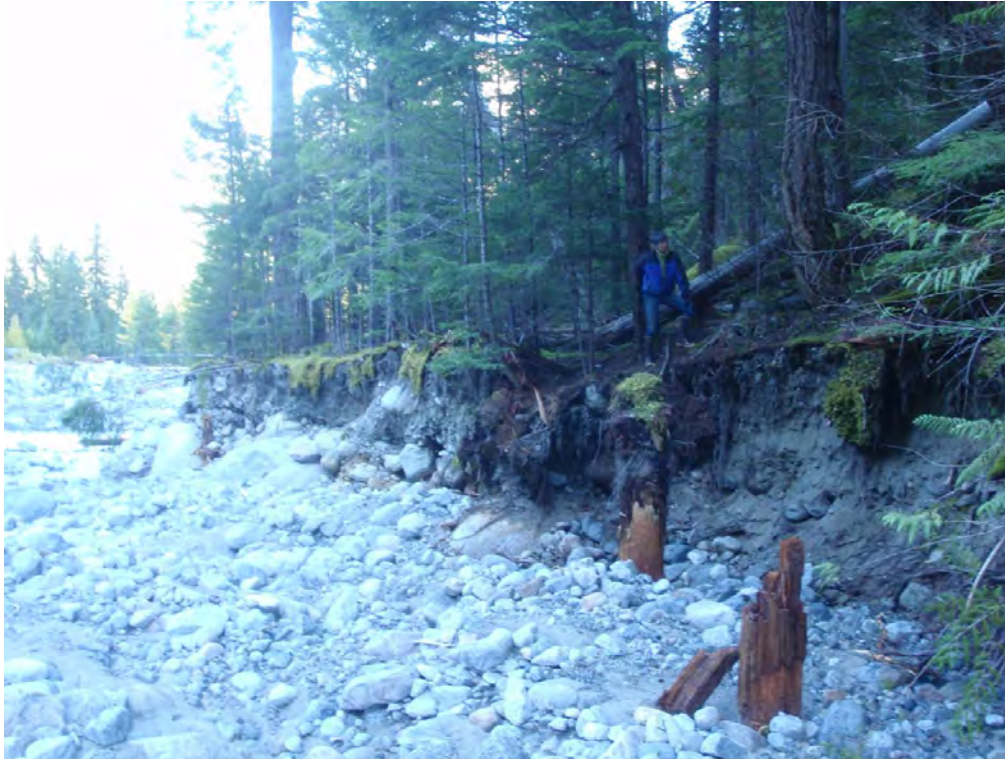
**Photo 9.** Right bank of South Creek near the fan apex. Buried tree stems exhumed by the Sept 19/20 debris flood. These stems indicate that a similar event of rapid aggradation has occurred on South Creek fan in the last century. Ongoing glacier recession will lead to chronic geomorphic activity on South Creek fan.

South Creek has had a long history of channel instability on the fan. Chronic channel instability required that in the late 1990s, the FSR was rerouted from its original alignment on the mid part of the fan, up to the fan apex. On September 19/20, 2015, the South Creek bridge was overwhelmed by about 5 m of sediment aggradation during a 20 year return rainstorm that followed immediately on a long hot summer drought (Cordilleran 2015). Access was severed for about 1 month until the bridge was repaired. This event was a debris flood, that appeared to affect the entire channel length from the fan to the glacier forefield, and was likely related to glacier retreat, possible subglacial drainage, and excess morainal sediment availability. It was not a one time occurrence: eroded banks revealed buried tree stems (Photo 9), suggesting that a similar event had occurred sometime within the previous century.

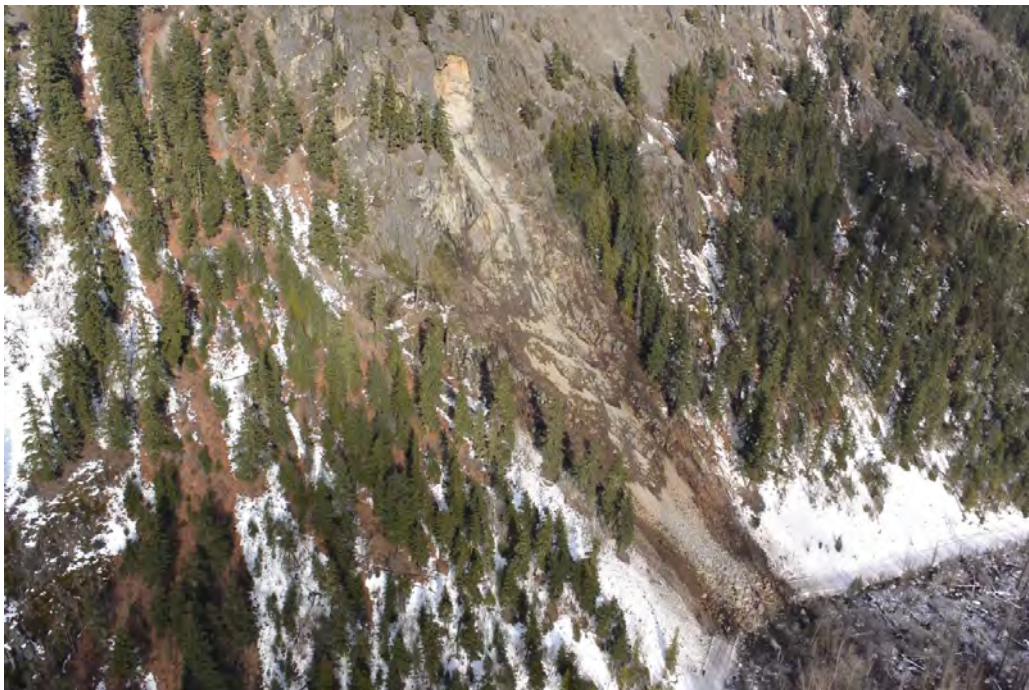
**Photo 10.** The February 2015, Mt Pauline rockfall. Rockfall at this site severs access on North Lillooet FSR.

On the morning of January 29, 2015 a rockslide was noted blocking Lillooet FSR at 6 km (Photo 10). At least one vehicle and several snowmobiles were trapped on the bushside of the deposit. The rockfall occurred from a steep, southerly rock face of Mount Pauline (Figure 6) rising 840 m above the Lillooet River floodplain. The rock is highly jointed and there is a high natural rockfall hazard at this site.
