***Gitanyow Fisheries  
Authority***

**The 2012 Beaver Dam Mitigation and Nuisance Beaver  
Control Project  
Contract #: 1005-40/EN13844003**

Date: April 17, 2013

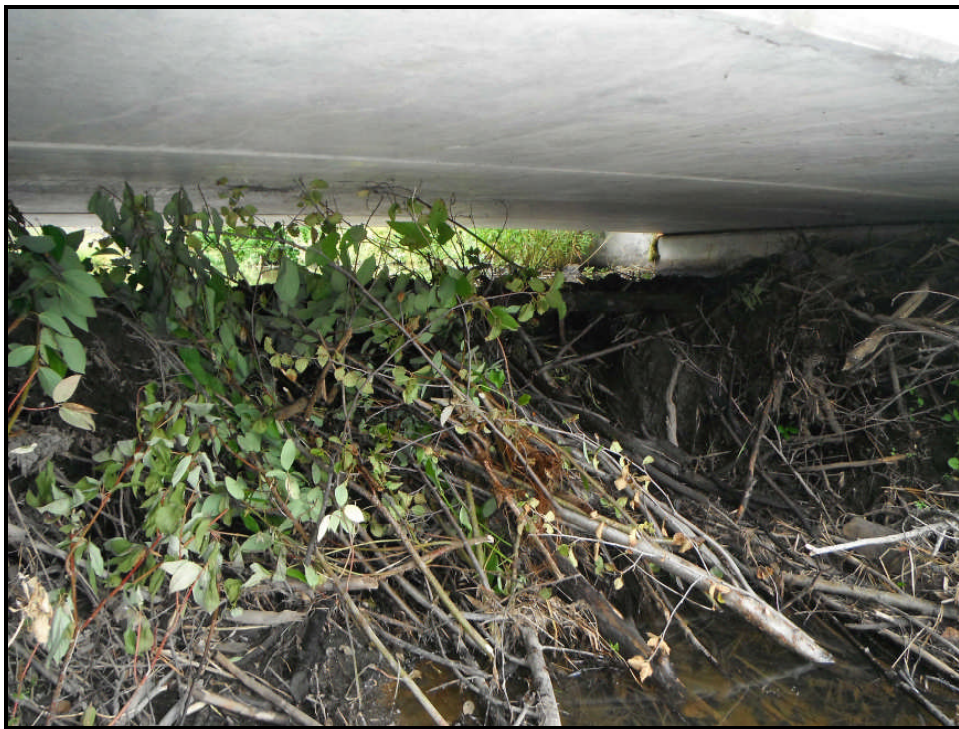
Photo 1: August 14th, 2012. Looking upstream under the bridge at km 3 on the 26-Mile FSR, before breaching.

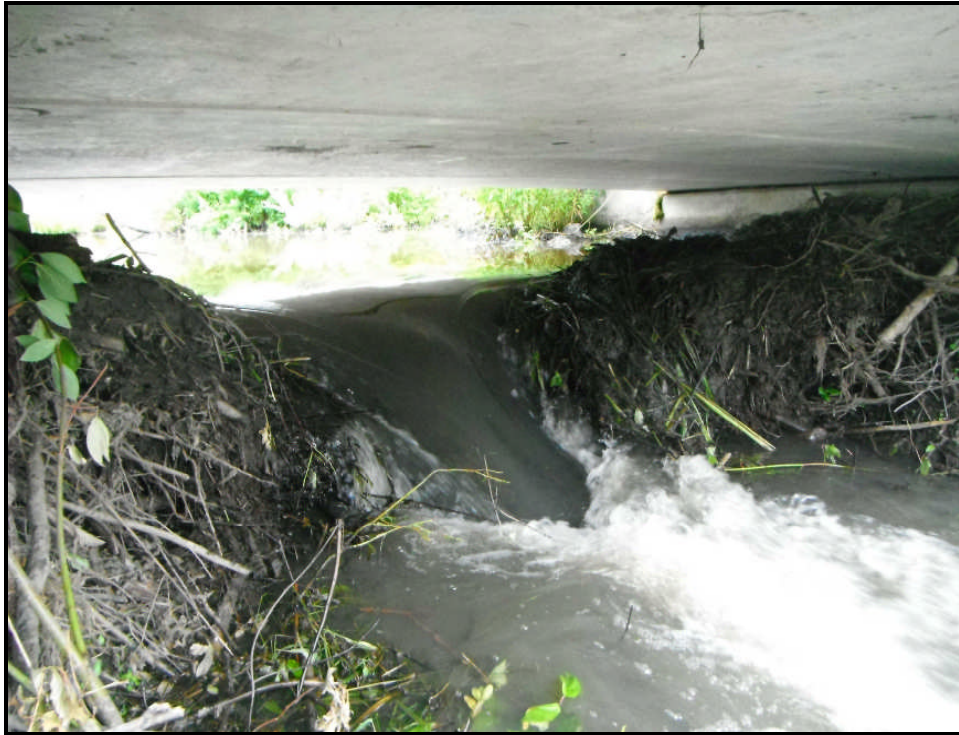
Photo 2: Looking upstream at same dam as previous photo after breaching.

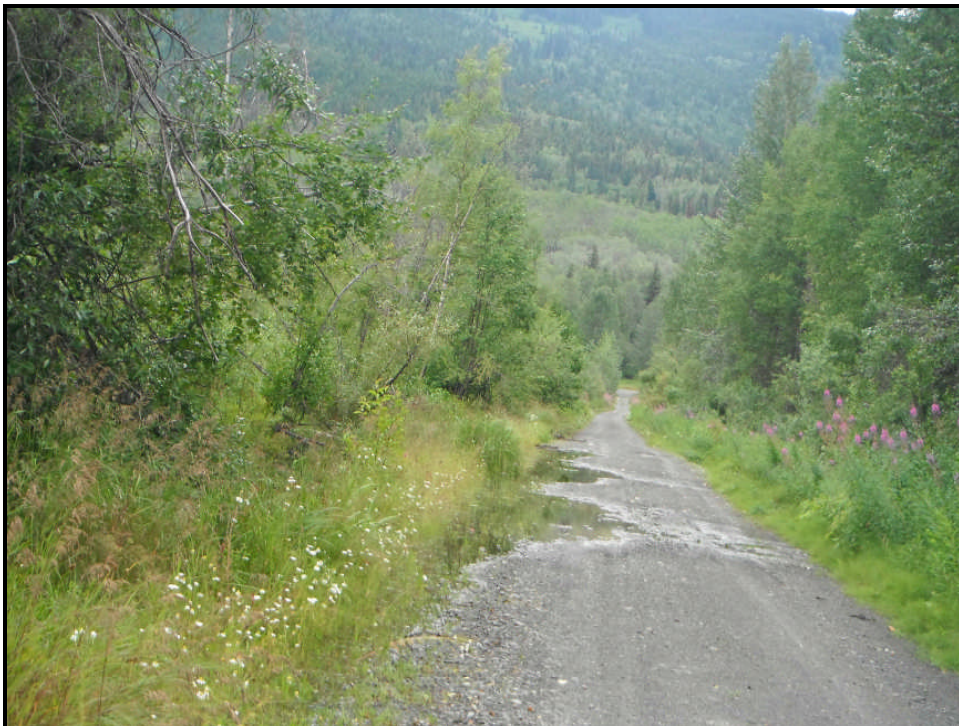
Photo 3: Looking east on 26-Mile FSR, road flooding caused by beaver dams (August 10, 2012).

The 2012 beaver dam mitigation and beaver control work along target FSR's in the Kitwanga and Cranberry Watersheds was successful in reducing flooding and erosion of roads. Without implementing these breaching activities, roadway washouts and associated sediment events are likely.

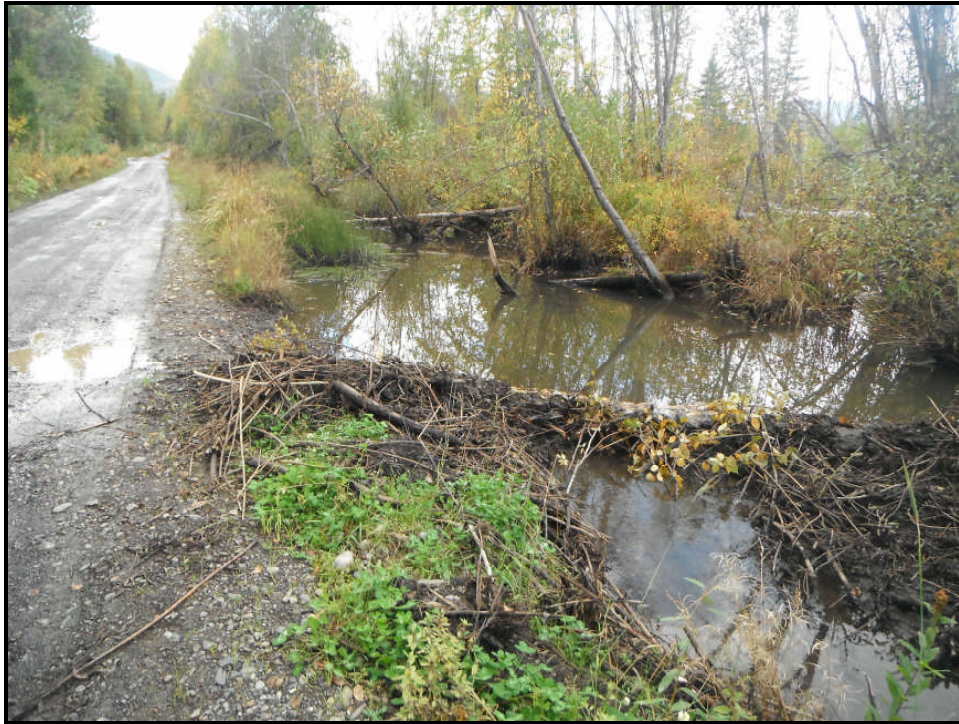
Photo 4: Looking west on 26-Mile FSR, typical beaver dam requiring breaching to prevent water from flooding the road (taken September 24, 2012).
