**Taan Forest Ltd. - Stream Assessment Report for  
Proposed Harvest Blocks IAN001 and IAN002**

# Stream Assessment Report for Proposed Harvest Blocks IAN001 and IAN002

May 2, 2016

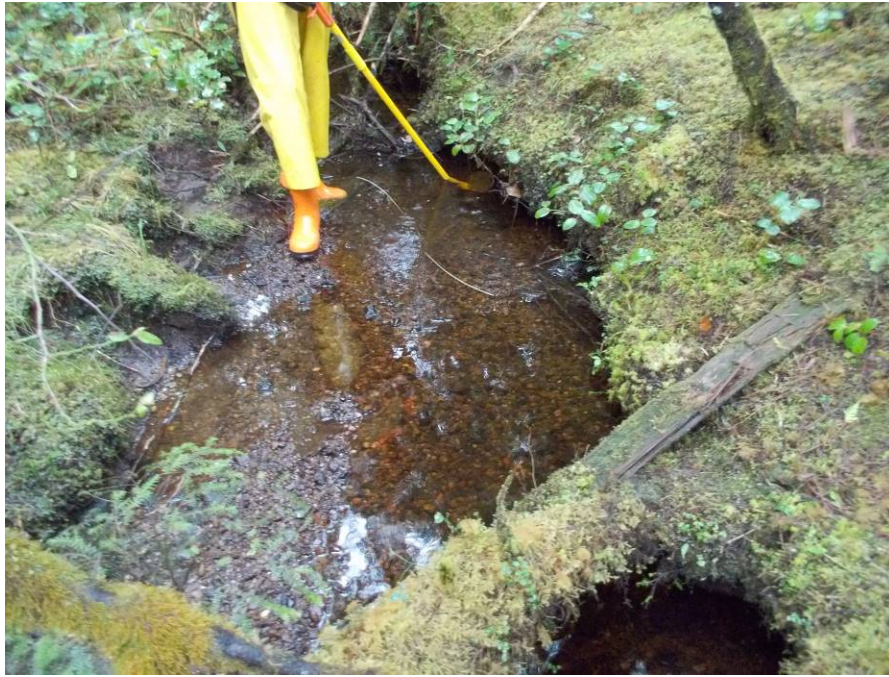
The point of commencement (POC= 0+000) of Reach 1 in Stream 23 was located downstream of the Tracey Main road crossing (UTM= 8 U, 653452.04 m E, 5956542.40 m N). Upstream of the POC the stream was characterized by a well confined channel with step-pool morphology and a substrate composed of gravel and cobble. At approximately 0+035m, the stream flowed under the Tracey Main forestry road through a wood-box culvert (WBC). Upstream of the crossing the channel remained well confined, however morphology shifted to riffle-pool and the substrate was predominantly composed of fines and gravel (Photo 1). Overall, reach 1 of Stream 23 had an average channel width of 0.9m and a gradient that ranged from 2-16%. At approximately 0+655m, the channel began to flow sub-surface in sections. The confluence with a small tributary was located on the right-wetted bank at approximately 0+775m. Upstream of the confluence, the channel in Stream 23 became narrow and less scoured. The point of termination (POT) in Reach 1 of Stream 23 was located at 0+790m where flow sourced from seepage at the base of a sloped bank (652955.65 m E, 5955991.44 m N ) (Photo 2). A survey of the terrain upslope of this point revealed only isolated pools of standing water over organic substrate and no connection to any adjacent watercourse. Electrofishing in Stream 23 resulted in one small cutthroat trout being captured.

Based on the average channel width, average gradient and confirmed presence of fish, **Reach 1 of Stream 23 was classified as a Type 2 stream.**

**Photo 1. An upstream view of the channel in Reach 1 of Stream 23.**

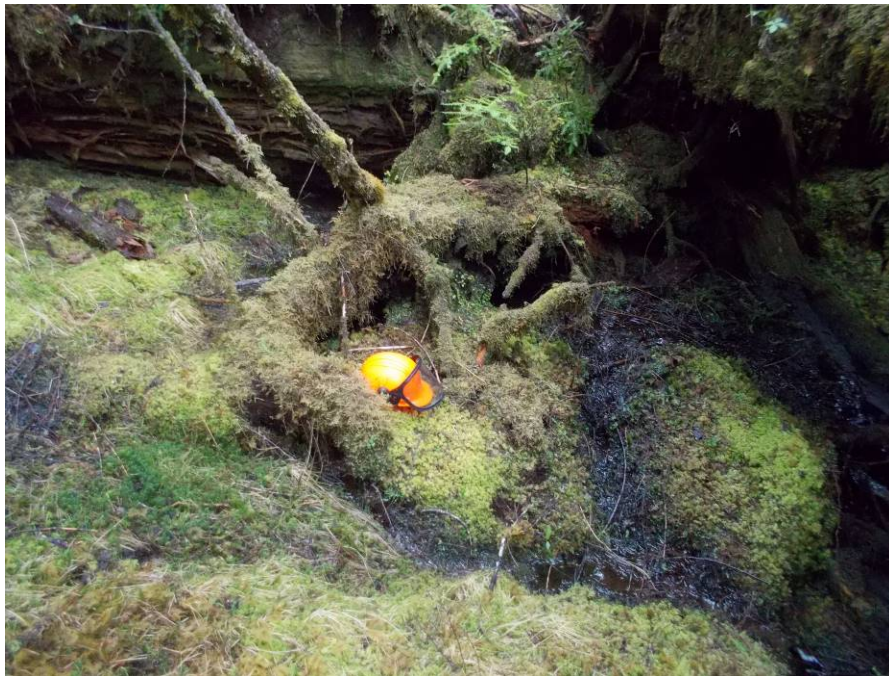
**Photo 2. An upstream view of the POT in Stream 23 where flow sourced as seepage at the base of a sloped bank.**

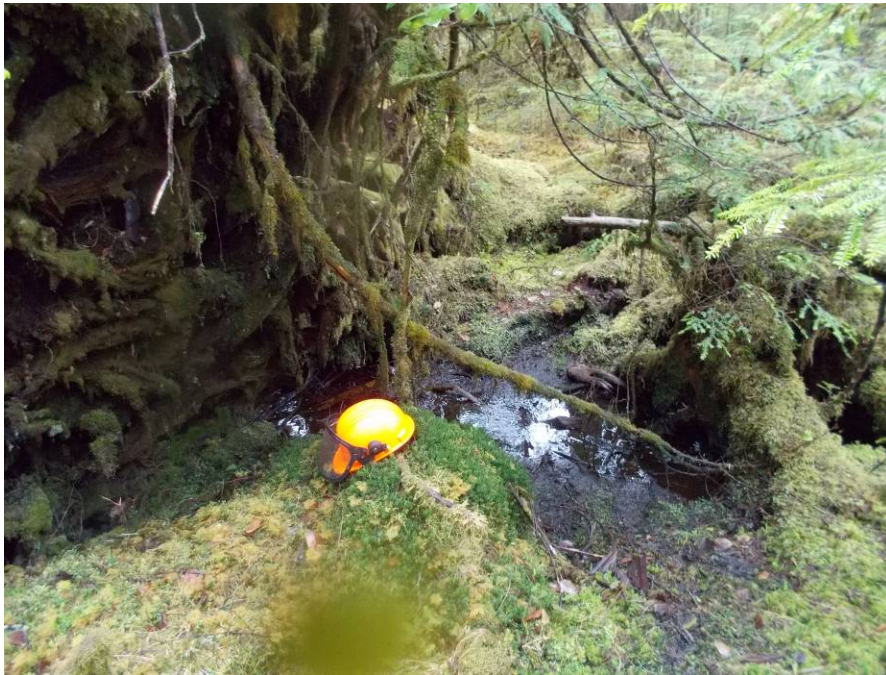
The POC of Reach 1 in Stream 23A was located at the confluence on the right-wetted bank of Stream 23 (652972.20 m E, 5955994.68 m N). Upstream of the POC, the reach was characterized by a narrow, poorly scoured channel with a substrate composed of organics and fines. The average channel width was approximately 0.5m and the gradient ranged from 7-10%. In general, the reach provided marginal rearing habitat in the form of small pools and undercut banks. The POT of Reach 1 in Stream 23A was located at approximately 0+035m where flow sourced from exposed seepage at the base of an overturned root wad (652969.37 m E, 5955961.31 m N). Upslope of this point flow was restricted to seepage and there was no indication of a connection to any adjacent watercourse. No electrofishing was conducted in Stream 23A; however, based on an unimpeded connection to a known fish-bearing water course (Stream 23) and the presence of marginal fish habitat, Reach 1 of Stream 23A received a default fish-bearing status.

Based on the average channel width, unimpeded fish access and presence of low gradient habitat, **Reach 1 of Stream 23A was classified as a Type 2 stream.**

**Photo 3. A cross-channel (right-bank to left-bank) of the POT in Stream 23A.**

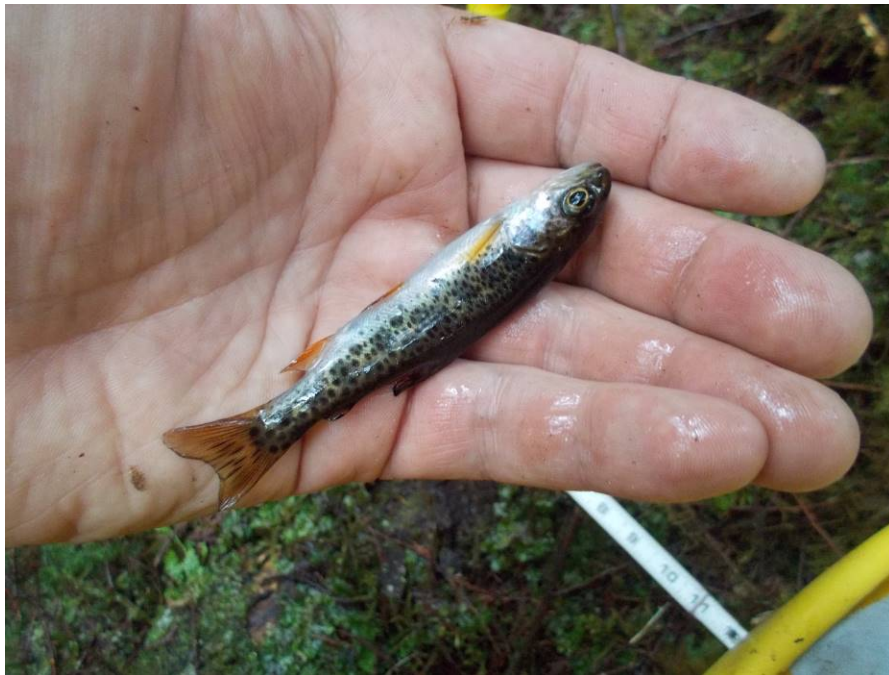
The POC (0+000) of Reach 1 in Stream 8A was located downstream of the Tracey Main road crossing (651636.64 m E, 5955030.86 m N). Upstream of the POC the stream was characterized by a well confined channel with step-pool morphology and a substrate composed of gravel and cobble. The reach had an average channel width of 1.5m and the gradient ranged from 7-20%. At approximately 0+035m the stream flowed over an identified barrier to fish passage. This point defined a reach break in the assessed portion of Stream 8A. A total of 100 seconds of electrofishing in Reach 1 of Stream 8A resulted in one small cutthroat trout being captured (Photo 4).

Based on the average channel width, average gradient and confirmed presence of fish, **Reach 1 of Stream 8A was classified as a Type 2 stream.**

**Photo 4. A juvenile cutthroat trout captured in Reach 1 of Stream 8A.**

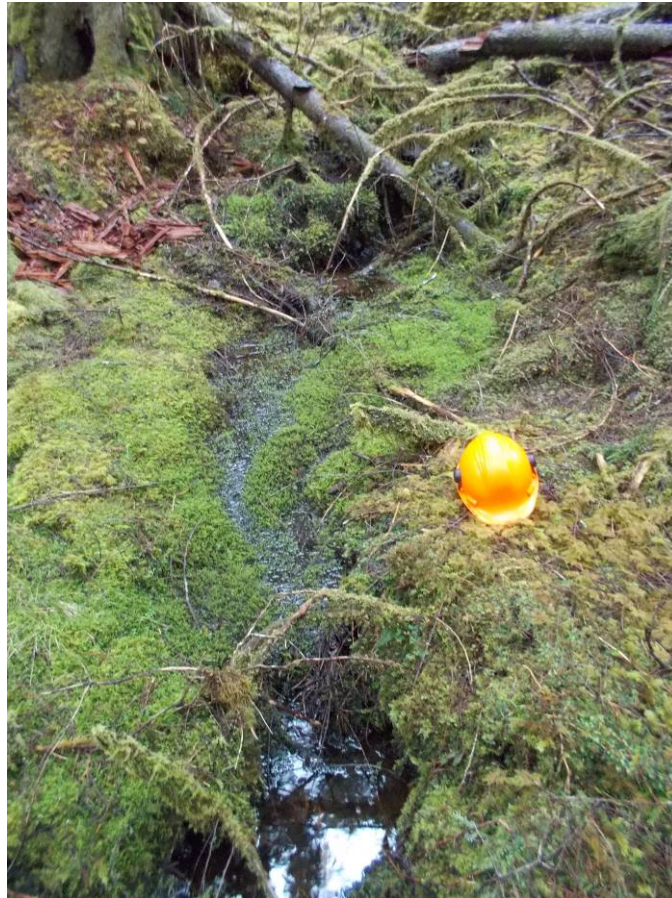
**Photo 7. An upstream view of the POT of Reach 1 in Stream 9 where flow becomes restricted to seepage.**
