## Post-Wildfire Risk Analysis, Fire N50320, Slocan Park – further details

Peter Jordan, P.Geo., MFLNRO, Nelson 12 Sept 2014

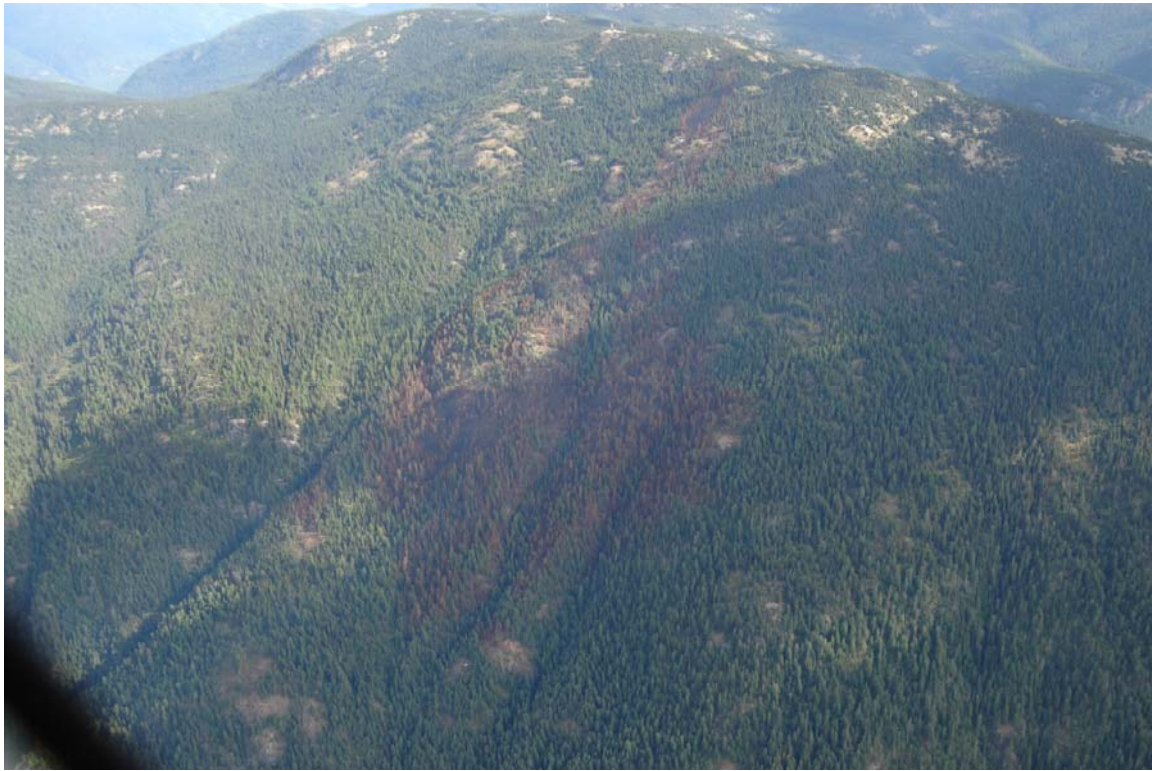
The fire and adjacent creek channels are on steep (40-70%), mainly rocky, ground. Creek 2 has two branches in the fire (photo 1). Where inspected in the field, the channel bed and banks were in bedrock or coarse colluvium, and there appeared to be little material that could be entrained in a debris flow. Also, the creek channels are bordered by a strip of unburned or lightly burned vegetation and intact soil, probably because of moister soil conditions than on nearly high ground. This makes it unlikely that a debris flow would start in the burned area.

Photo 1. Overview of Fire 320, taken on 28 August 2014. Radcliffe Creek is on left; the two branches of creek 2 are in lower centre.

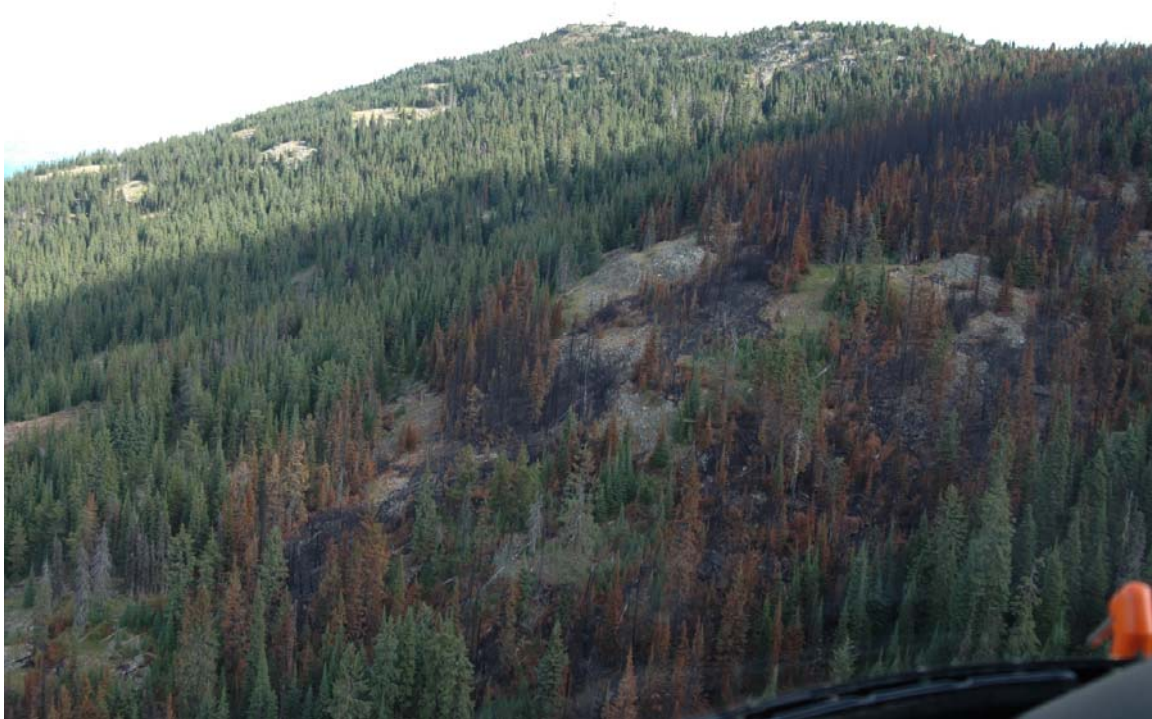
Photo 2. Patchy burn in rocky terrain in upper part of the fire.

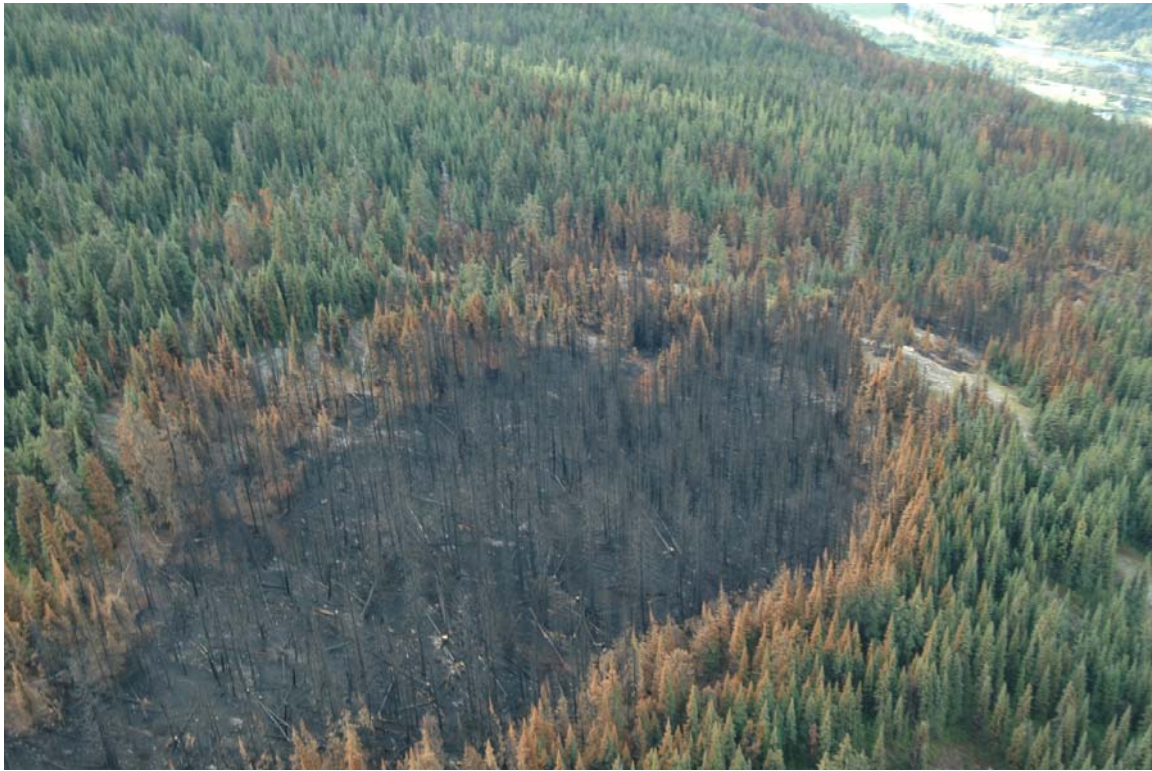
There is a patch, about 2 ha in area, of high severity burn at the top of the fire (a separate fire start), which was not checked in the field. From the air, this patch appeared to have higher soil burn severity than was seen in the lower part of the fire.

The high elevation, high burn severity patch (photo 3), sits on a steep slope above a small, steep tributary of Radcliffe Creek. There is a remote possibility that if a small landslide occurred in this burned patch, it could trigger a small debris flow which could descend Radcliffe Creek.

Photo 3. Patch of high-severity burn in upper part of the fire, above Radcliffe Creek tributary (right); looking down the slope toward Slovan River.

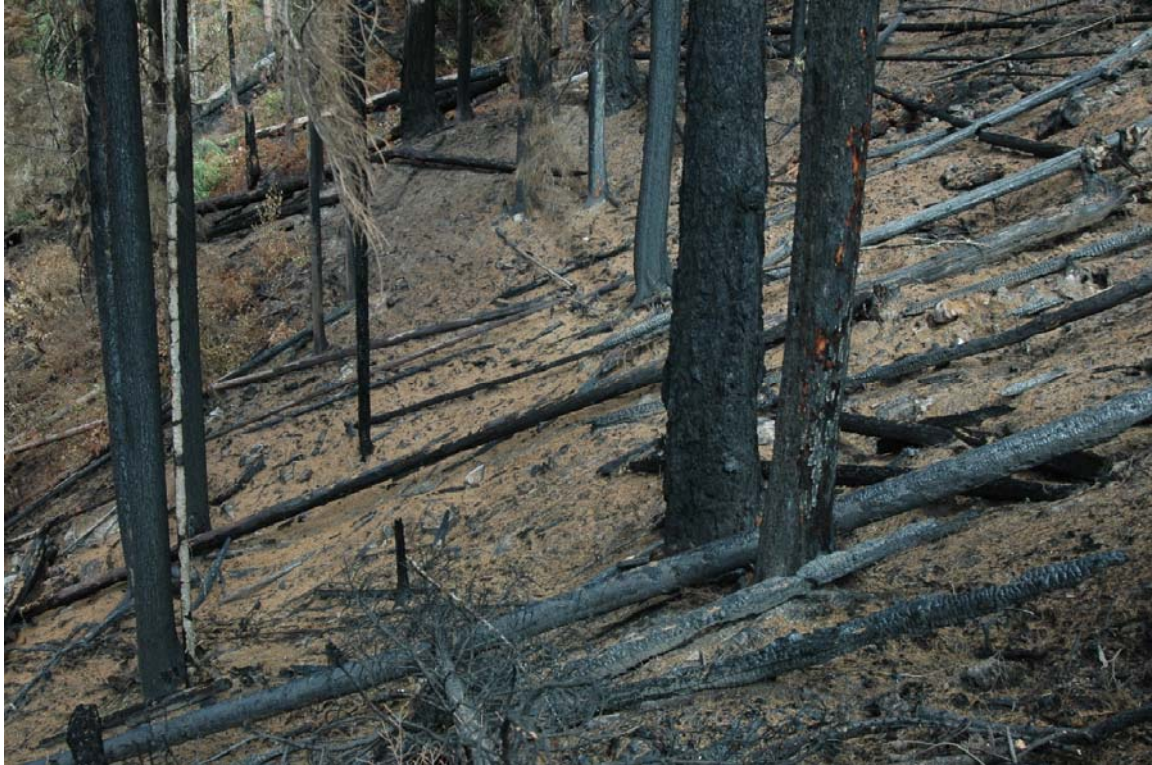
Photo 4. Moderate severity burn in lower part of the fire. Note natural mulching from needle fall, which protects the soil from erosion.

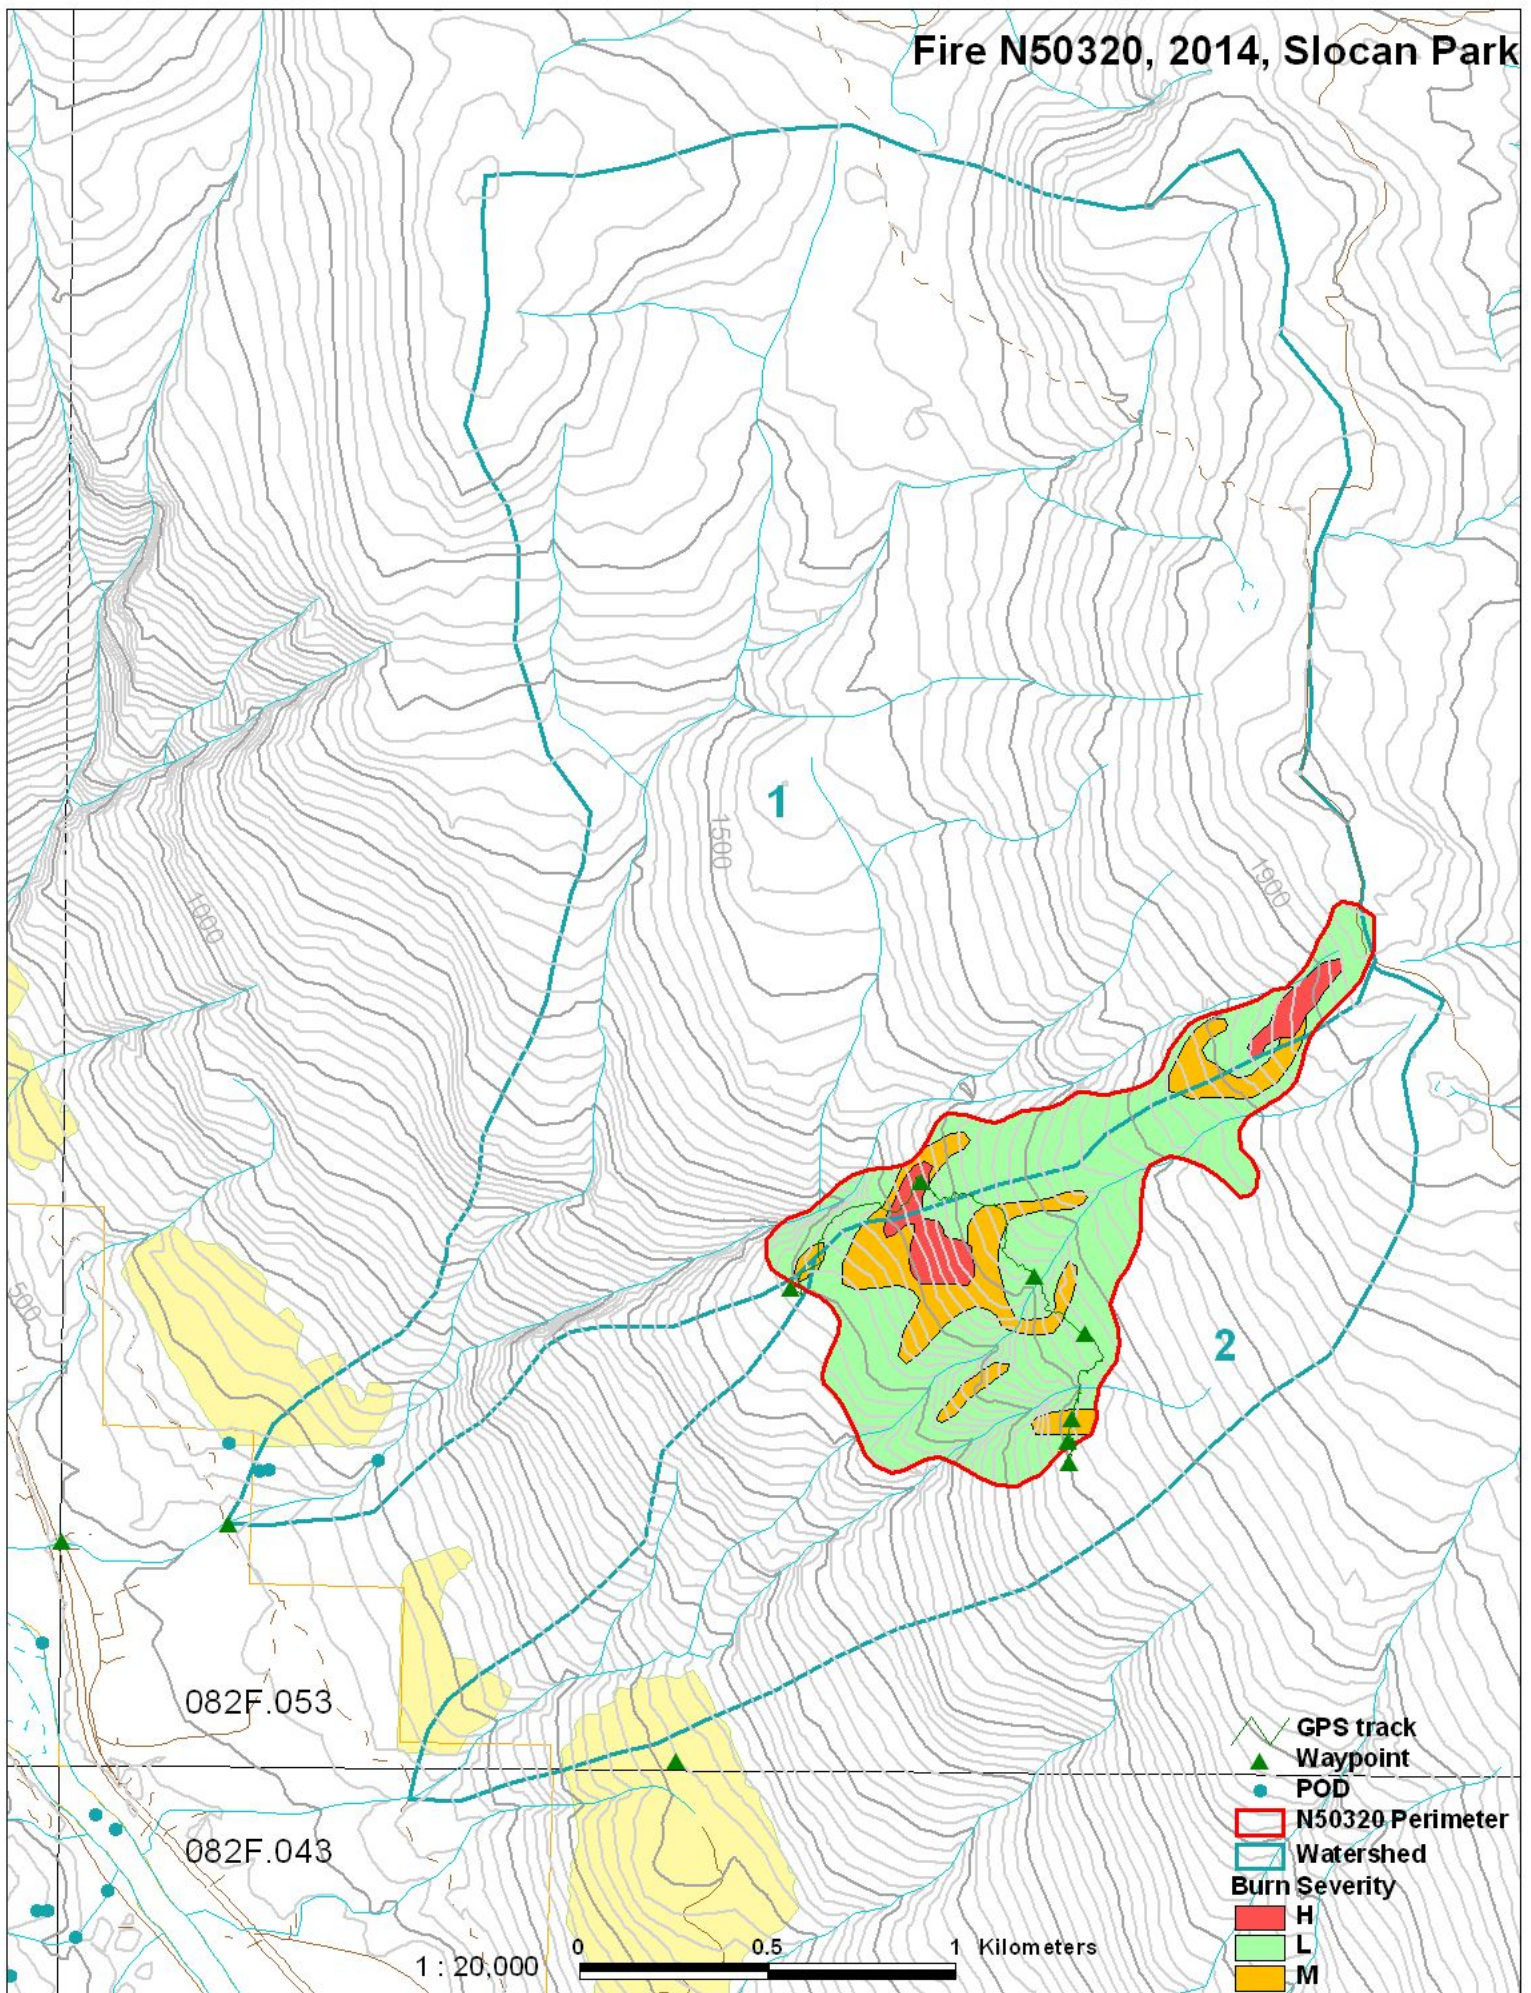
# Fire N50320, 2014, Slocan Park

The attached map (Figure 1) shows the burned area and the two watersheds draining it. Burn severity was mapped from photos taken from the air on August 28, with ground checking of representative sites on the same day.

Figure 1. Map of Slocan Park fire and adjacent watersheds. (at end of report)
