# Post-wildfire landslides in southern British Columbia

P. Jordan

*British Columbia Ministry of Forests, Lands & Natural Resource Operations, Nelson, BC, Canada*

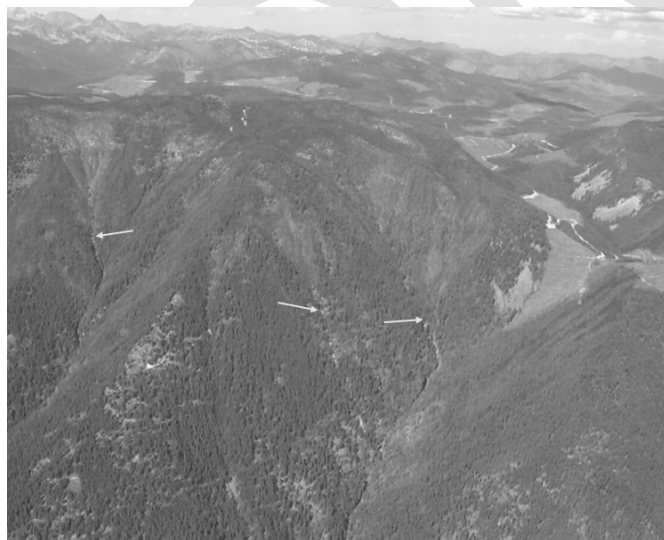
The most destructive events occurred in the Kuskonook fire, about 25 km north of Creston. On the night of 6-7 August 2004, a heavy rainstorm occurred in the area, triggering large debris flows in the channels of Kuskonook and Jansen Creeks (Jordan et al 2006; VanDine et al. 2005). Two houses were destroyed, and a large part of the Kuskonook Creek fan was covered with debris. Field investigations after the events found extensive high soil burn severity, water repellent soils, and evidence of overland flow in a plateau area draining into the steep channels. Although shallow surface erosion was widespread, relatively little debris was produced in the source area. The Kuskonook Creek debris flow initiated from failure of the bed and banks, at a point where the channel steepened to about 29 degrees and entered a confined gully in glacial deposits (Figure 2). Almost all of the estimated 20,000 to 30,000 m<sup>3</sup> of debris originated from the channel.

Figure 2. Overview of Kuskonook fire debris flows of August 2004. Debris flow initiation points are shown by arrows.

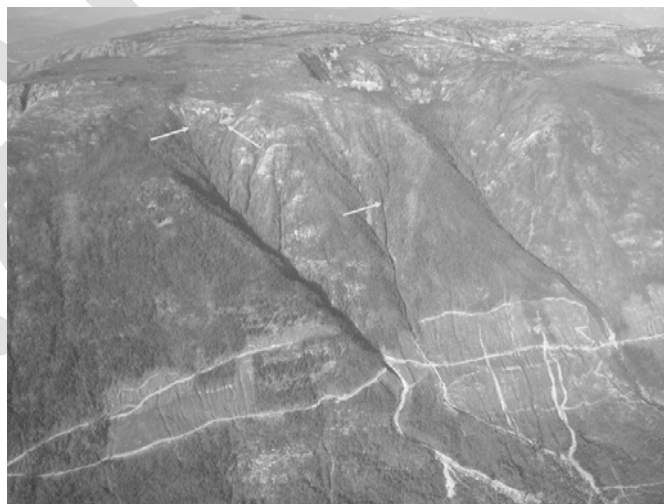
The Ingersoll fire burned a very steep, bedrock-dominated slope, and a plateau above, bordering Lower Arrow Lake. In October 2005, two years after the fire, a 2-day rainstorm triggered 15 debris flows and debris slides (Figure 3). Most of the events were debris flows, which initiated in the upper parts of steep gullies incised in bedrock and apparently were triggered by overland flow spilling from the plateau into the gullies. This incident differed from the others in that the rainfall was of low intensity and long duration. It is likely that snowmelt contributed to the supply of water, and it is possible that lingering water repellency or other effects of high soil burn severity reduced the infiltration capacity.

Figure 3. Several of the October 2005 debris flows in the Ingersoll fire. Debris flow initiation points are shown by arrows.

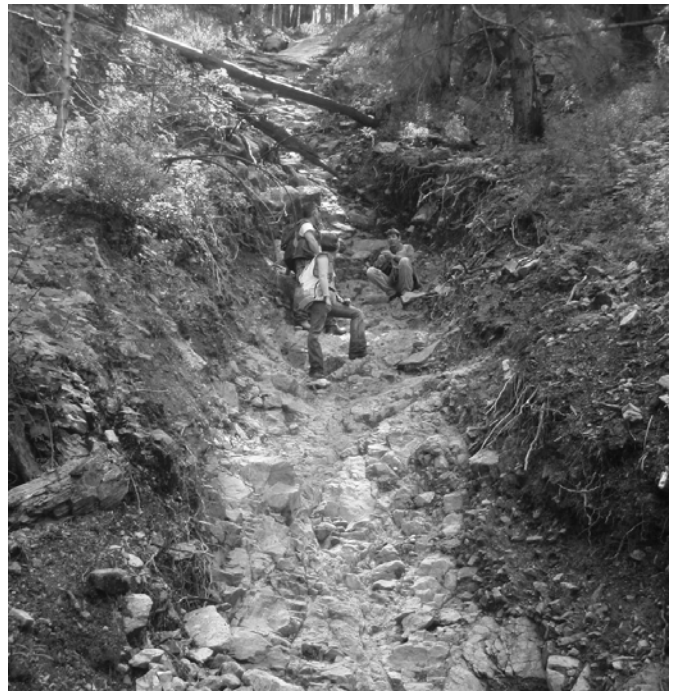
Figure 5. Initiation point of the May 2011 debris flow in the Middle Van Tuyl Creek channel.

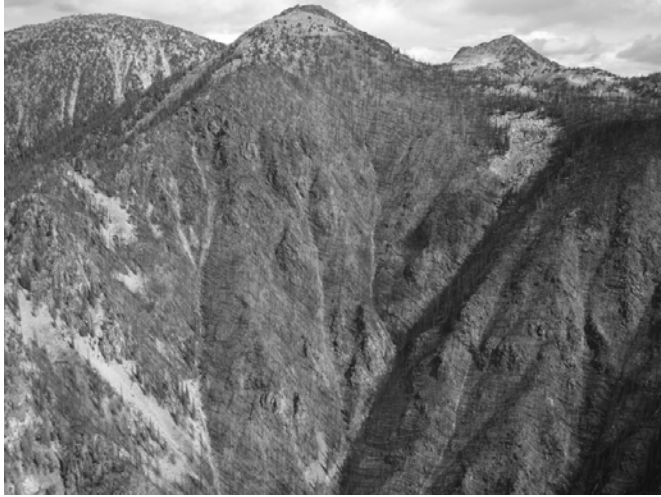
Four large (about 1000 to 3000 m<sup>3</sup>) debris flows and several smaller ones occurred in the nearby Enterprise Creek drainage, in very steep, bedrock-dominated, gully systems, during moderate rainfalls in August 2007, August 2008, and September 2009. Three of these occurred in the same channel, the upper part of which is shown in Figure 6. These channels were subject to occasional debris flows before the fire, with estimated return periods of several decades. However, the likelihood of debris flows was substantially increased after the fire, probably by the loss of large woody debris in the channels and on adjacent steep slopes, and possibly by water repellency on slopes above the gullies. Due to extremely steep and inaccessible terrain, we did not walk the channels. From aerial observations, it appears that at least two of them started in multiple diffuse sources, in rockfall-fed gullies. The rate of rockfall typically increases greatly after a fire, and fallen wood in the gullies which normally stabilizes the rockfall debris was consumed by the fire; these two factors may have led to much more debris being available for mobilization in the gullies.

Figure 6. Headwaters of a tributary of Enterprise Creek burned in the Springer fire, in which debris flows occurred in 2007, 2008, and 2009. Photo taken 6 September 2007.

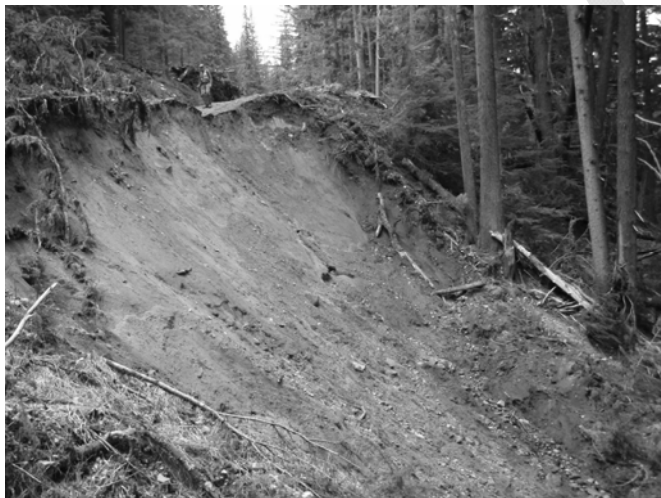
In the Sitkum fire near Nelson, a debris slide occurred on a mine road during snowmelt in May 2008 (Figure 7). High groundwater level caused by increased snow accumulation and snowmelt rate on the burned slopes above was the most likely cause. This slide affected water quality in a community watershed.

Figure 7. Debris slide of May 2008 below the Sitkum fire. The road is at the top of photo. Several holes from piping of groundwater are visible in the middle part of the slide scarp.
