## Post-wildfire natural hazards and risk analysis in British Columbia

### ABSTRACT

Several damaging debris flow and flood events occurred in areas burned by severe wildfires in 2003 and 2007. The BC Forest Service has developed a procedure for analyzing risks to public safety and infrastructure from such events. Each fire season, for wildfires which present potential risks, burn severity is mapped and sites of potential hazards are identified. The results are communicated to local governments and other stakeholders, who are responsible for evaluating risks, warning residents, and applying mitigation strategies. The 2009 Terrace Mountain fire near Kelowna is presented as an example of the procedure.

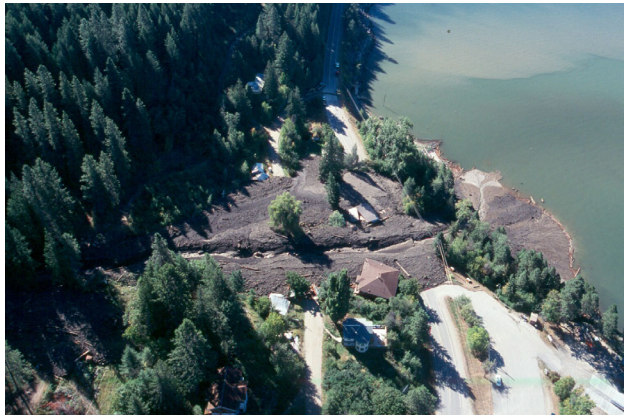
Figure 1. Kuskonook debris flow, August 2004. Photo: Peter Jordan.

The most destructive events occurred in the Kuskonook fire, about 25 km north of Creston. On the night of 6-7 August 2004, a heavy rainstorm occurred in the area, triggering large debris flows in the channels of Kuskonook and Jansen Creeks (Jordan et al 2004; VanDine et al. 2005). Two houses were destroyed, and a large part of the Kuskonook Creek fan was covered with debris (Figure 1). Field investigations after the events found extensive high soil burn severity, water repellent soils, and evidence of overland flow in a plateau area draining into the steep channels. Although shallow surface erosion was widespread, relatively little debris was produced in the source area. The debris flow initiated from failure of the bed and banks, at a point where the channel steepens to about 29 degrees and enters a confined gully in glacial deposits. Most of the estimated 20,000 to 30,000 m<sup>3</sup> of debris originated from the channel.

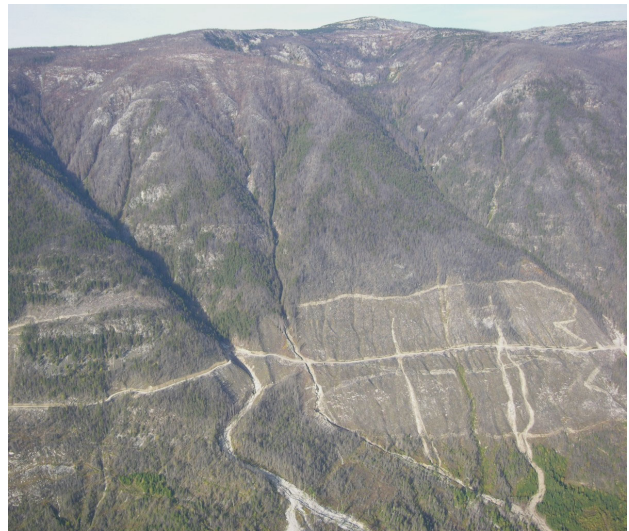
Figure 2. Debris flows of October 2005, Ingersoll fire. Three debris flows (left, centre left, and extreme right) started high in gullies below the burned upper slopes. Two events (lower right) began as debris slides in a cutblock logged before the fire. Neither logging nor the deactivated backspare trail (accentuated by the burn) were implicated in the slides. Photo: Peter Jordan.

The Ingersoll fire burned a very steep, bedrock-dominated slope, and a plateau above, bordering Lower Arrow Lake. In October 2005, two years after the fire, a heavy 2-day rainstorm triggered 15 debris flows and debris slides (Figure 2). Most of the events were debris flows which initiated in the upper parts of steep gullies incised in bedrock, and apparently were triggered by overland flow spilling from the plateau into the gullies. This incident differed from the others in that the rainfall was of low intensity and long duration. It is likely that snowmelt contributed to the supply of water, and it is possible that lingering water repellency or other effects of high soil burn severity reduced the infiltration capacity.

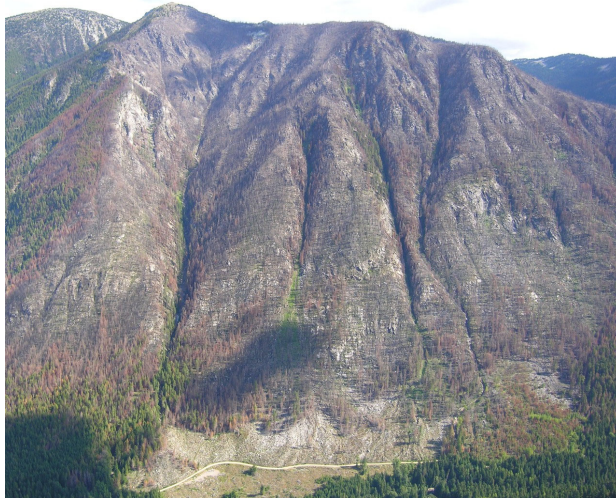
Figure 3. Steep, gullied face burned by the 2007 Springer fire in Enterprise Creek valley. Debris flows which reached the valley bottom occurred in the large gully at left (2007, 2008, and 2009) and the right gully (2008). Smaller events also occurred in the intervening gullies. Photo: Peter Jordan.

Four large debris flows and several smaller ones occurred in the nearby Enterprise Creek drainage, in very steep, bedrock-dominated, gully systems, during moderate rainfalls in August 2007, August 2008, and September 2009 (Figure 3). Three of these occurred in the same channel. These channels were subject to occasional debris flows before the fire, with return periods of probably several decades. However, the likelihood of debris flows was substantially increased after the fire, probably by the loss of large woody debris in the channels and on adjacent steep slopes, and possibly by water repellency on slopes above the gullies.

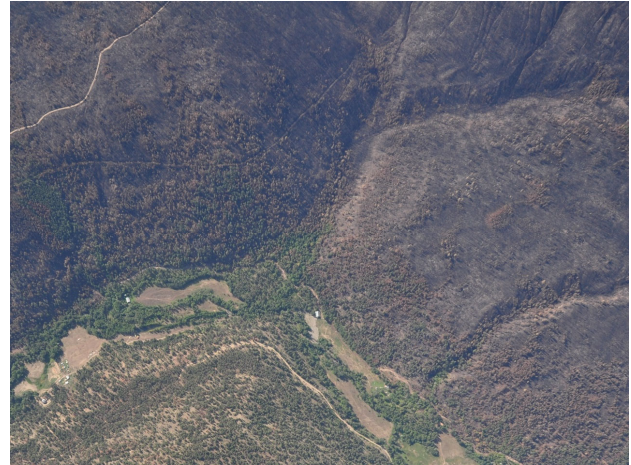
Figure 5. Aerial photos help identify hazard locations. Shorts Creek valley, Terrace Mountain fire. Photo: Peter Jordan.

An important component of the procedure is the mapping of burn severity. A simple preliminary map can be prepared with the aid of high-elevation photographs taken from an aircraft (for example, see Figure 5 in section 4.1). However, a much better map can be prepared using LANDSAT satellite imagery acquired before and after a fire. These burned area reflectance classification (BARC) maps are more accurate and are much preferred, especially for large fires, but their preparation must wait until a suitable post-wildfire image is obtained, which may take a month or longer. The raw BARC data must be calibrated to field observations of actual burn severity, since it can be affected by forest age and type, recent logging, aspect, and atmospheric conditions (Parsons et al. 2010). An example of a completed BARC map is given at the end of this paper. The BARC maps give a good representation of loss of the forest canopy (or vegetation burn severity), but to evaluate potential hydrologic effects caused by changes to soil properties, it should be converted to a map of soil burn severity (Parsons et al. 2010). To do this, it is necessary to collect field data on post-wildfire soil and vegetation conditions, as well as comparable data in adjacent unburned forest.

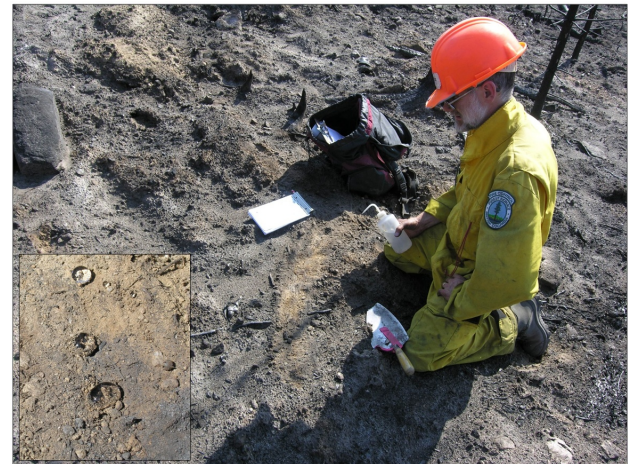
Figure 6. Field inspections to assess soil burn severity. Terrace Mountain fire, August 2009. Inset: water drops showing strong repellency. Photo: Peter Jordan.

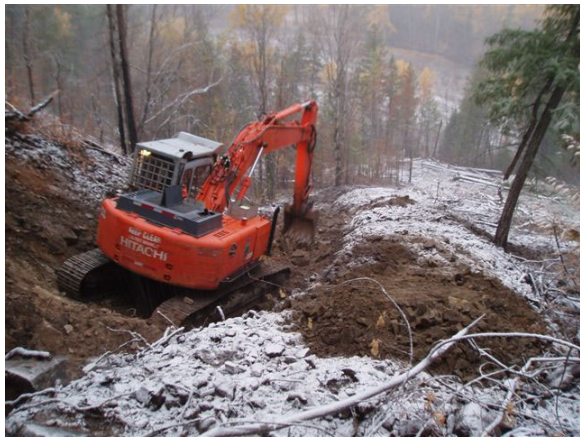
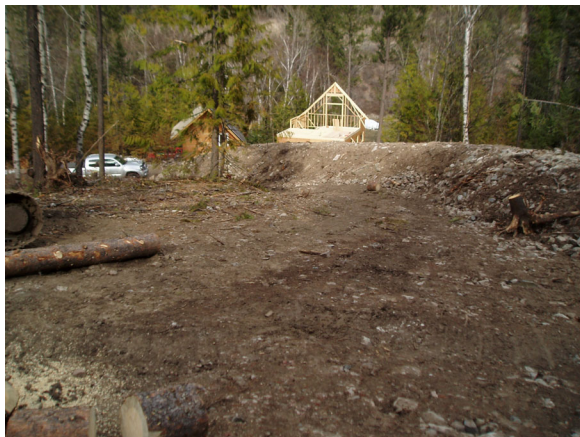
Figure 7. Mitigation works constructed to protect dwellings from increased debris flow hazard, Terrace Mountain fire. a) Constructing cross-ditches on abandoned logging road crossing gully. b) Berm on Wilson Creek fan. Photos: Tim Smith.

As a result of these recommendations, mitigative works were completed in October 2009. They included deactivation of an old, abandoned, logging road above one of the houses (Figure 7a), construction of berms on the steep fans to divert any future debris flows away from the houses (Figure 7b), and additional culverts on the active logging road above the area at risk. This road was further deactivated by the forest licensee in the summer of 2010, with all culverts in the contributing drainage area replaced with large cross-ditches. The drainage area contributing to the high-risk gully was demarcated, and areas of high soil burn severity were identified on the ground. These areas were treated with straw mulch, spread manually by a Wildfire Management Branch firefighting crew (Figure 8).

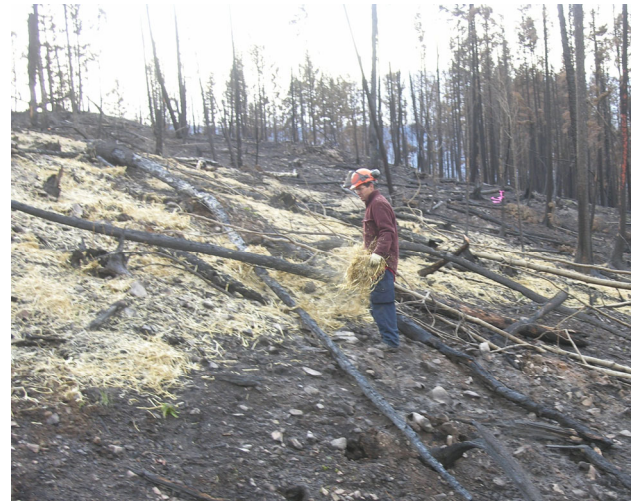
Figure 8. Spreading straw mulch by hand, Terrace Mountain fire. Photo: Peter Jordan.
