# Environmental & Engineering Geoscience

## **Debris Flows and Floods Following the 2003 Wildfires in Southern British Columbia**

PETER JORDAN<sup>1</sup>

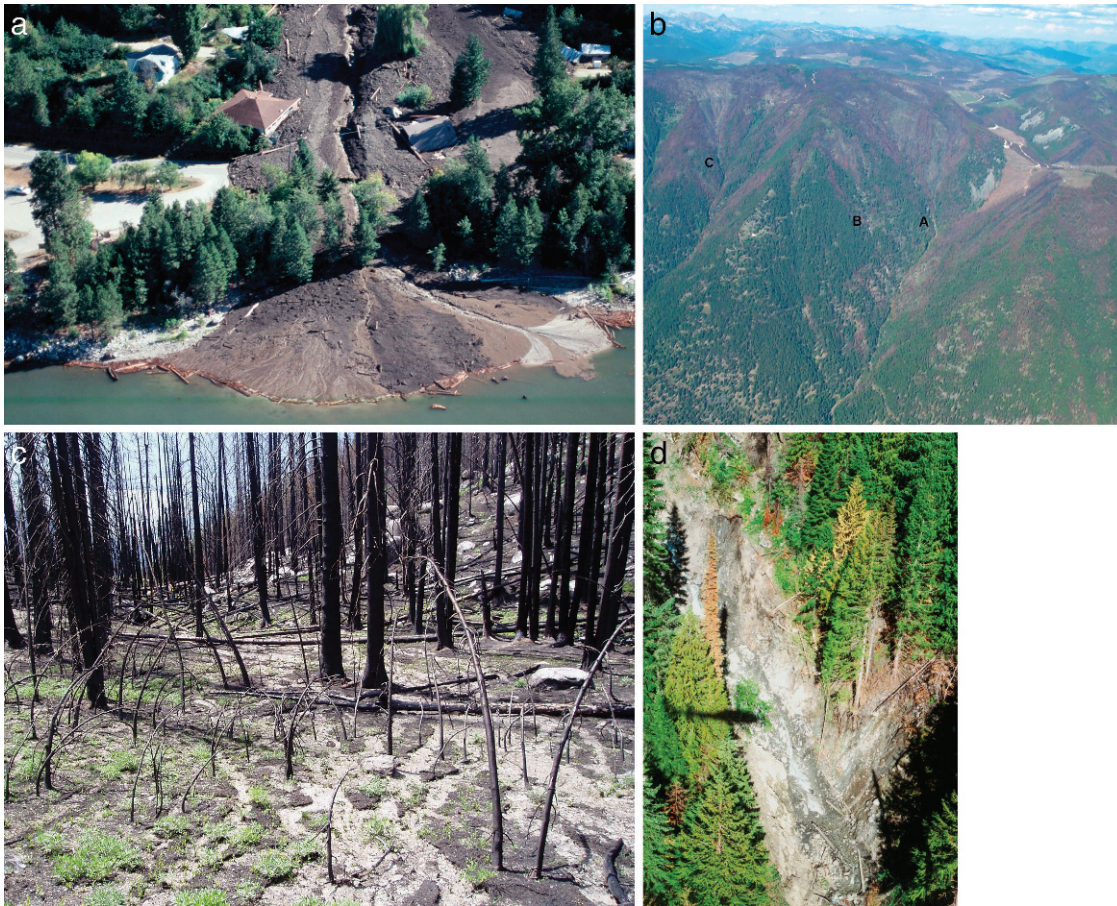
Figure 3. Kuskonook Creek debris flows of August 2004. (a) Kuskonook Creek fan from the air. (b) Aerial view of the watersheds; A is the start of the debris flow in Kuskonook Creek channel; B is a smaller debris flow that started below a small severely burned patch; C is the start of the debris flow in Jansen Creek channel. (c) Shallow soil erosion caused by overland flow near headwaters of Kuskonook Creek. (d) Kuskonook Creek channel from the air, just below the point of transition to a debris flow. Photos by: Peter Jordan (a, d), Doug Nicol (b), Mike Curran (c), BC Forest Service.

On the night of 6–7 August 2004, a heavy rainstorm occurred in the area, triggering a large debris flow in the channel of Kuskonook Creek. The event has been described by Jordan et al. (2004), VanDine et al. (2005), and Jordan et al. (2006). The debris flow destroyed two houses on the fan, damaged several other buildings, and closed the highway for several days (Figure 3a). The affected houses were not occupied at the time, and there were no fatalities or injuries. A smaller debris flow occurred on Jansen Creek, an adjacent drainage to the north (Figure 3b); this event also blocked the highway but did not damage any residences.

Field investigations immediately after the August events found that the burned area in the upper part of the Kuskonook Creek watershed had extensive water repellent soils, and there was abundant evidence of overland flow (Figure 3c). Further field visits were

made in October 2004 and July 2005, and plots were established to record burn-severity data. In areas of high and moderate soil burn severity, strong water repellency was measured in seven of eight plots; it was typically a discontinuous thin layer at a depth of 1–2 cm in the mineral soil, covering 60 to 100 percent of the trench length. Apart from the plots, repellency was observed in quick tests in all areas that showed evidence of overland flow. There was a visually apparent correlation between soil burn severity and overland flow: evidence of rills, small terraces and fans, and flattened grass was observed in and below most areas of high soil burn severity. Areas of moderate or low soil burn severity had little evidence of water repellency or overland flow initiation. Much of the headwaters area of the watershed has relatively gentle slopes, and severely burned areas produced overland flow that accumulated in hollows and ephemeral channels while causing only shallow erosion (Figure 3c). As the headwaters channels steepened

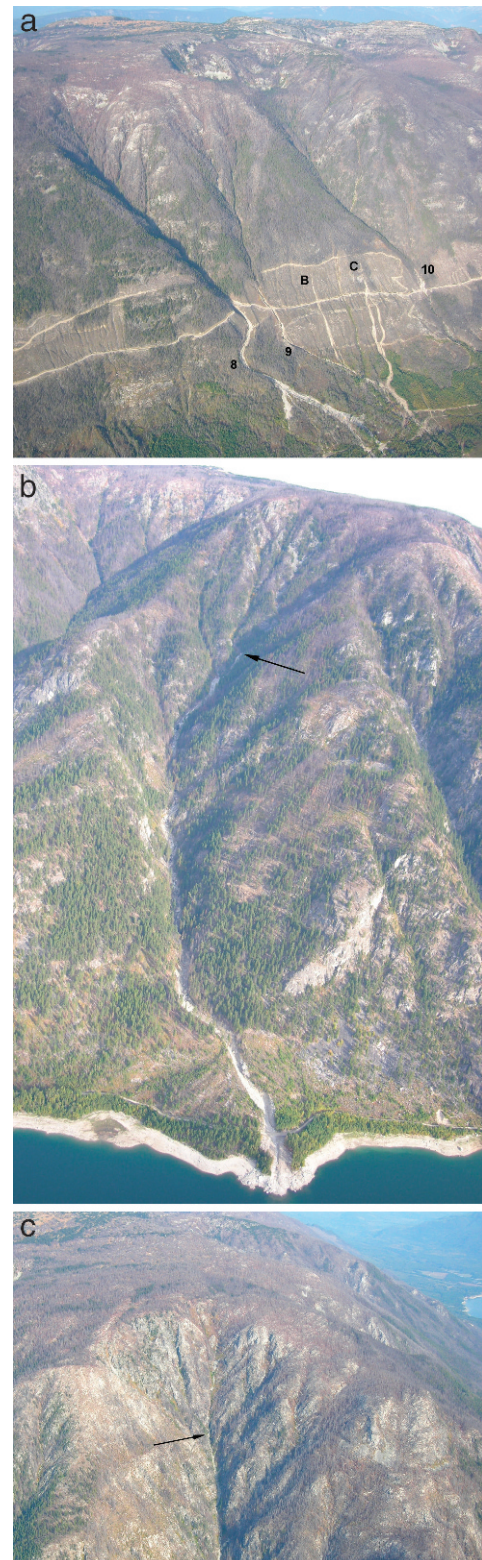
Figure 5. Mt. Ingersoll mass movement events of October 2005. (a) Overview of part of the burn, showing debris flows 8, 9, and 10, and landslides B and C. (b) Debris-flow 2; note initiation point (arrow) where gullies converge. (c) Initiation area of debris-flow 3 (arrow), where gullies converge below plateau rim. Photos by: Peter Jordan, BC Forest Service.

On 17 October 2005, during a 2-day rainstorm, about 15 debris flows, debris slides, and debris avalanches occurred in the southern part of the burn (Figure 5), destroying or damaging at least 10 stream crossings on the main forest road accessing the area. The events were inspected the next day from the air by a geotechnical consultant (Miller, 2005, personal communication). Because of bad weather and the arrival of winter snow soon after, further field

The events at Mt. Ingersoll are shown in Figures 2e and 5, and data for the larger debris flows are summarized in Table 2. Twelve debris flows, two debris floods, two debris avalanches, and four small debris slides are mapped; one of these, a small debris flow in watershed 6 (Figure 2e), is reported to have occurred in fall 2004. The other events are all believed to have occurred on 17 October 2005, although it is possible that some of the smaller events that did not damage the road occurred on other dates.

Two debris slides occurred on the same date, above the logging road (Figure 5a, slides B and C). They started on a moderately steep (30–35 degrees), slightly gullied slope blanketed with sandy glacial till and progressed into debris flows as they entered gullies below. These slides started below a re-contoured logging trail, which was constructed for salvage logging soon after the fire. The area was inspected on the ground in September 2006, and moderate to weak water repellency, high to moderate soil burn severity, and some evidence of overland flow and soil erosion were observed in the area above the slides. However, no obvious surface-flow pathways leading to the slides were observed. A possible mechanism for the initiation of these slides is surface runoff from the

At the Ingersoll fire, two large debris flows were initiated by debris slides on an open slope that entered shallow gullies (Figure 5a). Several other small debris flows appear to have been initiated by rockfall. These events are typical of the landslide-initiated debris flows that are commonly observed in unburned forested landscapes in this region.
