# **Post-wildfire Natural Hazards Risk Analysis in British Columbia**

Graeme Hope, Peter Jordan, Rita Winkler,  
Tim Giles, Mike Curran, Ken Soneff, and  
Bill Chapman

Hope, G., P. Jordan, R. Winkler, T. Giles, M. Curran, K. Soneff, and B. Chapman. 2015. Post-wildfire natural hazards risk analysis in British Columbia. Prov. B.C., Victoria, B.C. Land Manag. Handb. 69.  
[www.for.gov.bc.ca/hfd/pubs/Docs/Lmh/LMH69.htm](http://www.for.gov.bc.ca/hfd/pubs/Docs/Lmh/LMH69.htm)

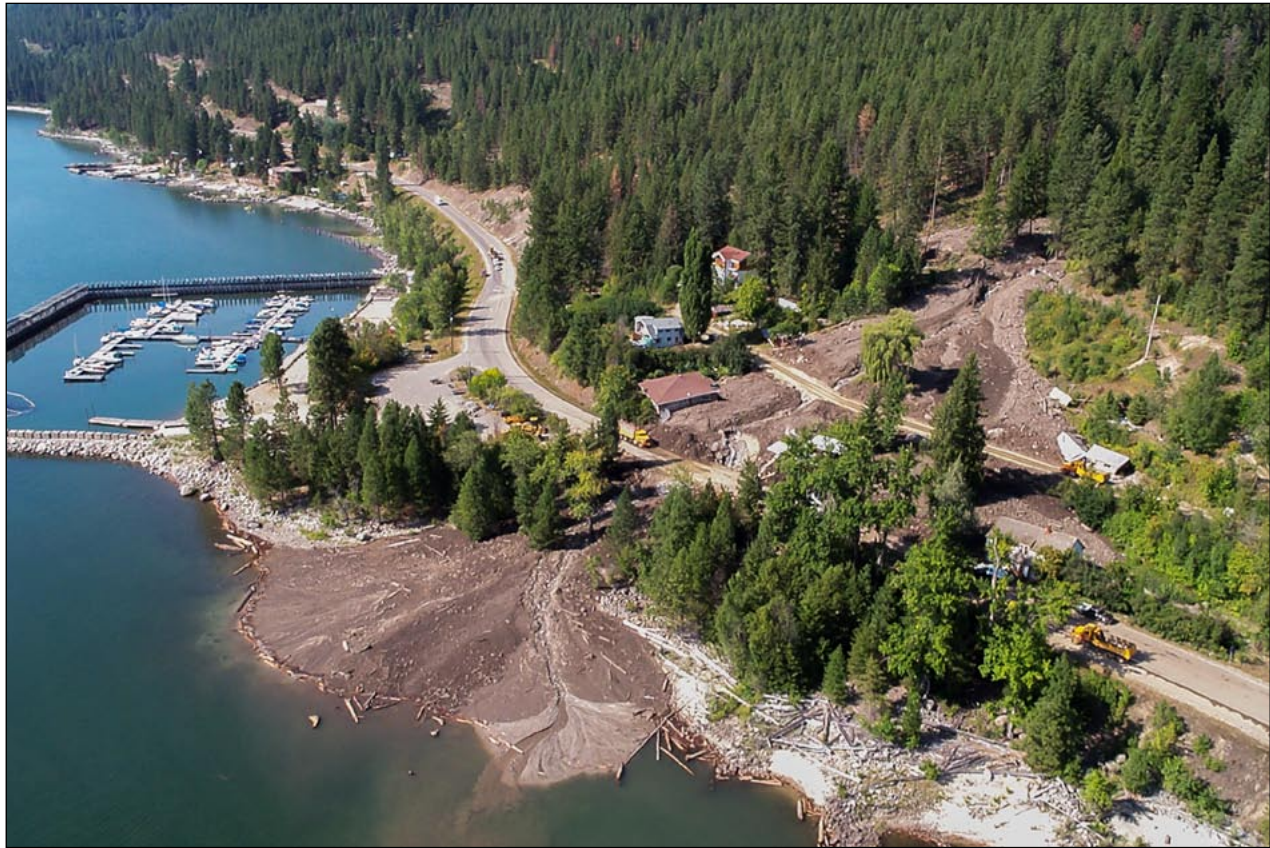
FIGURE 1 *Deposition zone of a debris flow that originated from the 2003 Kuskanook Fire, north of Creston, B.C. The fire burned in 2003, and the debris flow occurred in August 2004 during a high-intensity rainstorm. (Photo: P. Jordan)*

The severe wildfire season of 2003 included several large interface fires. Following these fires, short-duration, high-intensity, or prolonged rainstorms initiated major landslides, such as that at Kuskanook Creek near Creston (Figure 1), and floods that caused significant damage to, or concern over, public safety and/or infrastructure (Jordan et al. 2006; Jordan and Covert 2009). In several other wildfire areas, similar events were relatively minor or of low consequence.

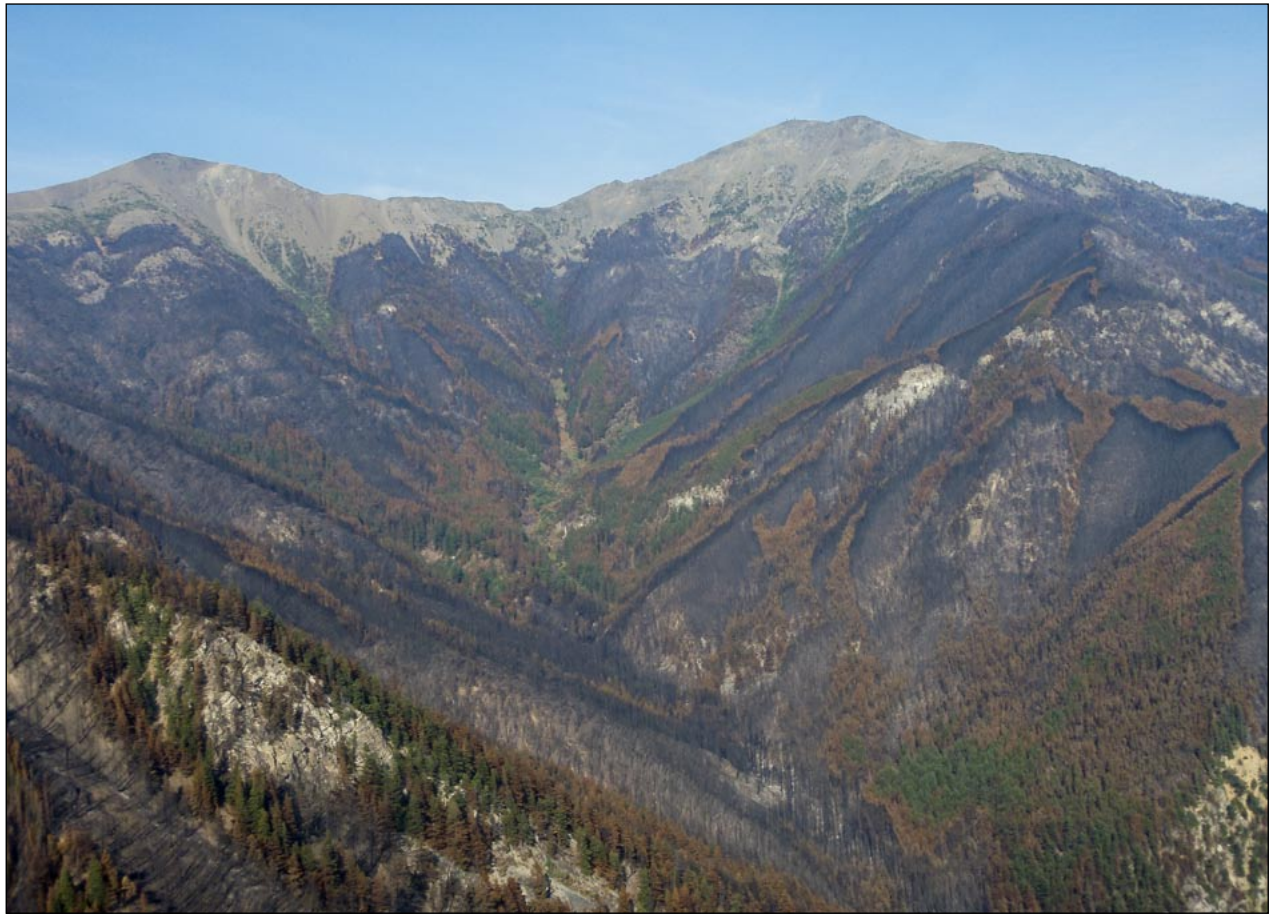
FIGURE 2 A mosaic of vegetation burn severity classes in the area burned by the 2009 Mount McLean Fire, Lillooet. Black areas mapped as high, brown areas (with needles) mapped as moderate, and green trees with underburn mapped as low. (Photo: T. Giles)

**Vegetation burn severity** is a relative measure that describes the effect of a fire on vegetative ecosystem properties (Figure 2). It is often defined by

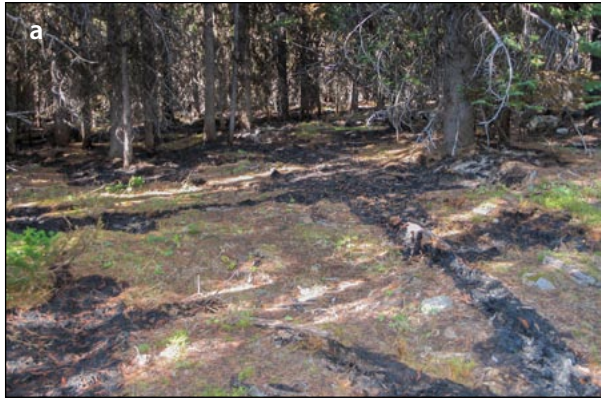
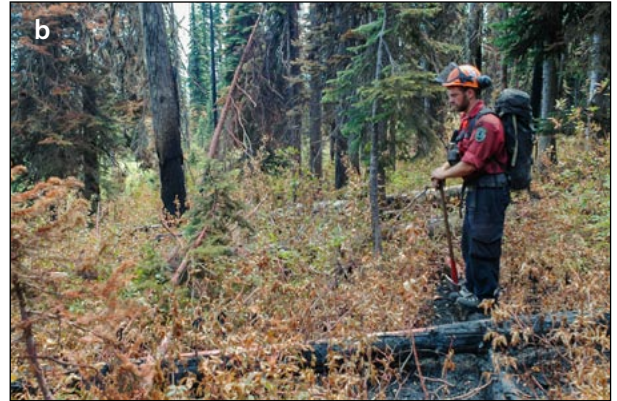
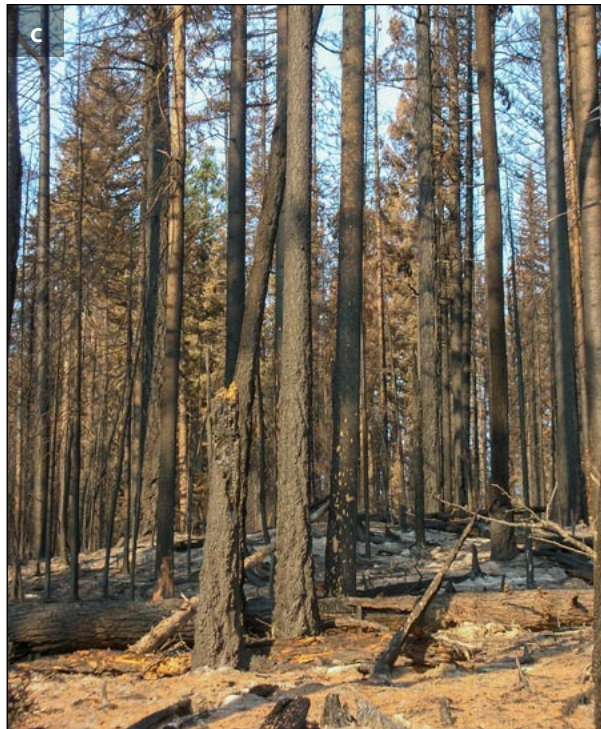
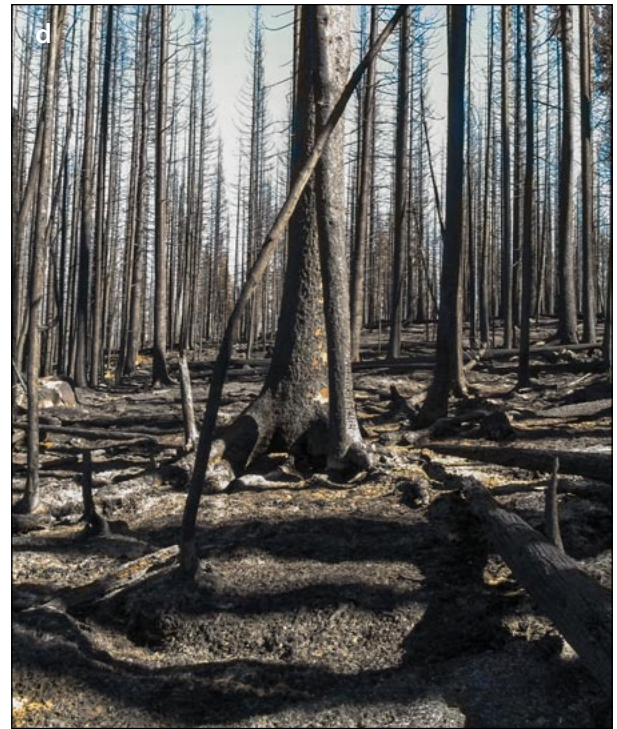
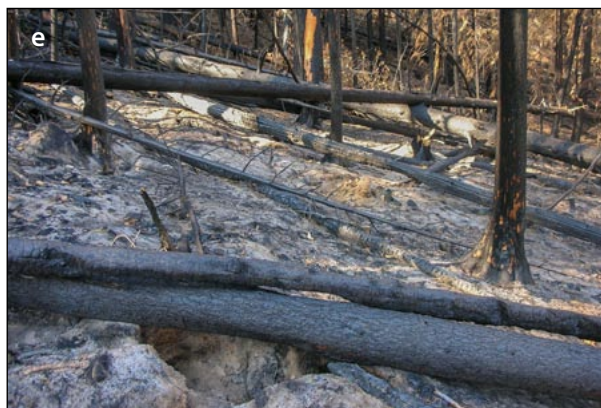
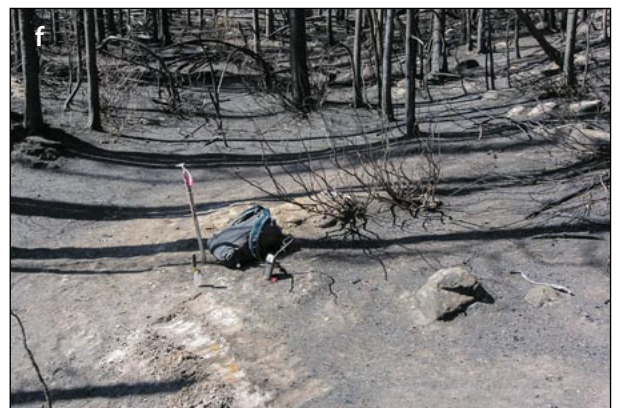
FIGURE 3 Ground views of burn severity classes: (a, b) low vegetation and soil burn severity; (c) moderate vegetation and soil burn severity; (d) high vegetation and moderate soil burn severity; and (e, f) high vegetation and soil burn severity. (Photos: a, c, d, e: G. Hope; b, f: P. Jordan)

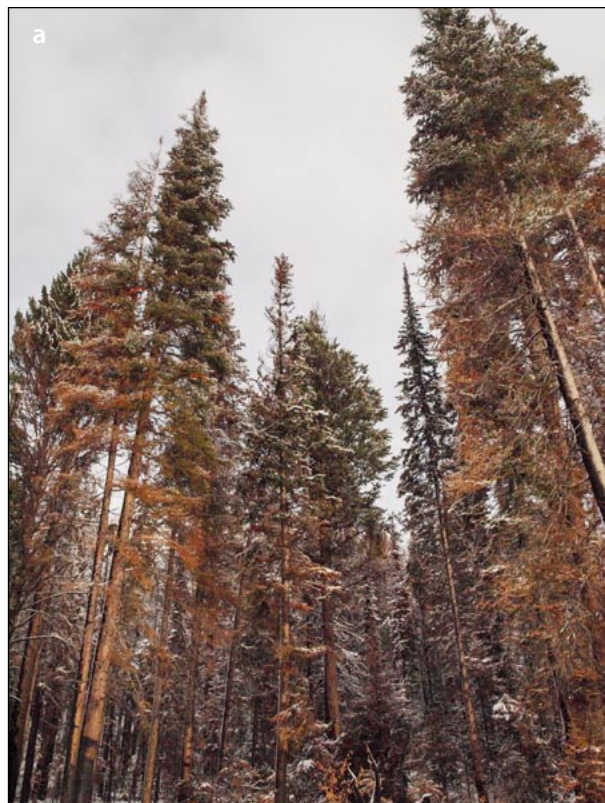
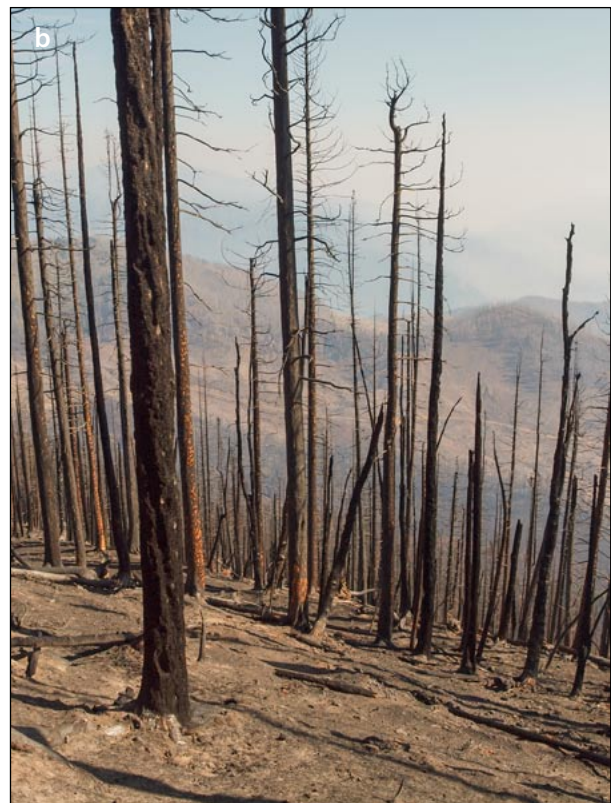
FIGURE 5 Low (a) and high (b) vegetation burn severity in the area burned by the 2009 Mount McLean Fire. As vegetation burn severity increases, so will post-fire hydrologic response. (Photos: R. Winkler)

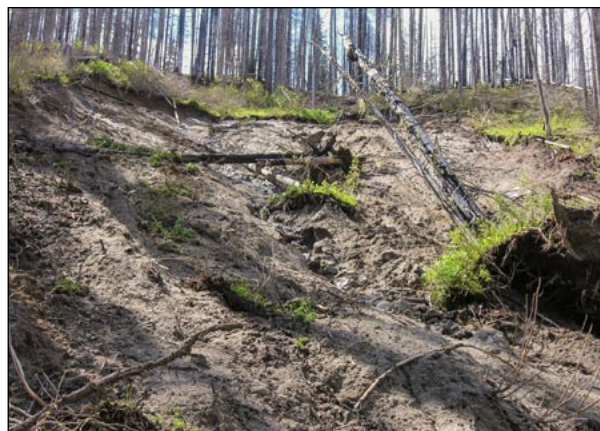
FIGURE 8 Debris slide initiated in an area severely burned by the 2007 Springer Creek Fire. (Photo: P. Jordan)

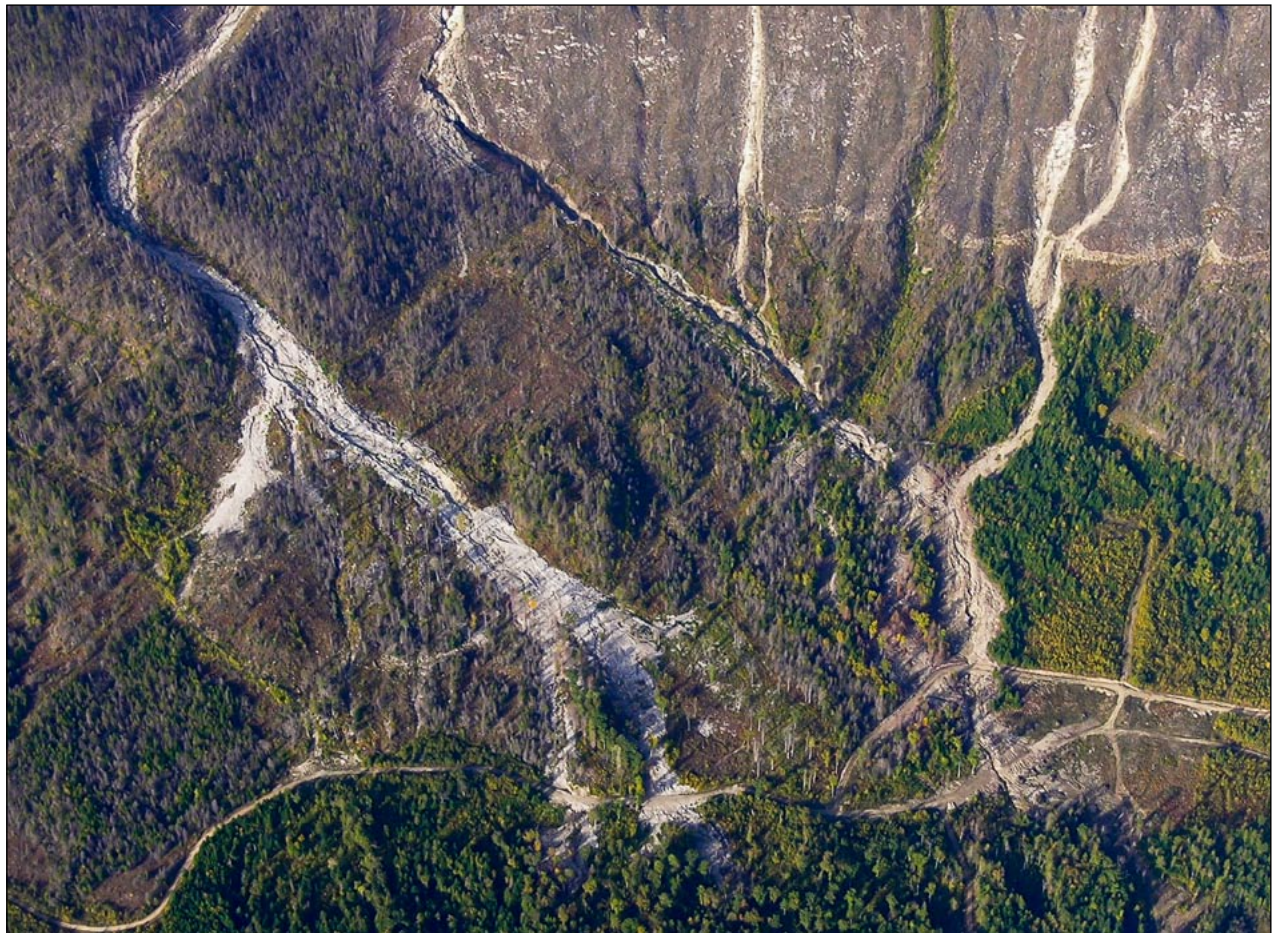
FIGURE 9 Debris flows originating in the area burned by the 2003 Ingersoll Fire near Burton (Arrow Lakes) after a long-duration, frontal rainstorm in October 2005. (Photo: P. Jordan)

Post-wildfire landslides can occur in spring, summer, and fall in response to snowmelt, localized high-intensity rainstorms, or long-duration frontal rainstorms (Figure 9). The deforested area in a severely burned watershed can approach 100%, leading to an increased hazard of spring snowmelt-triggered

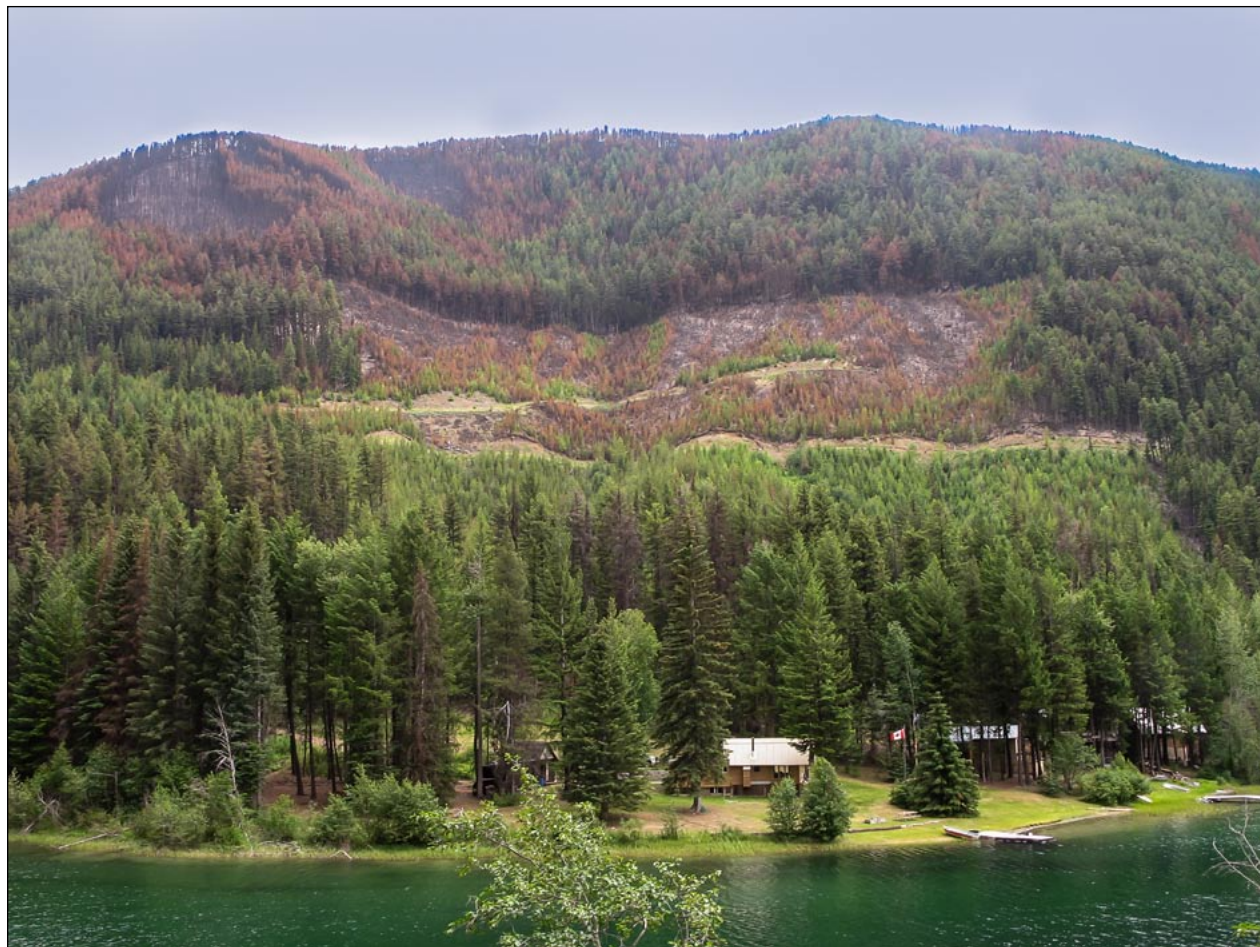
FIGURE 10 Seasonal residence on an alluvial fan at risk from hazards on burned slopes within the 2009 Tyaughton Lake Fire.  
(Photo: T. Giles)

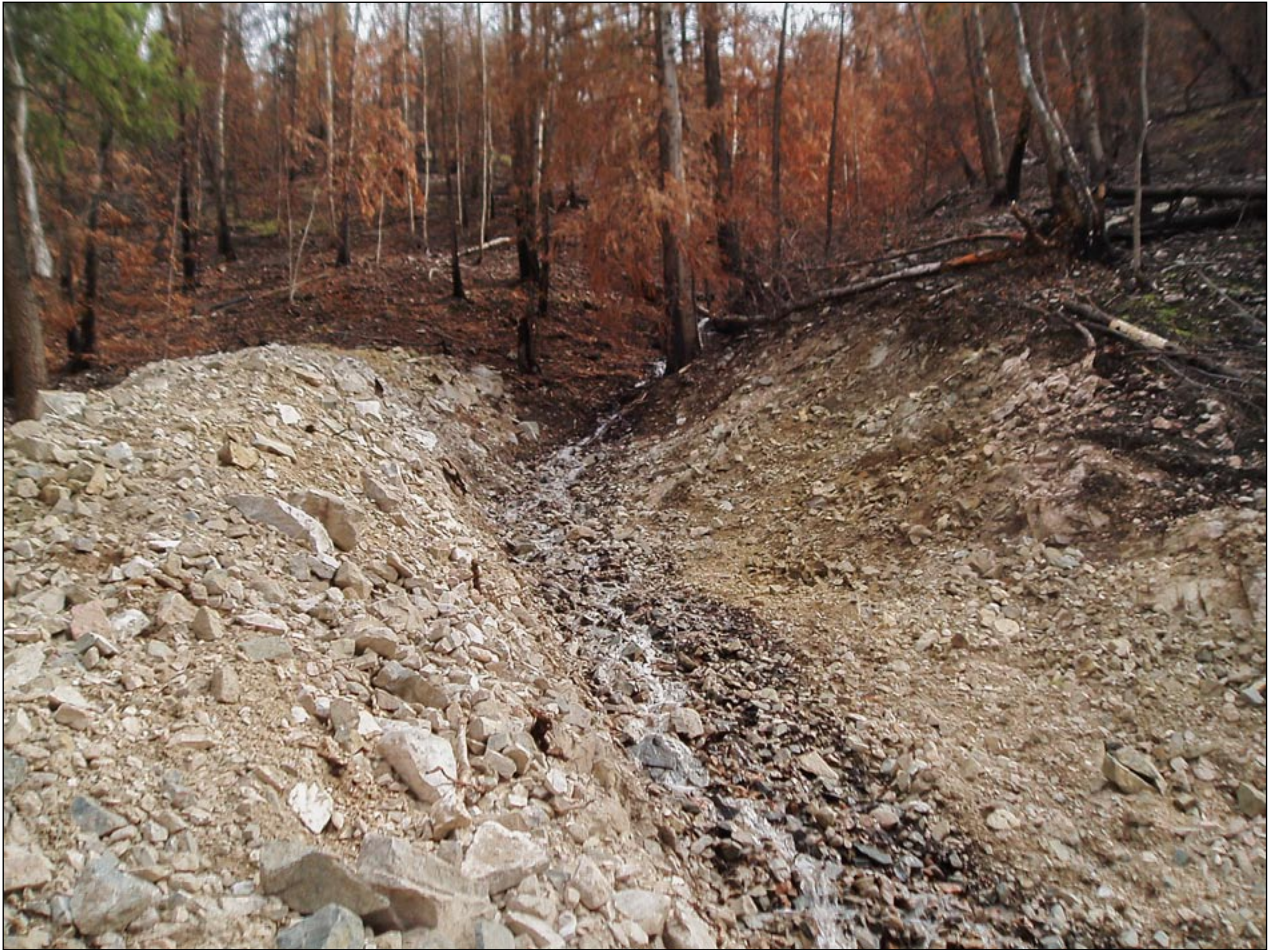
FIGURE 11 *Debris flow deflection berm constructed to protect a residence at risk below the 2009 Terrace Mountain Fire.*  
(Photo: T. Smith, Westrek)

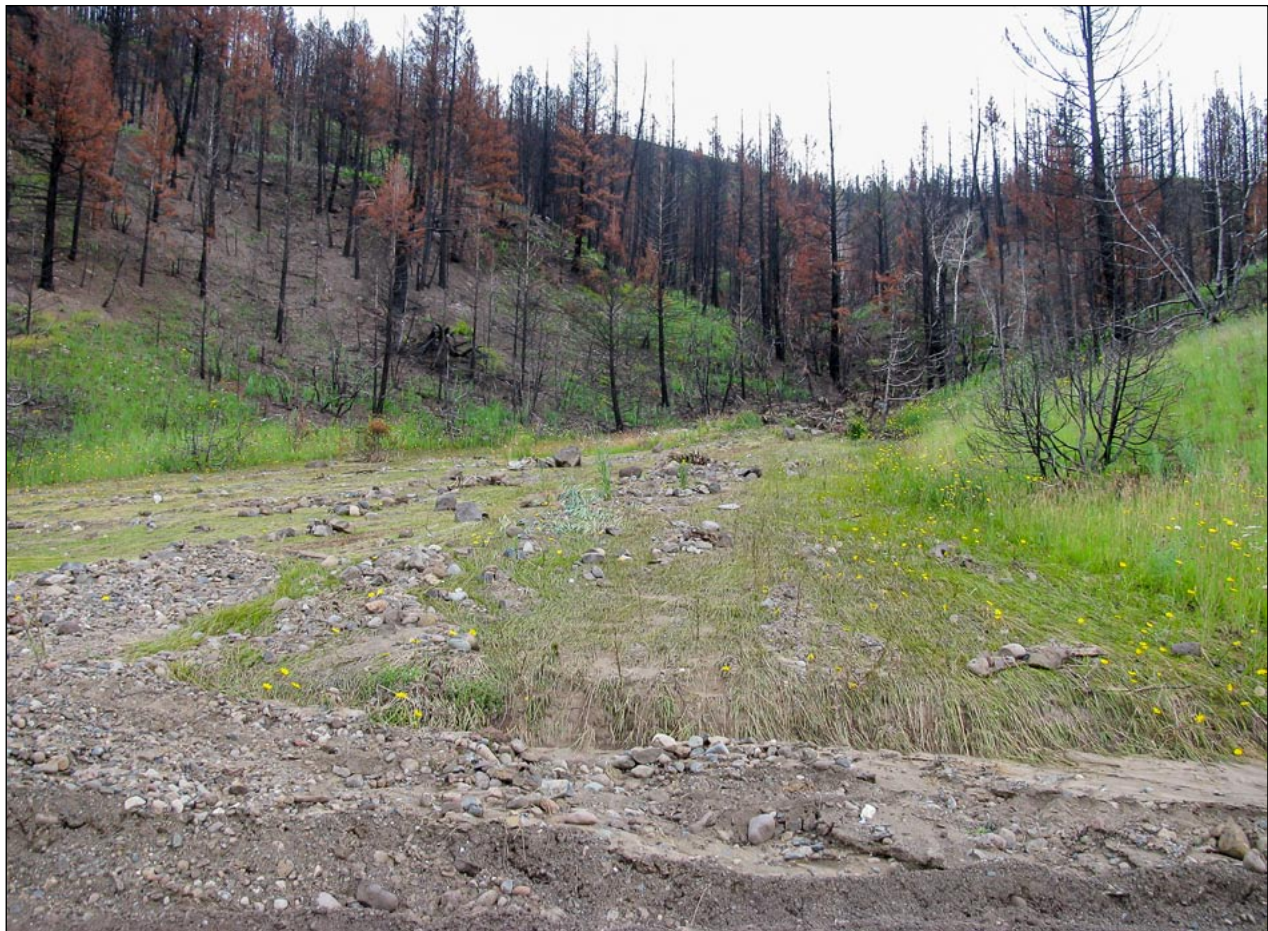
FIGURE 14 *Deposition zone of a post-wildfire debris flow onto Dog Creek Road (berm of road in foreground), following the 2010 Place Lake Fire. (Photo: B. Chapman)*

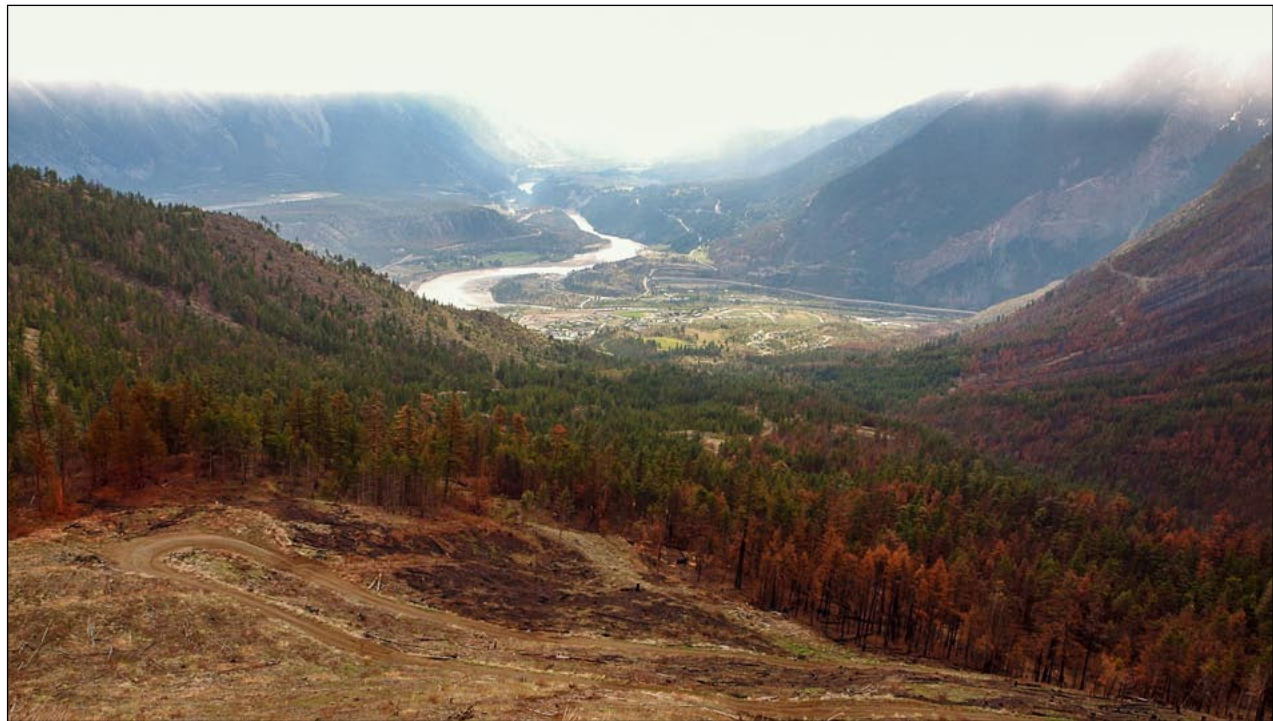
FIGURE 18 Aerial view of the Town Creek watershed showing residential, industrial, and recreational values, highways, and key salmon habitat downstream of the fire. (Photo: R. Winkler)

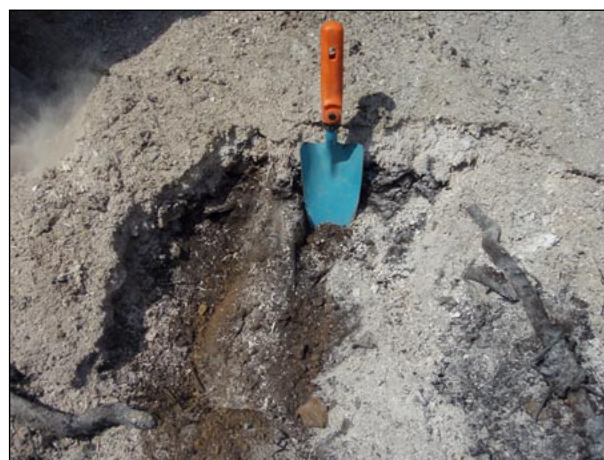
FIGURE 19 Surface mineral soil after the 2009 Mount McLean Fire, rated as moderate soil burn severity, showing the deep ash layer, almost complete loss of forest floor, and largely unaltered mineral soil. (Photo: G. Hope)
