| Appendix 1 Riparian Assessment Report | | | | | | | | | | | | | | | | |
|---|---|---|---|---|---|---|---|---|---|---|---|---|---|---|---|--|
| Riparian Assessment Report | | | | | | | | | | | | | | | | |
| TSL | TA1918 | Block ID | CAR-155, CAR-160, & CAR-162 | | | | Report Date | 2021-10-27 | | | | | | | | |

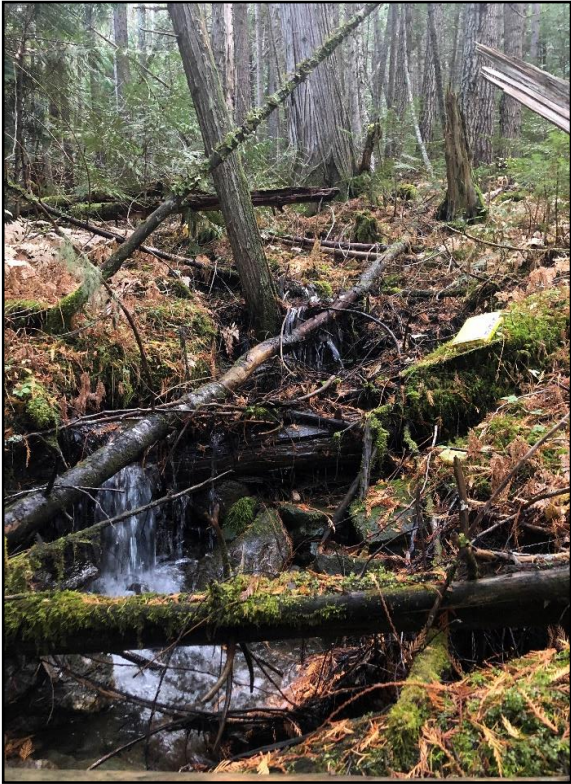
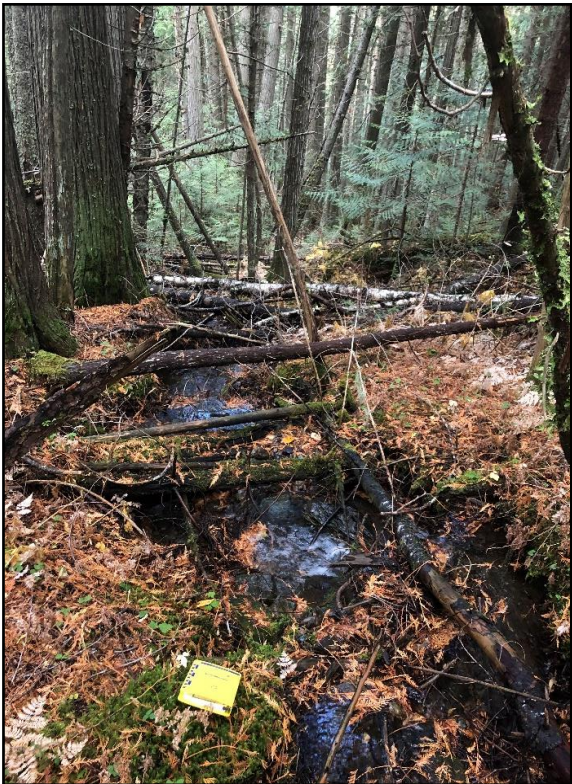
| APPENDIX 1 - PHOTOS | | |
|---|---|---|
| <p><b>Description:</b> Site 918A, Reach 2. The reach had a cascade-pool morphology and had a continuous gradient of &gt;30%.</p> | <p><b>Description:</b> Site 918A, Reach 1. The channel had an average channel width of 1.11m. The reach had sloped banks and was vegetated by a mature mixed forest.</p> | <p><b>Description:</b> Site 918B, Reach 1. The reach had an average gradient of 27% and a cascade-pool morphology.</p> |

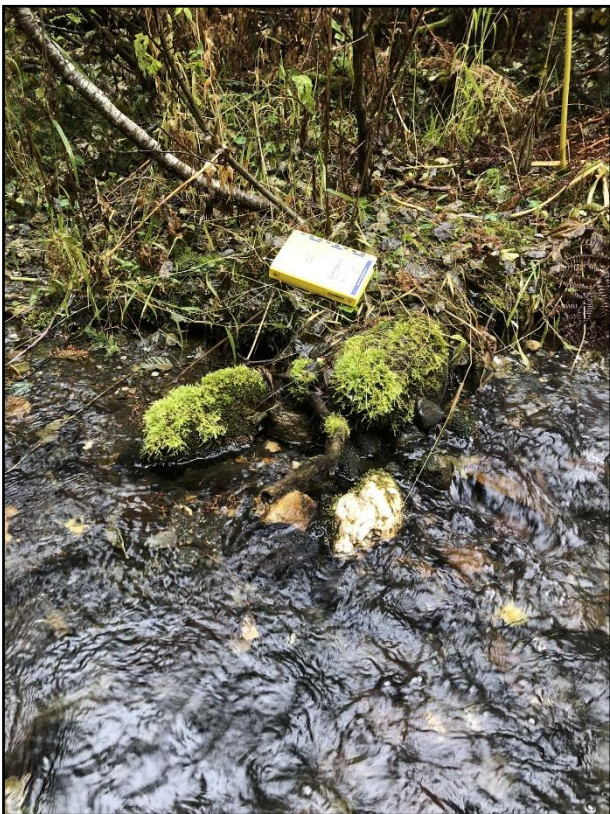
| Site 918C | 2 | 10U 607280E, 5833995N; Reach 2 (S6). This reach was the mainstem (Collins Creek) downstream of Sites 918B - 918G. The reach acted as a fish barrier due to the cascade-pool channel morphology and the sustained gradient of >20%. No fish were observed throughout the survey. As the gradient was determined to be a fish barrier, no fish sampling was undertaken in Collins Creek, or any of the reaches upstream (Sites 918 B - 918G). Reach 1 was downstream of the closest road access point and ~250m downstream from the nearest block. Therefore, as this was more than 100m away from the block, surveying Reach 1 of stream was determined to be not required. |

**Description:** Site 918C, Reach 2. Reach 2 had a cascade-pool morphology and a consistent gradient of >20% which acted as a fish barrier.

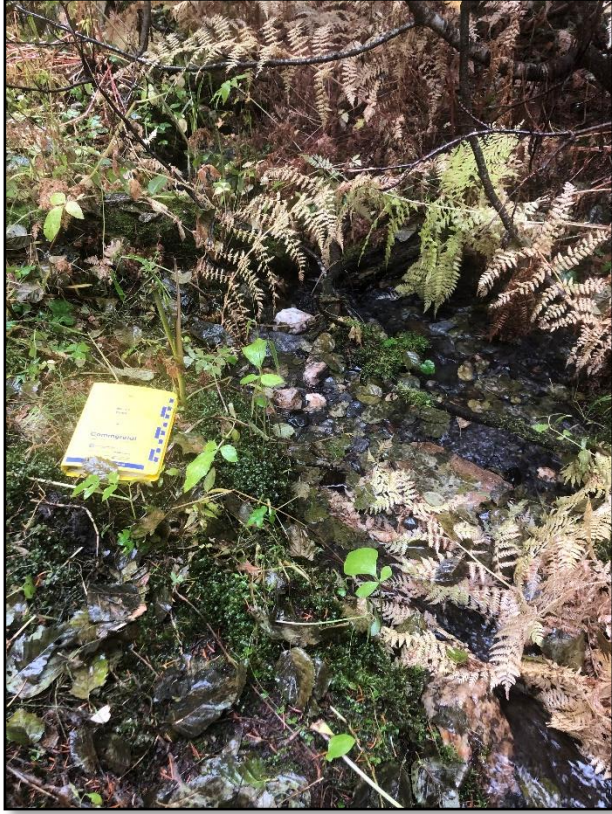
| Site 918D | 1 | 10U 607449E, 5834128N; Reach 1 (S6). The stream was well-defined and had an average gradient of 17%. Downstream fish barriers (the gradient in in Reach 2 of Site 918C) precluded fish access into this reach. |

**Description:** Site 918D, Reach 1. Reach 1 had an average channel width of 0.37m and an average gradient of 17%.

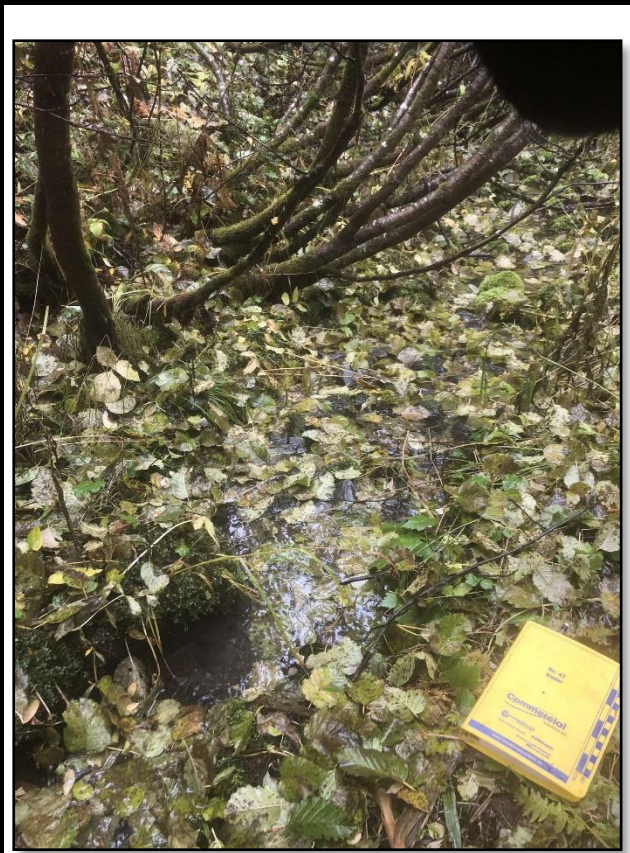
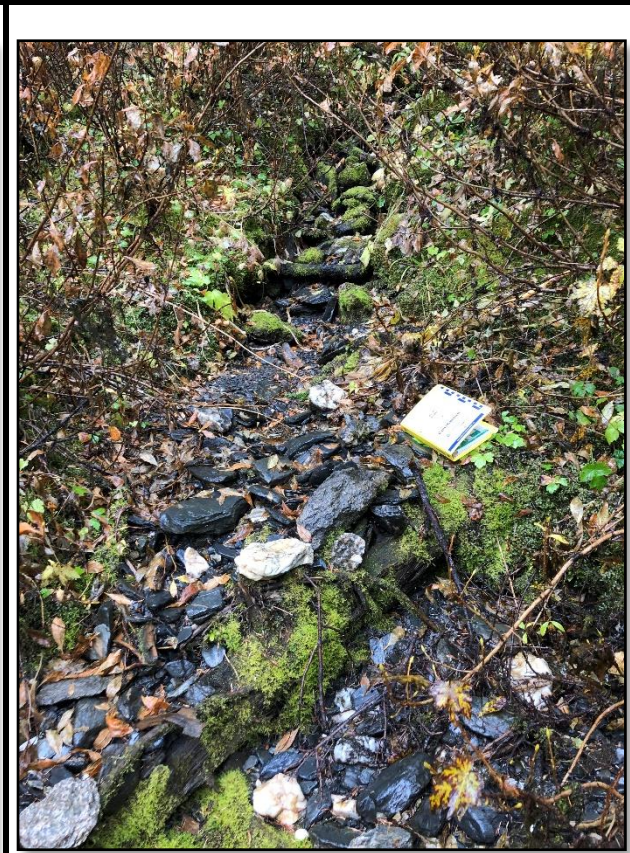
| <p><b>Description:</b> Site 918E, Reach 1. The reach had an average channel width of 0.39m and a predominant substrate of gravel with fines.</p> | <p><b>Description:</b> Site 918F, Reach 1. The reach was primarily dry at the time of survey, however, it was well defined and had an average channel width of 0.76m.</p> | <p><b>Description:</b> Site 918F, Reach 1. The reach had a predominant substrate of gravels and cobbles and an average gradient of 29.5%.</p> |

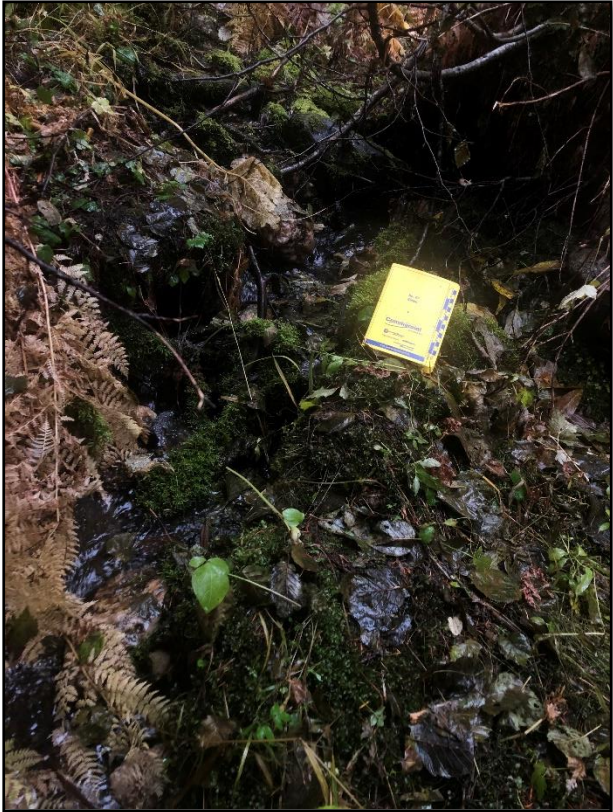
| Site 918G | 1 | 10U 607293E, 5833964N; Reach 1 (S6). The majority of site 918G was beyond the block boundary. |

| <p><b>Description:</b> Site 918G, Reach 1. The reach had an average channel width of 0.56m and a gradient of 22%.</p> | | |
