**Terrain Stability Assessment**

**TA1918 Blocks CAR-153, 155, 160, 162, 176,  
177, 178, 180**

**Seller Creek – Collins Creek Area**

December 12, 2022  
File: 317-20

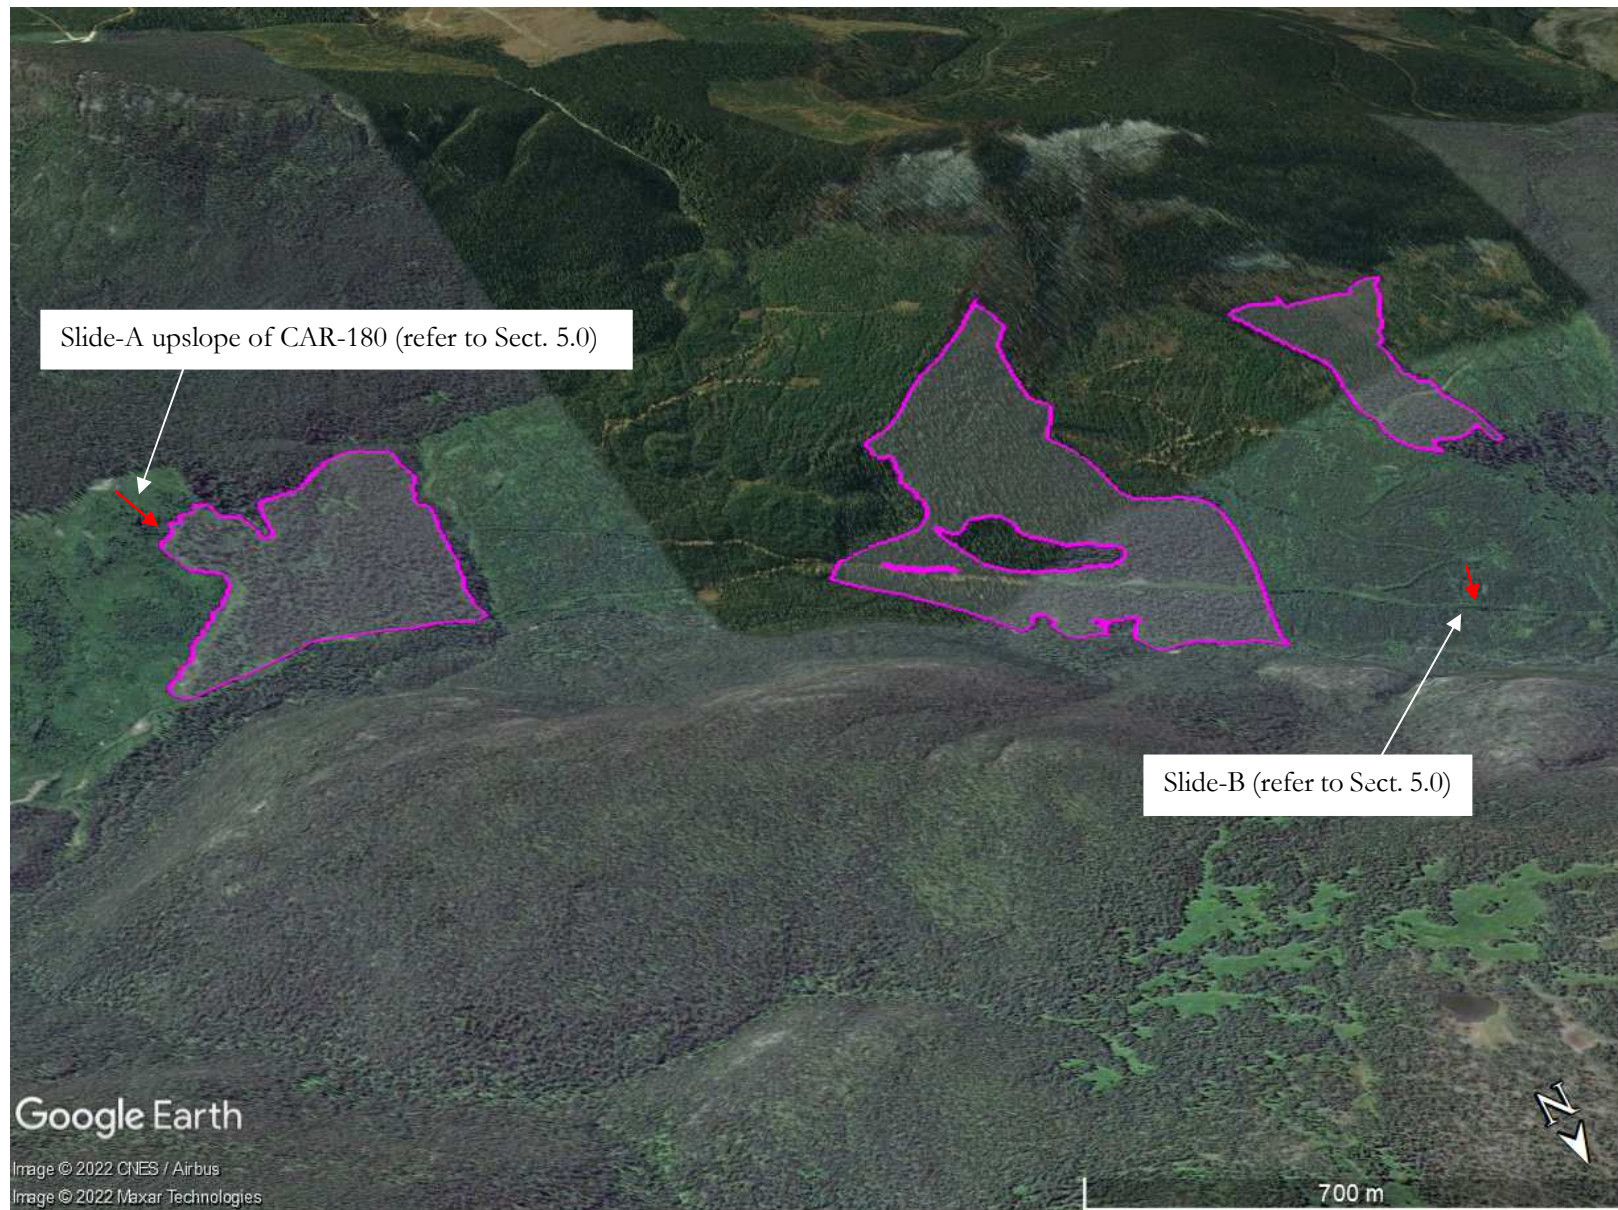
**Figure 12:** Oblique Google Earth Image of the Recce Polygons for TA1918 CAR-177, CAR-178, and CAR-180.
